# Physical Description and Condition Assessment

## 1 Site

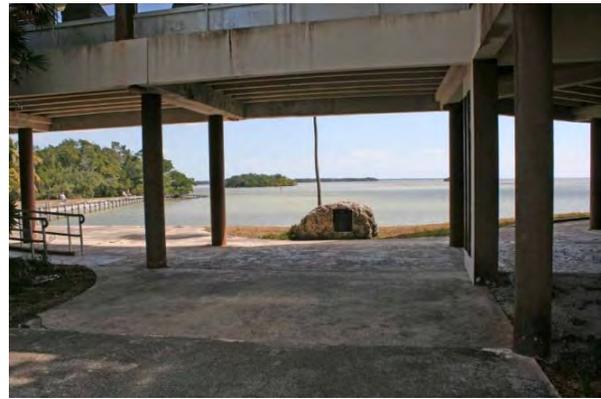
35 In addition, the Guy Bradley Memorial has been  
36 moved from its original location adjacent to the  
37 entry walk and placed at the terminus of the  
38 breezeway sidewalk, interrupting the intended  
39 view of the bay (Figure 92).

40  
41 **FIGURE 92.** The Guy Bradley Memorial has been  
42 moved from its original location adjacent to the  
43 entry walk.

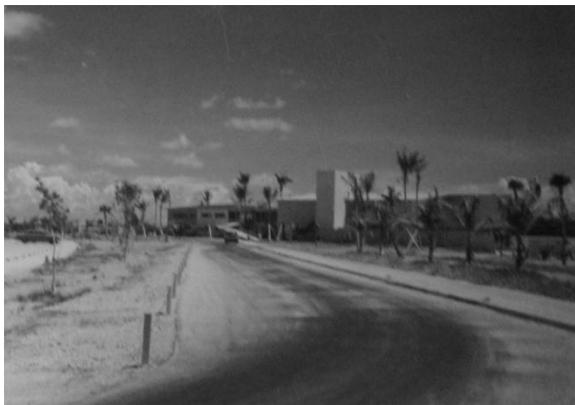
23  
 24 **FIGURE 98.** Coconut and sabal palms were planted in  
 25 1958 but do not survive.

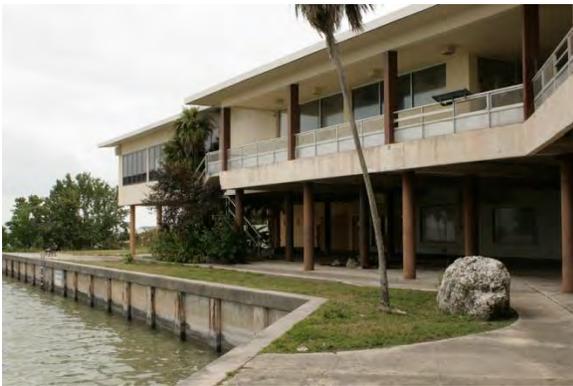
54 The two linear planting beds along the edge of  
 55 basin no. 3 were originally planted with natal plum  
 56 (*Carissa grandiflora* syn. *Carissa macrocarpa*) and  
 57 saltwort (*Severinia buxifolia*) (Figure 102). Natal  
 58 plum tolerates heavy winds and both species are  
 59 known for their salt-tolerance. It is not known  
 60 when and why these plantings were removed, but  
 61 today the planting beds host only Bermuda grass  
 62 (Figure 103).

5  
6 **FIGURE 103.** Today the planting beds contain only  
7 Bermuda grass and the palm visible in the  
8 foreground of this view.

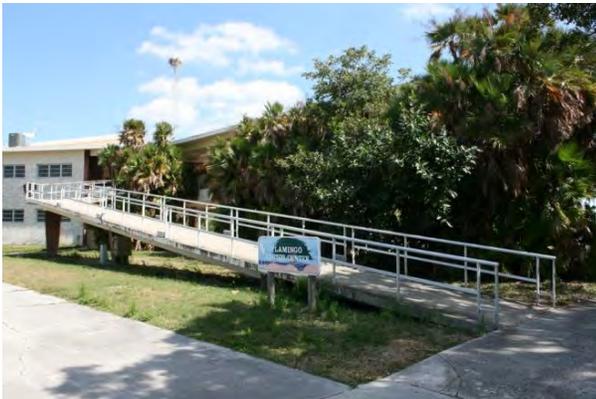
20 In general, the vegetation around the visitor center  
21 is in only fair condition, being either overgrown or  
22 entirely absent from planting beds. Paurotis palms  
23 have been allowed to develop thickets and  
24 volunteer growth has established, blocking views  
25 to Florida Bay (Figure 105). In general, with the  
26 exception of the taller palms, the vegetation  
27 around the visitor center no longer expresses the  
28 original design intent.<sup>115</sup>

29  
30 **FIGURE 105.** Overgrown vegetation obscures views at  
31 the visitor center.

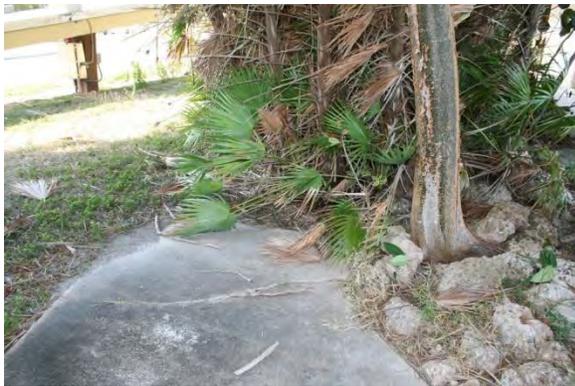
7  
8 **FIGURE 109.** A sidewalk is obscured by overgrowth  
9 from the Paurotis palms.

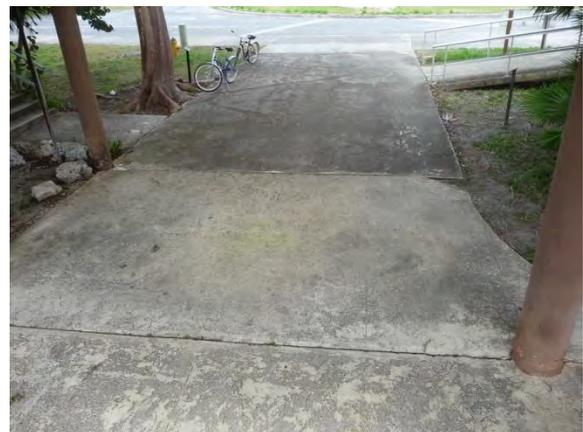
29 good condition, although later replacements and  
30 additions were installed with a simple broom  
31 finish and do not match the original architectural  
32 design or finish (Figure 110).

43  
44 **FIGURE 110.** Replaced areas of paving do not match  
45 the original rock salt textured surface.

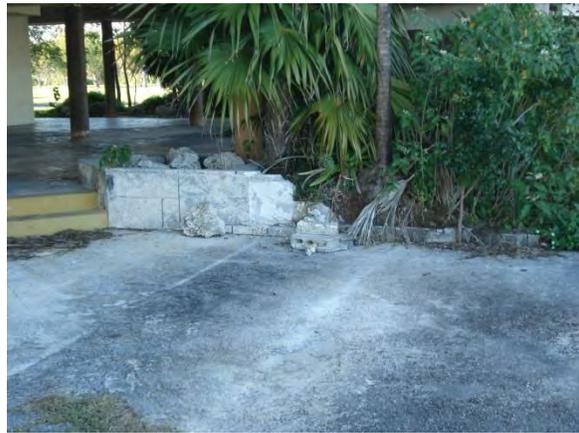
19 south corner. Keystone veneer has debonded from  
20 the mortar bed and several panels are missing. The  
21 exterior raised planting bed wall is in poor  
22 condition (Figure 112).

33  
34 **FIGURE 112.** The planter at the breezeway edge has  
35 been damaged at the south corner.

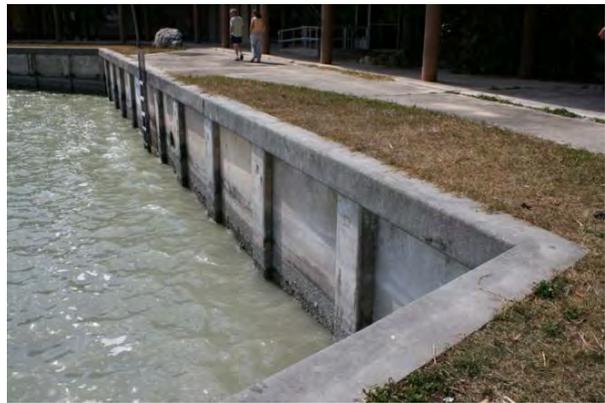
36  
37 **FIGURE 113.** The concrete bulkheads of basin no. 3.

10 The concrete bulkhead elements such as the T  
 11 piles and the cast-in-place bulkhead cap beams  
 12 were not included in the condition assessment;  
 13 however, we observed severe deterioration of  
 14 these elements. The observed deterioration  
 15 included large corrosion cracks and significant  
 16 concrete spalling. Reinforcement was exposed  
 17 at a number of locations.<sup>117</sup>

18 The 2007 report stated that the dead man piers and  
 19 tie rods were in fair to good condition. However,  
 20 the concrete T piles, panels, and cap were  
 21 observed to have large cracks and concrete spalls  
 22 due to corrosion of the embedded reinforcing  
 23 steel. Distress in the form of extensive cracking  
 24 was observed at the top of the cast-in-place  
 25 bulkhead cap beam. Concrete cracking and  
 26 spalling, corrosion of embedded reinforcing, and  
 27 corrosion staining were observed on concrete T  
 28 piles and panels. The deterioration that was  
 29 observed was concentrated near the top of T piles,  
 30 immediately below the concrete cap beam. As part  
 31 of the 2007 report, further investigation was  
 32 recommended to determine if repair of the  
 33 concrete piles, panels, and cap was possible, or if  
 34 these elements were beyond repair.

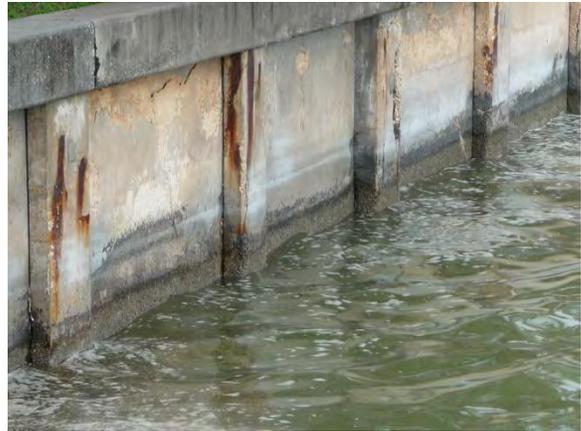
42 Distress in the form of extensive cracking was  
 43 observed at the top of the cast-in-place bulkhead  
 44 cap beam. Concrete cracking and spalling,  
 45 corrosion of embedded reinforcing, and corrosion

46 staining were observed on concrete T piles and  
 47 panels. The deterioration that was observed was  
 48 concentrated near the top of T piles, immediately  
 49 below the concrete cap beam. As discussed in the  
 50 2007 report, we recommend that additional  
 51 assessment of the concrete elements of the  
 52 bulkhead be performed, including inspection  
 53 openings to reveal existing and as-built conditions,  
 54 and to determine the viability of repair or  
 55 replacement of the bulkhead (Figure 114).

56  
 57 **FIGURE 114.** Corrosion staining on the bulkhead  
 58 walls.
