Physical Description and Condition Assessment

10 **Exterior Condition Assessment**

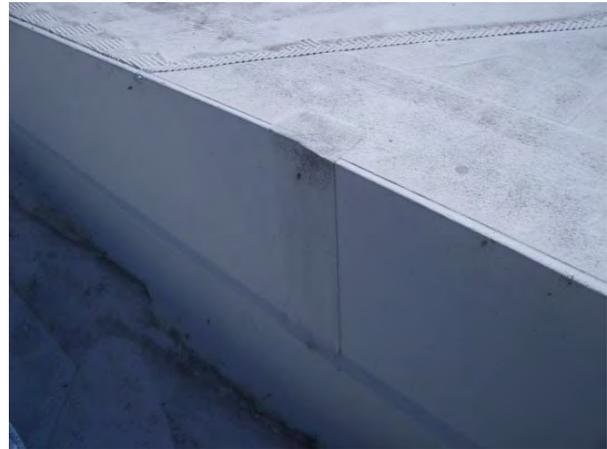
40
41 **FIGURE 198.** At joints in the fascia, strips of
42 membrane have been applied.

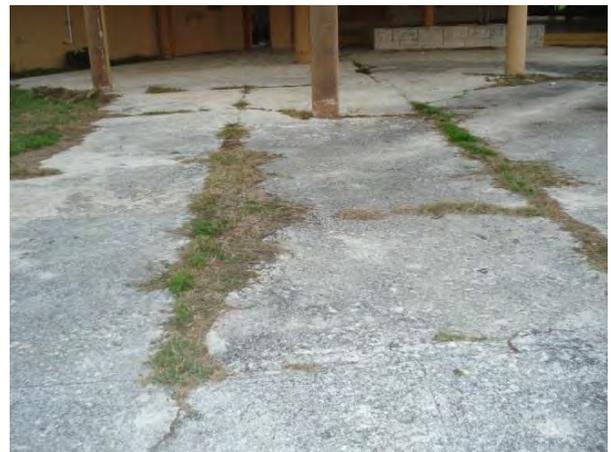
- 12 ▪ Organic growth in the form of small plants was
13 observed on upward facing surfaces at
14 construction joints and between concrete
15 construction joints (Figure 202). Organic
16 growth was most pronounced at the south end
17 of the site, where pedestrian traffic and
18 routine maintenance are less frequent.

34
35 **FIGURE 202.** Vegetation growing from joints in
36 concrete paving.

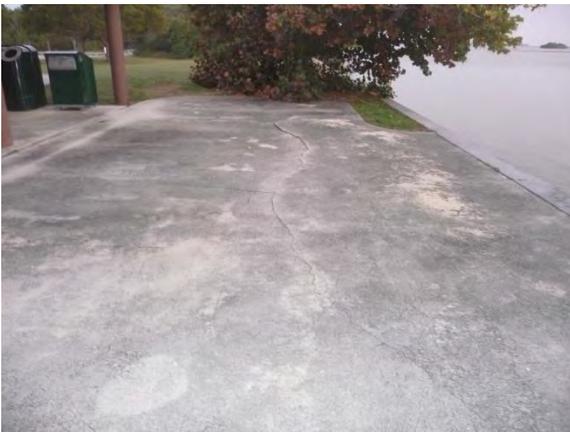
- 25 ▪ Cracks indicating differential settlement in the
26 plaza paving were observed just south of
27 the office and museum component (Figure 204
28 and Figure 205).

4
5 **FIGURE 204.** Crack in concrete paving due to
6 differential settlement.

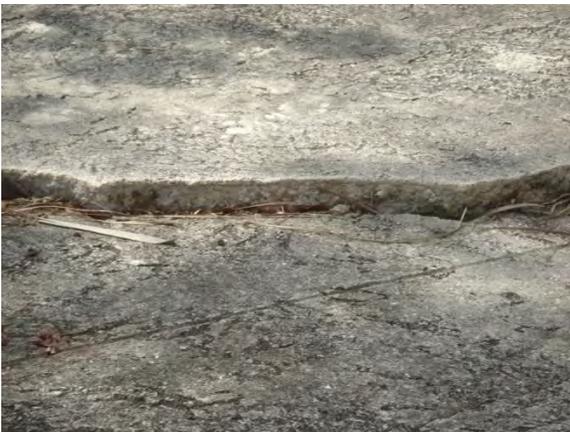
7
8 **FIGURE 205.** Crack in concrete paving and differential
9 settlement.

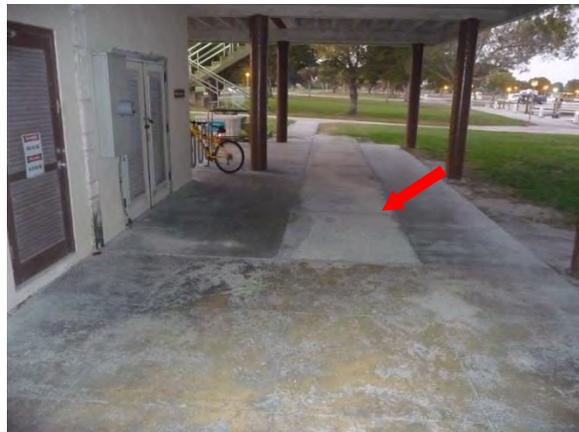
- 12
- 13 ▪ Sections of the original first floor patio
14 pavement on the north and west sides of the
15 building have been replaced by new concrete
16 pavement. The replacement paving does not
17 retain the texture, color, or paving pattern of
18 the original pavers (Figure 207 and
19 Figure 208). Differences in pavement texture
20 and color were most noticeable at the north
21 end of the office and museum component and
22 at the foot of the concrete ramp on the west
23 side of the site.
 - 24 ▪ Minor spalling and cracking at edges of
25 concrete paving were observed at the first
26 floor level (Figure 209).

26
27 **FIGURE 207.** Areas of replaced concrete paving do
28 not match the original in color or texture (original
29 concrete in the foreground).

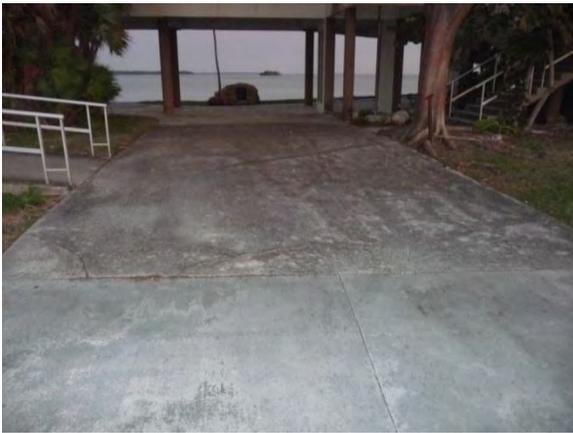
1
2 **FIGURE 208.** Localized replacement of concrete
3 paving that does not match the original in color or
4 texture (original concrete in the background).

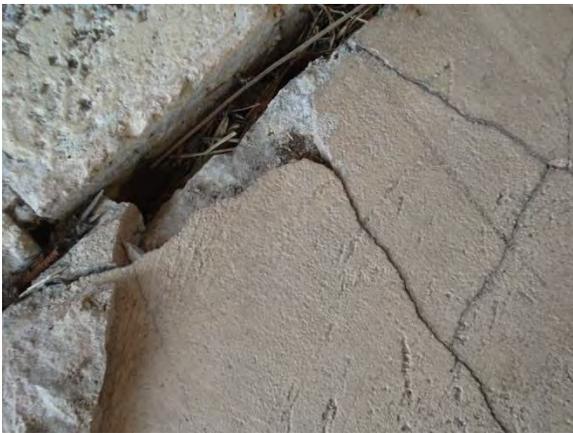
5
6 **FIGURE 209.** Minor spalling and cracks in first floor
7 concrete slab.

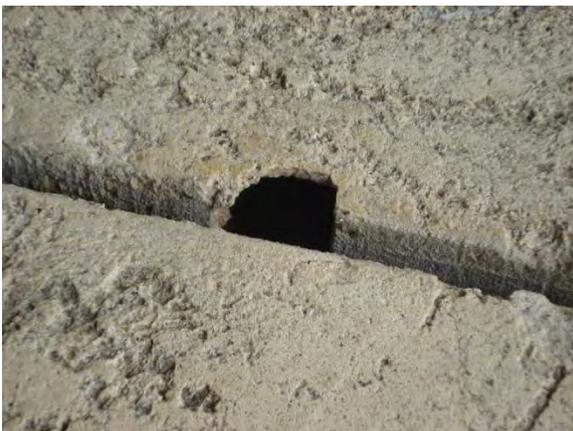
- 8 ■ Physical impact damage in the form of holes in
9 the first floor concrete pavement was
10 observed (Figure 210). Holes in the concrete
11 pavers were located at edges of the pavers
12 where construction joints were displaced.

13
14 **FIGURE 210.** Impact damage to concrete pavers.

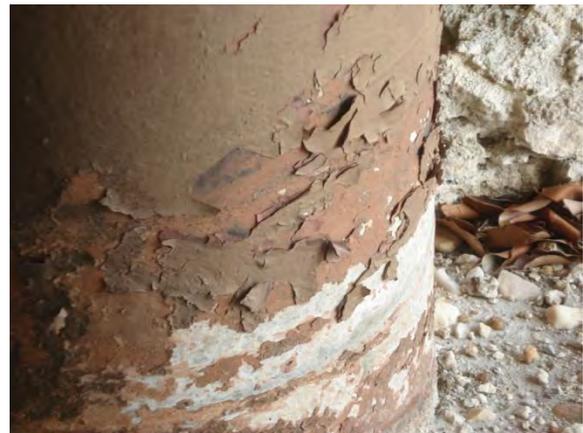
- 17 ■ Peeling paint was observed on all painted
18 surfaces (Figure 211 through Figure 213).
19 Extensive peeling was identified at the base of
20 the first and second floor columns and on
21 stucco walls and spandrel panels. Blistering
22 and peeling paint were observed at several
23 locations on the first and second floor
24 columns and piers (Figure 214).
- 25 ■ Organic growth in the form of mold,
26 vegetation, and algae were observed at roof
27 gutters and on vertical surfaces such as the
28 raised stucco panels (Figure 215). Organic
29 growth was most pronounced on the west
30 elevation, where landscape vegetation is most
31 dense.

32
33 **FIGURE 211.** Peeling paint on concrete columns.

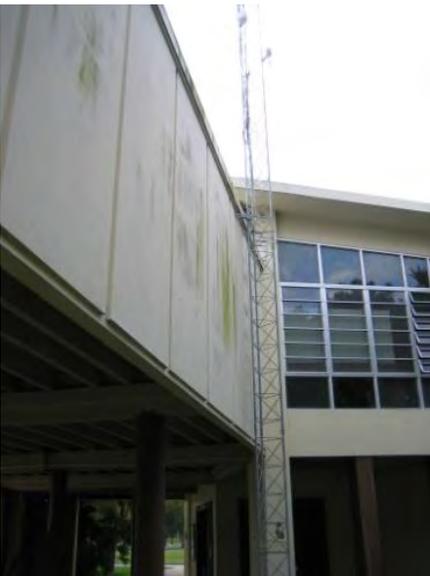
5
6 **FIGURE 215.** Organic growth on stucco cladding.

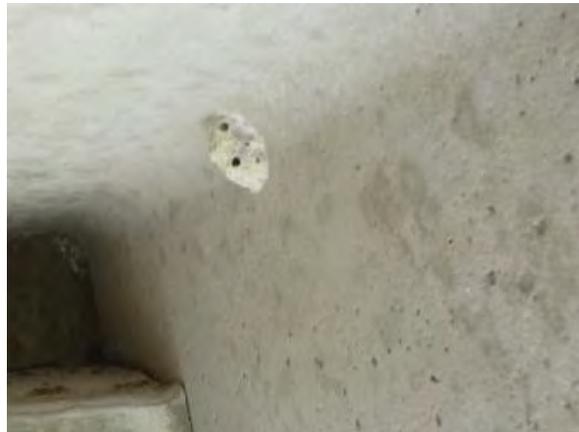
8 ■ Biological impacts in the form of
9 yellowjackets' nests were observed on the
10 underside of the double-tee beams. An osprey
11 nest is present on top of the
12 telecommunications tower adjacent to the
13 office and museum component (Figure 216).

25
26 **FIGURE 216.** Yellowjacket nest on underside of
27 concrete structural framing.

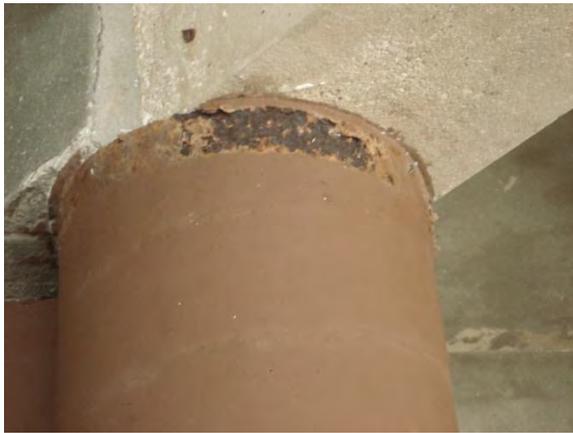
14 ■ Peeling paint and surface corrosion was
15 observed on metal top plates above columns
16 under the south wing of the concessionaire
17 component (Figure 217 and Figure 218).
18 There appeared to be no sectional loss to the
19 metal plate.

1
2 **FIGURE 217.** Surface corrosion of metal column top
3 plates.

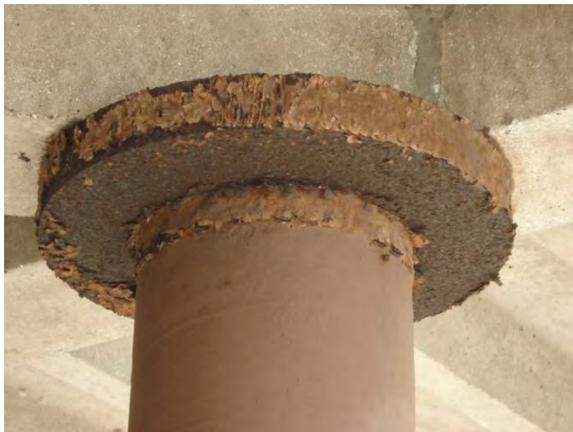
4
5 **FIGURE 218.** Surface corrosion of metal column top
6 plates.

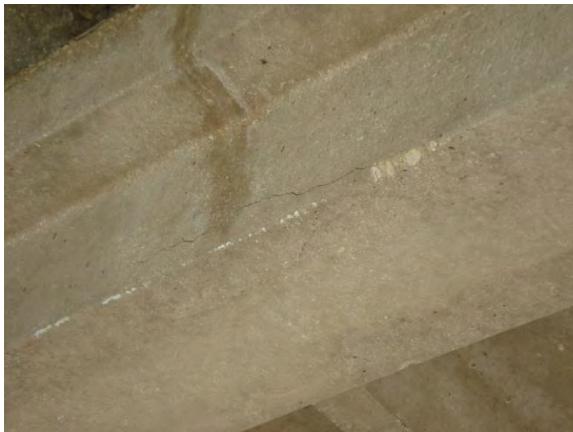
20 ■ Exposed surfaces of the double-tee beams and
21 concrete girders have an abraded and etched
22 appearance (Figure 219). The deterioration
23 may be related to prior use of abrasive
24 cleaning or preparation techniques.¹²⁵

7
8 **FIGURE 219.** Overall abraded appearance of concrete
9 framing members attributed to prior use of high
10 pressure water cleaning techniques.

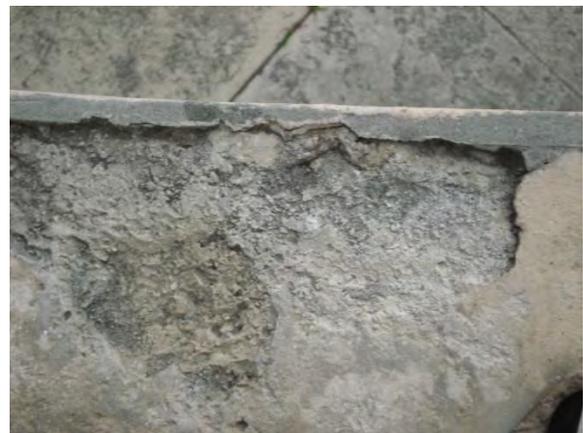
- 12
- 13 ■ Small spalls were noted at the edges of the second floor concrete slab (Figure 220).
- 14
- 15 ■ Corrosion staining and concrete patches were observed on the west side of the second level flooring (Figure 221). The staining and repairs were associated with the removal of previously existing seating units.

44
45 **FIGURE 220.** Concrete spall on top layer of second
46 floor slab.

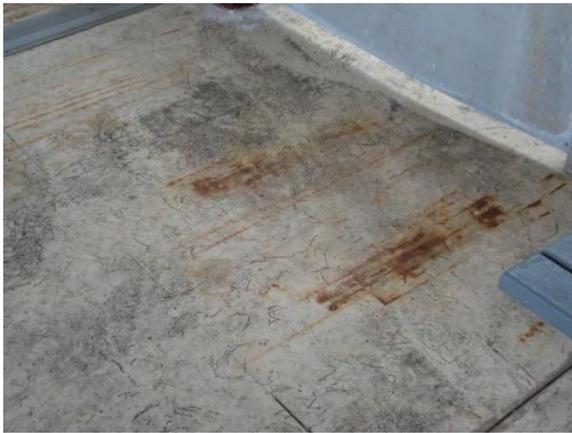
1
2 **FIGURE 221.** Corrosion staining on second floor slab.

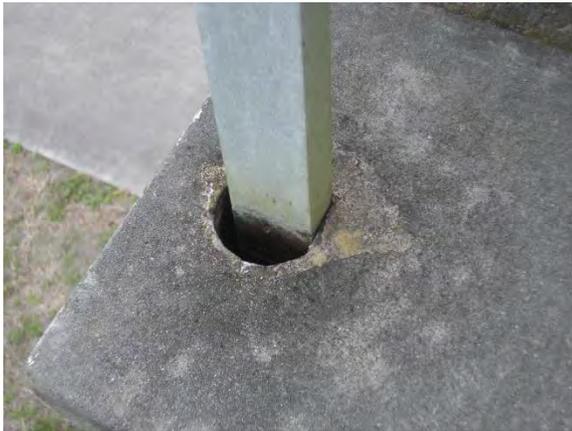
- 16
- 17
 - 18
- 19
- 20 ■ Grout within pockets at metal handrail supports was observed to have deteriorated and in many instances the grout pockets contained moisture and organic growth (Figure 222). Previous repairs included the infill of grout pockets with what appeared to be a gypsum-based grout (Figure 223). Expansion of the gypsum grout when exposed to moisture resulted in cracking and spalling of the textured concrete adjacent to the pockets.

3
4 **FIGURE 222.** Open grout pocket for handrails.

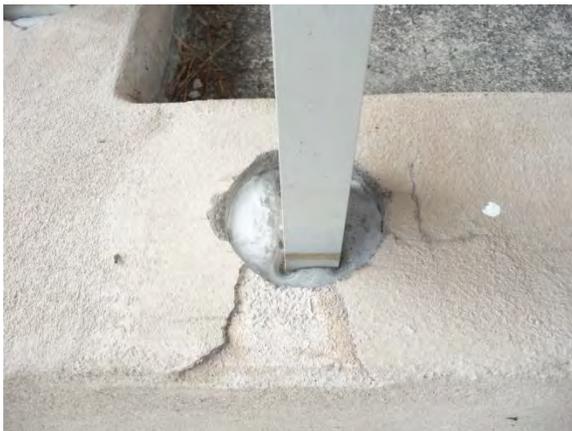
5
6 **FIGURE 223.** Possible gypsum-based grout repair with
7 cracking of surrounding concrete.

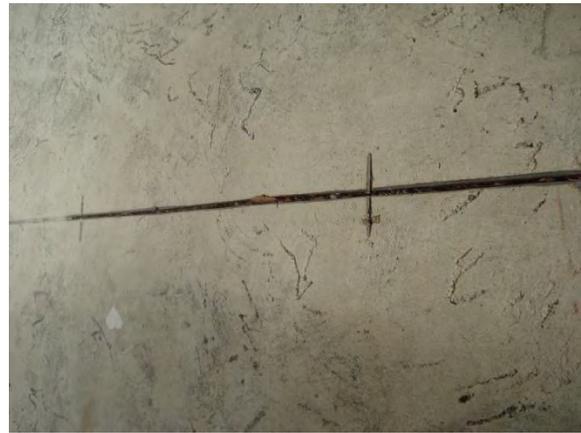
- 21
- 22
 - 23
 - 24
 - 25
 - 26
 - 27
 - 28
 - 29
- 30
- 31 ■ Alterations were previously made to the concrete floor slab in an effort to reduce flooding of the breezeway area. Drainage was enhanced through the saw cutting of existing cracks in the concrete slab and installation of metal drainage channels and cross ties (Figure 224). Additionally, the edges of existing score or control joints in the concrete slab were deepened and widened through saw cutting. The joint was apparently enlarged to enhance drainage. As a result, staining and organic growth have appeared on the stucco of the spandrel panel immediately below the saw cut joints.

8
9 **FIGURE 224.** Drainage channel saw cut in second floor
10 slab to enhance drainage.

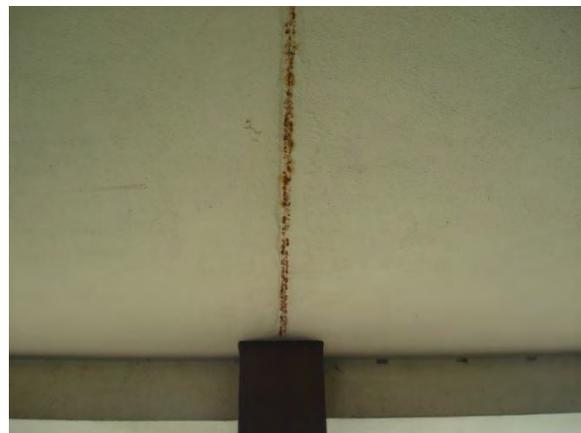
- 11 ▪ Corrosion staining attributed to the metal
12 expansion bead used to frame the stucco
13 ceiling was observed on the ceiling of the
14 second floor breezeway (Figure 225).
- 15 ▪ Concrete spalling and exposed corroded
16 reinforcing was observed in the roof overhang
17 above the loading dock on the west elevation
18 of the concessionaire component (Figure 226).
- 19 ▪ Horizontal cracking of the raised stucco
20 panels was observed at multiple locations on
21 the office and museum component (Figure 227
22 and Figure 228). Typically, the cracks were 30
23 inches above the bottom of the panels and
24 were related to the location of the concrete
25 floor slab. The reflective cracking in the stucco
26 is associated with differential movement of the
27 concrete slab and concrete spandrel panels.

28
29 **FIGURE 225.** Corrosion of metal expansion bead in
30 stucco.

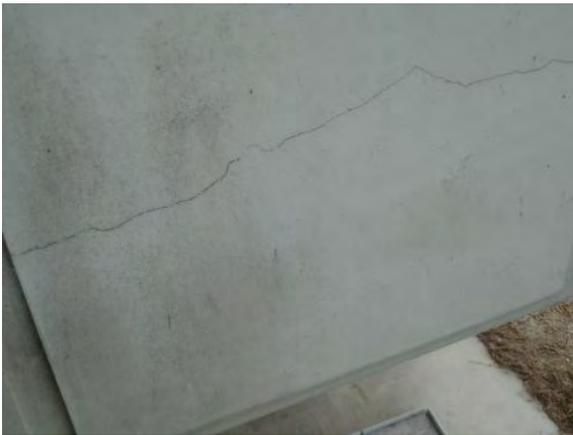
5
6 **FIGURE 227.** Horizontal cracking in raised stucco
7 panels.

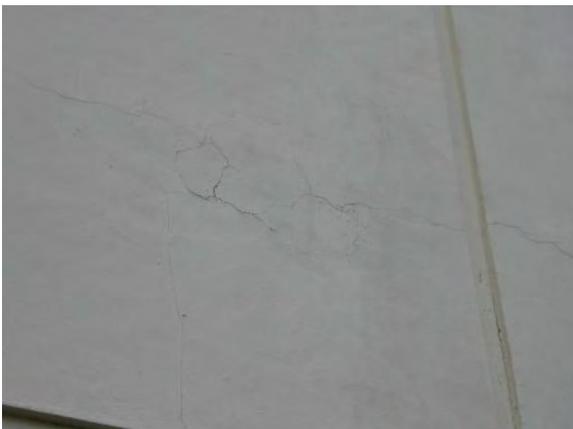
8
9 **FIGURE 228.** Horizontal cracking in raised stucco
10 panels.

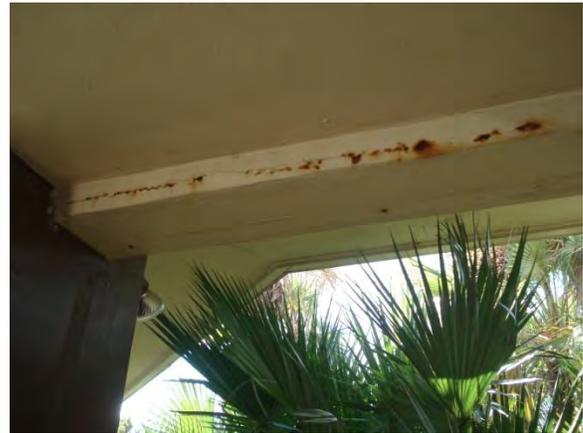
12 ■ Cracks, spalls, and corrosion staining was
13 observed at the corner of concrete tie beams at
14 the second floor level of the breezeway
15 (Figure 229).

26
27 **FIGURE 229.** Cracking, spalling, and corrosion staining
28 on concrete tie beams at the second floor
29 breezeway.

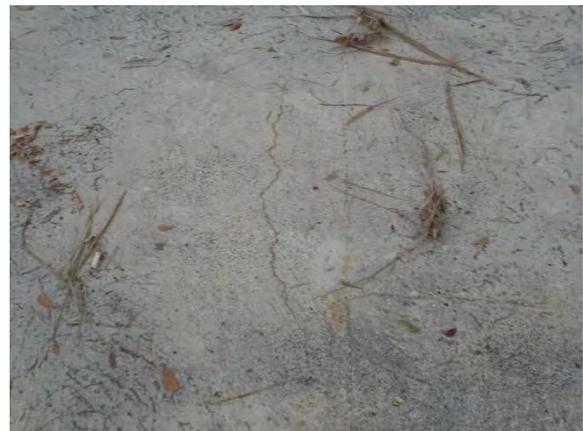
16 ■ The concrete topping slab on the second floor
17 slab was debonded at several locations. Cracks
18 were typically observed at areas of the
19 debonded concrete (Figure 230 and
20 Figure 231).

30
31 **FIGURE 230.** Crack in second floor concrete slab and
32 delaminated top coat.

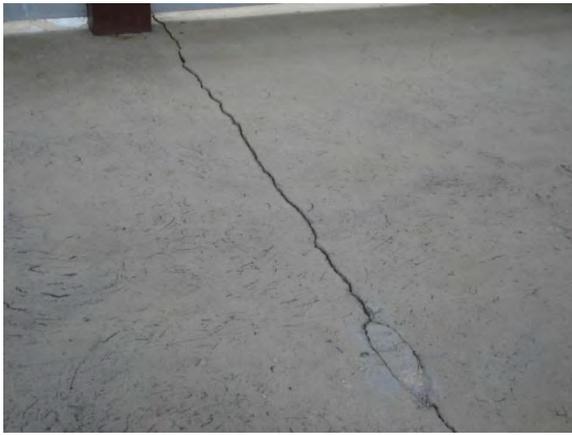
1
2 **FIGURE 231.** Cracks in the second floor concrete slab
3 and delaminated top coat.

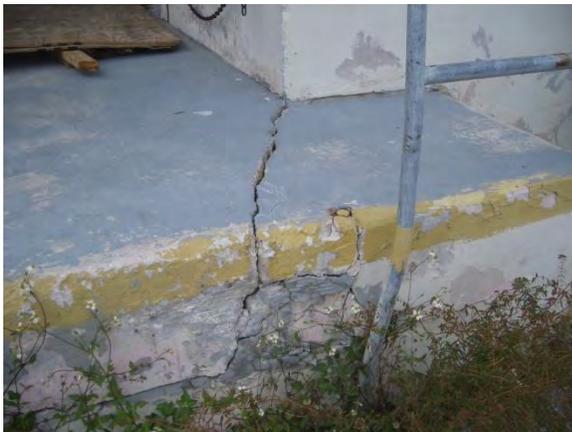
21 ■ Severe cracking and spalling of the loading
22 dock concrete was observed (Figure 232).

4
5 **FIGURE 232.** Spalling and cracking of concrete at
6 loading dock.

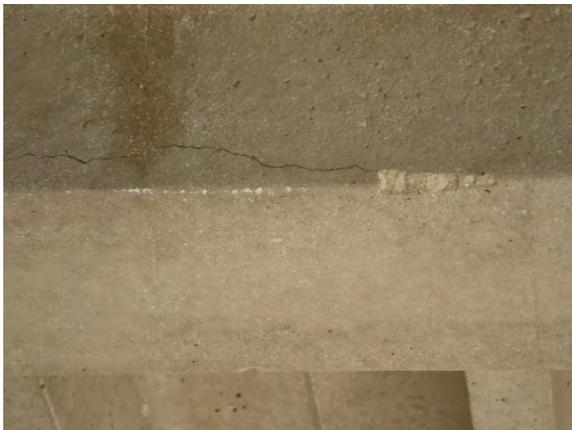
23 ■ Hairline horizontal cracks in precast concrete
24 framing members were noted at isolated
25 locations (Figure 233).

7
8 **FIGURE 233.** Hairline crack in precast concrete
9 framing members.

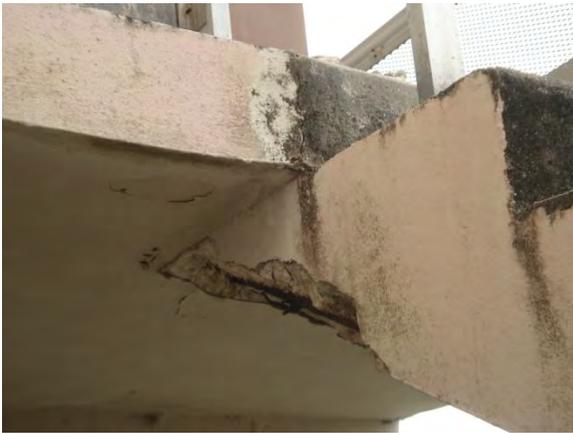
1
2 **FIGURE 235.** Staining and organic growth at stairs,
3 localized in areas subject to moisture run-off.

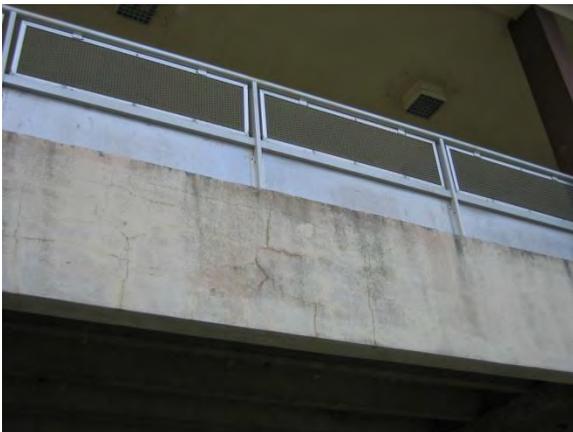
4
5 **FIGURE 236.** Staining and organic growth on stucco
6 spandrel panels localized to areas of moisture run-
7 off.

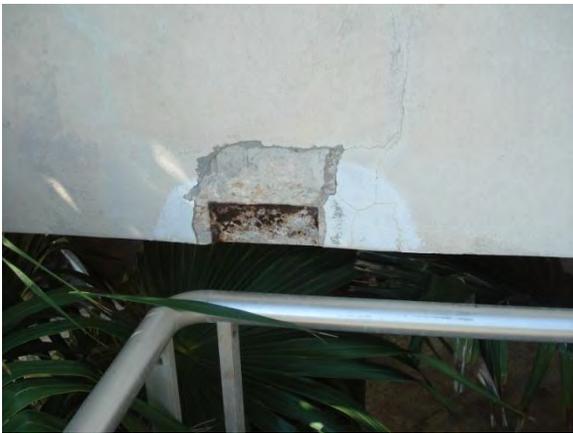
8
9 **FIGURE 237.** Spall in stucco and corroded exposed
10 metal anchor at spandrel panel.

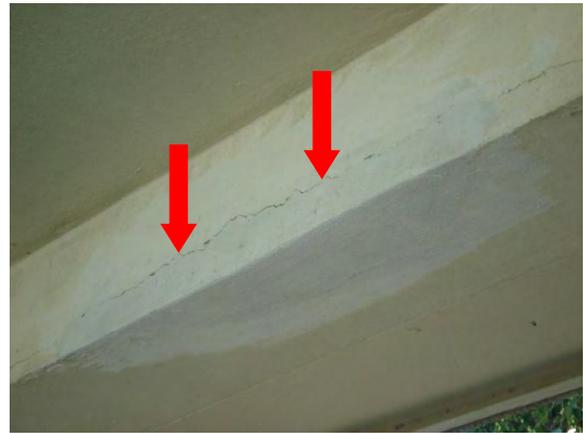
- 11
- 12 ■ Exposed and corroded reinforcing steel was
13 observed at the stair tower of the
14 concessionaire component where a Keystone
15 veneer panel had been removed (Figure 234).
 - 16 ■ Staining and organic growth were observed at
17 areas of moisture run-off across stucco
18 spandrel panels and along stair structures
19 (Figure 235 and Figure 236).
 - 20 ■ Spalling of stucco spandrel panels due to
21 corroded metals anchors was observed on the
22 east elevation of the concessionaire
23 component (Figure 237).
 - 24 ■ Cracking and debonding of previously
25 patched and repaired concrete beams was
26 observed. The previously installed patches
27 appear to be shallow, trowel applied materials
28 that are not mechanically attached to the
29 concrete substrates and have debonded from
the original concrete substrate (Figure 238).

11
12 **FIGURE 238.** Cracking at a previously patched and
13 repaired concrete tie beam.

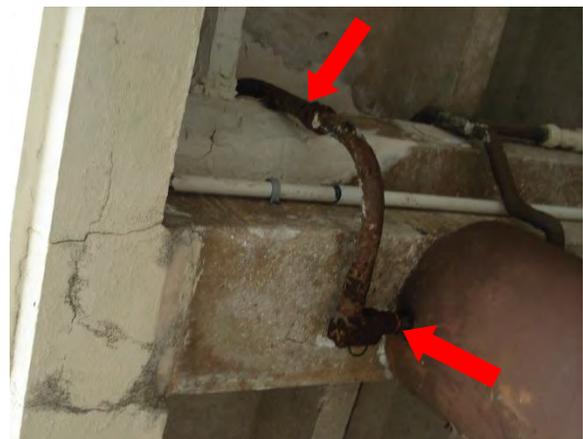
- 14 ▪ Electrical conduit and pipes are surface-
15 mounted and exposed to view on the
16 underside of structural framing members. In
17 some instances, the pipes and conduit
18 penetrate structural concrete columns
19 (Figure 239).
- 20 ▪ Exposed grout pockets are located in some
21 second floor columns where railings were
22 once installed and mounted (Figure 240). The
23 railing was removed between two columns on
24 the west elevation to allow for access to an
25 elevator lift.126
- 26 ▪ Spalling of parge coating was observed on the
27 concrete columns (Figure 241).

28
29 **FIGURE 239.** Arrows point to electrical conduit
30 penetrating concrete columns and beams (view
31 looking up at ceiling of first floor breezeway).

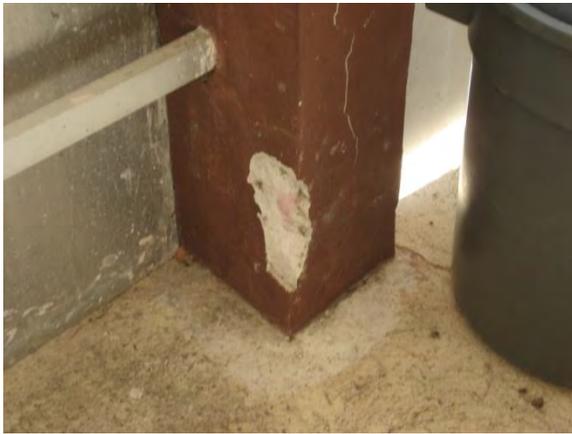
5
6 **FIGURE 241.** Spall in parge coating of at base of
7 second floor concrete column.

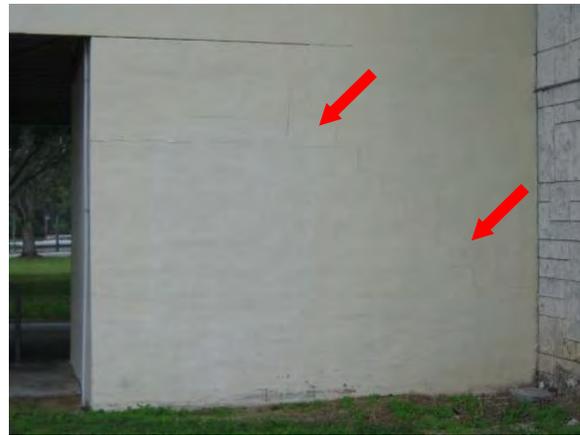
- 10 ■ Step cracking and open mortar joints were
11 noted at the west elevation of the north wing
12 of the office and museum component
13 (Figure 242).
- 14 ■ Deterioration and delamination of vertically
15 oriented Keystone veneer panels was observed
16 at the concessionaire component stair tower
17 and at elevated planting units at the south
18 plaza (Figure 243 and Figure 244).
19 Deterioration appeared to have occurred at
20 locations where the bedding plane of the
21 veneer panel was exposed or was impact
22 related. Delamination was associated with
23 failure of the mortar setting bed.
- 24 ■ Organic growth in the form of mold,
25 vegetation, and algae is present on the
26 Keystone veneer (Figure 245).

27
28 **FIGURE 242.** Step cracking in CMU wall on west
29 elevation of office and museum component.

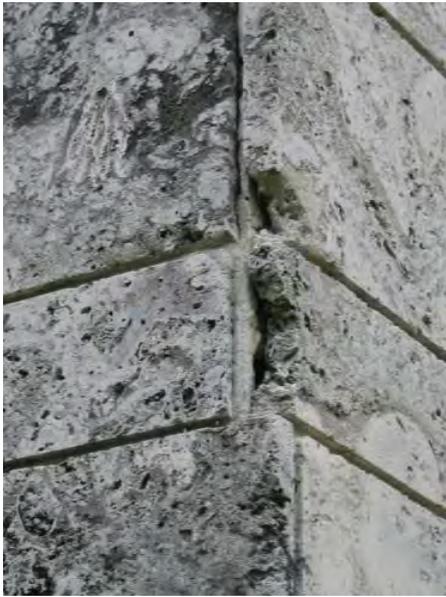
1
2 **FIGURE 243.** Deteriorated Keystone veneer panel.

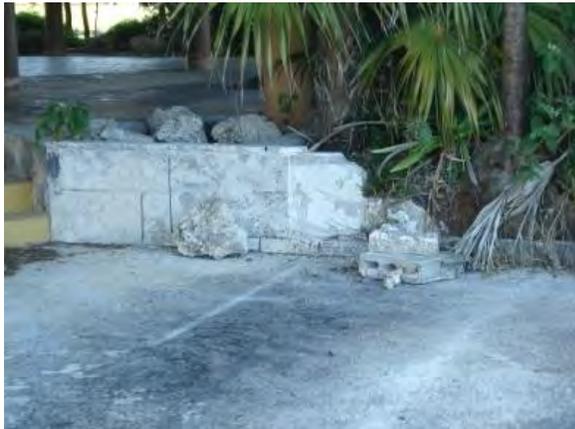
3
4 **FIGURE 244.** Delaminated Keystone veneer panel on
5 planting bed.

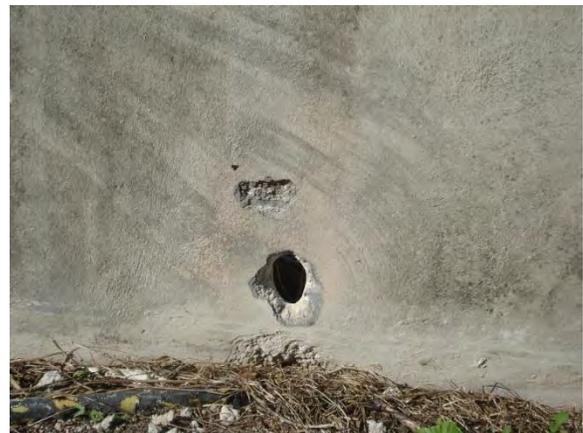
- 10 ■ Physical impact damage to masonry in the
11 form of holes was observed at the south screen
12 wall surrounding the service yard (Figure 246).
13 Reinforcing bar is exposed at the spalls in the
14 screen wall.

FIGURE 246. Impact damage to screen wall.

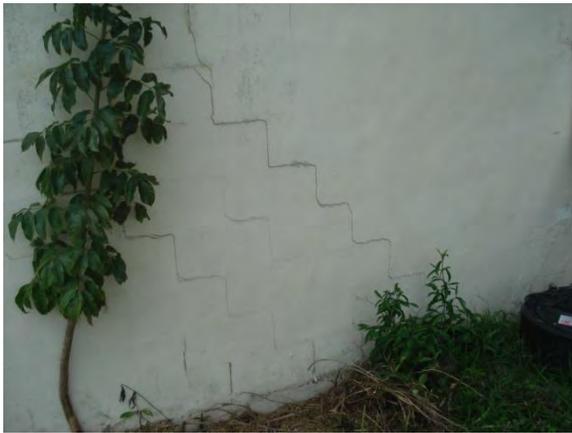
- 15 ■ Step cracking and open mortar joints were
16 observed at the concrete block screen wall
17 surrounding the service yard (Figure 247). The
18 cracking and deterioration of mortar joints is
19 associated with differential settlement and
20 lateral movement of the wall structure.

FIGURE 247. Step cracking in screen wall.

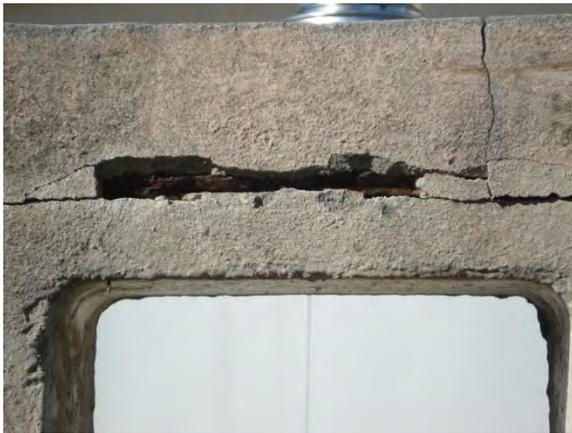
- 21 ■ Corroded reinforcing bar was observed
22 through open joints (Figure 248).
- 23 ■ Horizontal cracks were noted in the screen
24 wall surrounding the service yard (Figure 249
25 and Figure 250). The cracks were located
26 between the precast concrete perforated units
27 and the CMU wall or cast-in-place concrete
28 wall cap. Cracking is associated with
29 differential movement between the CMU wall
30 and cast concrete coping.

FIGURE 248. Cracking in concrete and exposed corroded reinforcing bar in screen wall.

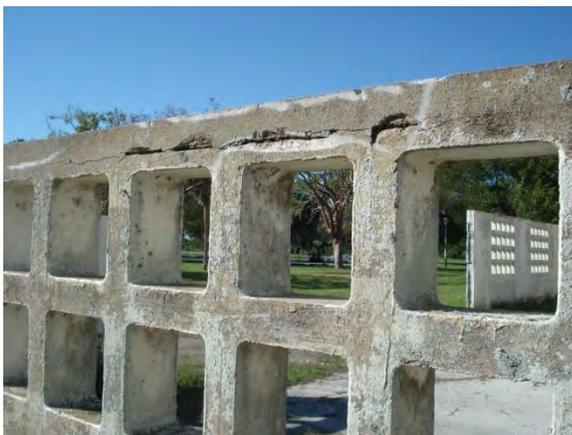
FIGURE 249. Horizontal crack between precast concrete perforated wall unit and cast-in-place concrete wall cap.

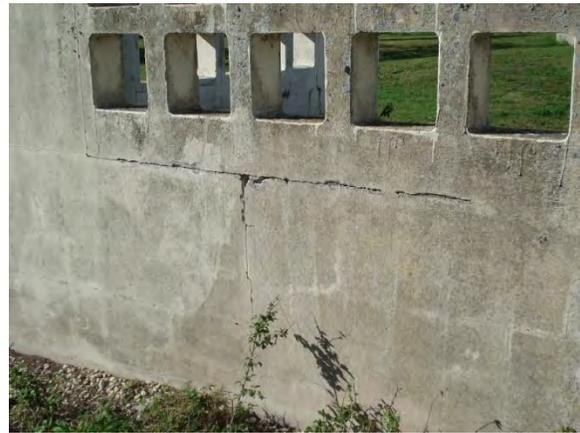
FIGURE 250. Horizontal crack between precast concrete perforated wall unit and CMU construction.

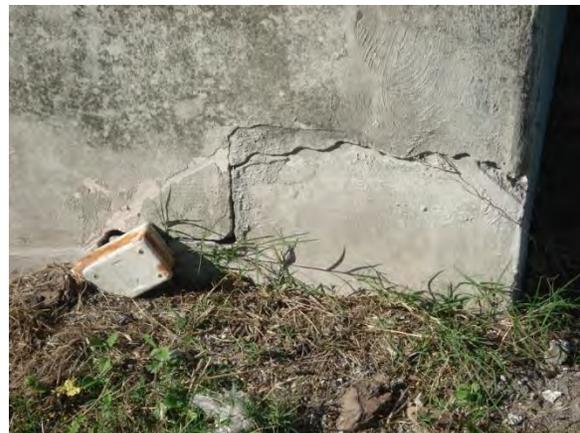
- 31 ■ Spalling of parge coating was observed on the
32 screen wall surrounding the service yard
33 (Figure 251).
- 34 ■ Organic growth in the form of mold and algae
35 was observed on the parge coating of the
36 service yard wall (Figure 252).

FIGURE 251. Spall of parge coating on screen wall.

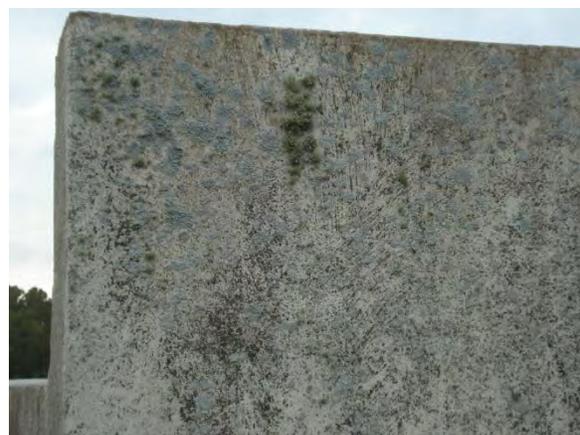
1
2 **FIGURE 252.** Organic growth on service yard screen
3 wall.

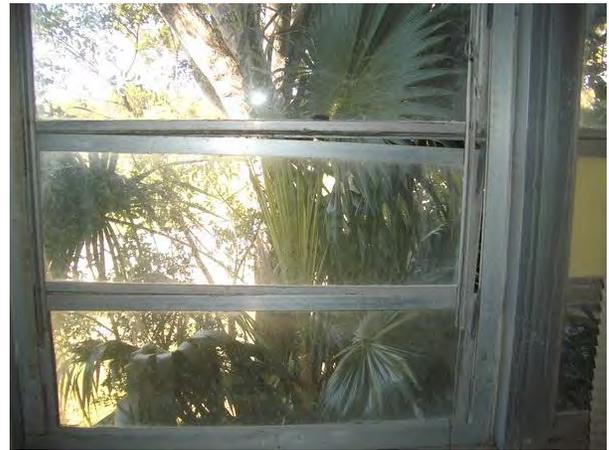
- 7 ▪ Many window units are missing entire sash
8 sections or have sash that have become
9 displaced (Figure 253 and Figure 254).

25
26 **FIGURE 254.** A dislodged window sash.

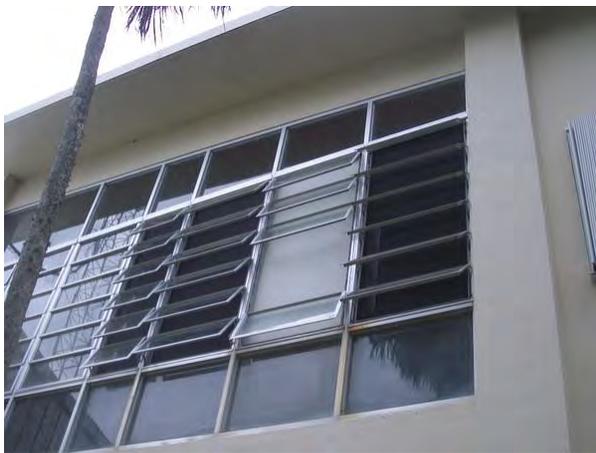
22
23 **FIGURE 253.** Two sash are missing from the east
24 elevation of the office and museum component.

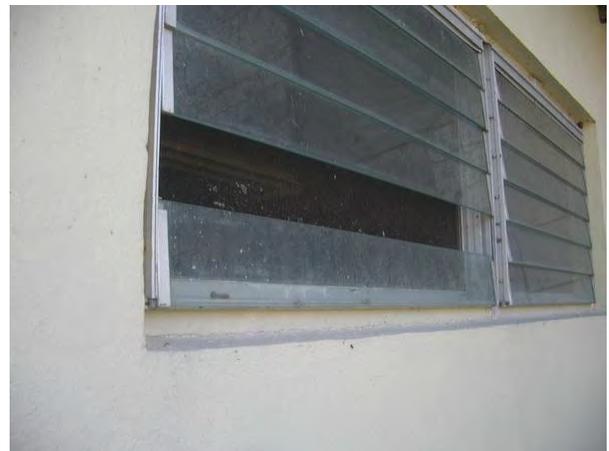
- 10 ▪ Two pair of what appear to be original jalousie
11 windows are located at the first floor west
12 elevation of the concessionaire component of
13 the building. The frames are in relatively good
14 condition however at least one glass slat is
15 missing (Figure 255 and Figure 256).

30
31 **FIGURE 256.** One glass slat is missing.

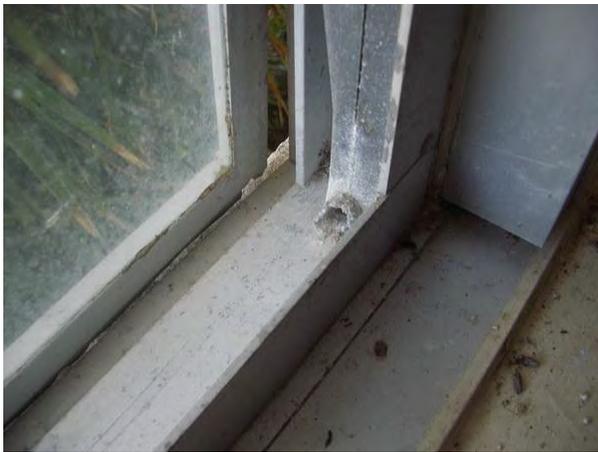
- 1 ▪ Most operating hardware for the awning
2 windows is not functional or missing,
3 rendering many sash inoperable (Figure 257).
4 Park staff reported that replacement rotary
5 hardware has become increasingly difficult to
6 obtain, oftentimes requiring them to rely on
7 salvage suppliers.

23
24 **FIGURE 257.** Missing hardware renders the unit
25 inoperable.

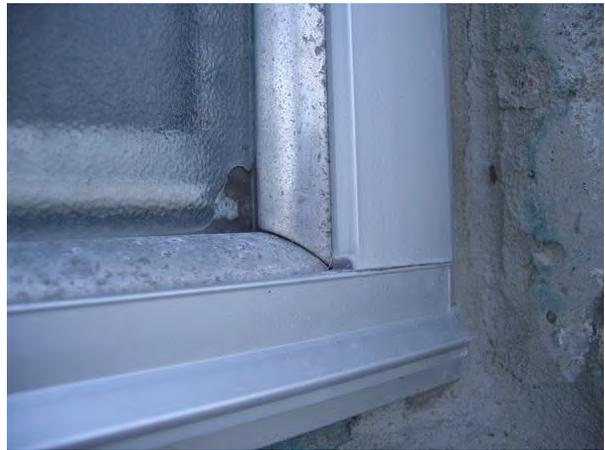
- 8 ▪ The apparent mill finish of the window
9 framing appears to be in relatively good
10 condition, exhibiting only minor surface
11 corrosion. The most significant corrosion was
12 observed on the quarter round glazing stops of
13 the sash (Figure 258).

26
27 **FIGURE 258.** Most of the surface exhibits only minor
28 corrosion; the quarter round glazing stops have more
29 significant corrosion.

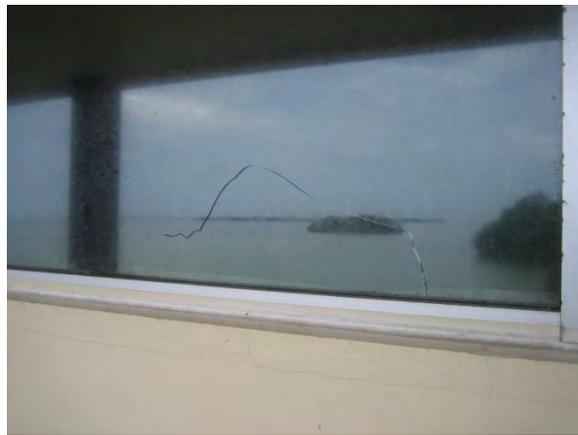
- 14 ▪ Cracks in the monolithic glazing were
15 observed in a number of windows at the
16 office/museum area as well as the
17 concessionaire portion of the building. Cracks
18 in window glazing appeared to be primarily
19 associated with physical impact damage;
20 however, some cracking may be related to
21 intimate contact between the glass and the
22 window frame (Figure 259 and Figure 260).

30
31 **FIGURE 259.** Cracked window glazing.

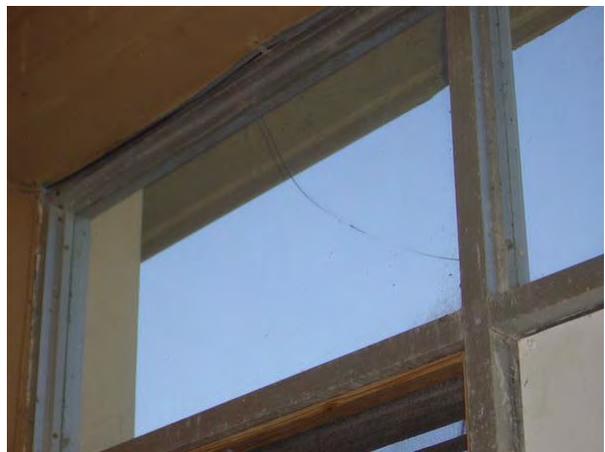
32
33 **FIGURE 260.** Cracked window glazing.

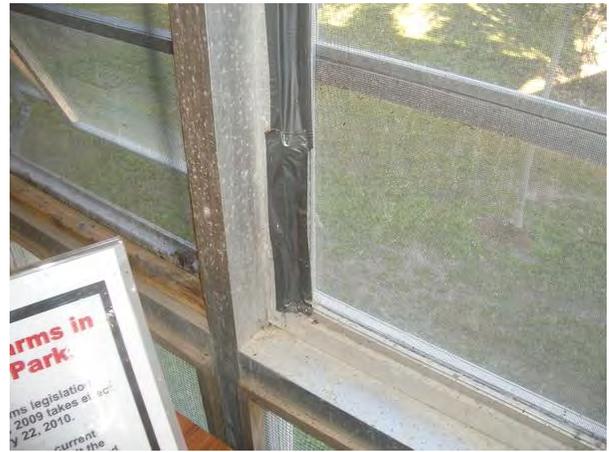
1 ■ The large window wall at the east elevation of
 2 the second floor lobby area is a non-original
 3 replacement unit, as documented in historic
 4 photographs and the original architectural
 5 drawings. The frame details and mullion
 6 configurations vary from other windows at the
 7 building. Several sash units are missing from
 8 this assembly; openings left by the missing sash
 9 are infilled with paneling. In addition, NPS
 10 staff report that many of the awning sash are
 11 inoperable and as such cannot be completely
 12 closed. Cracks exist in several of the glass
 13 panes (Figure 261 through Figure 263).

19
 20 **FIGURE 263.** Cracked glass in the east wall lobby
 21 window.

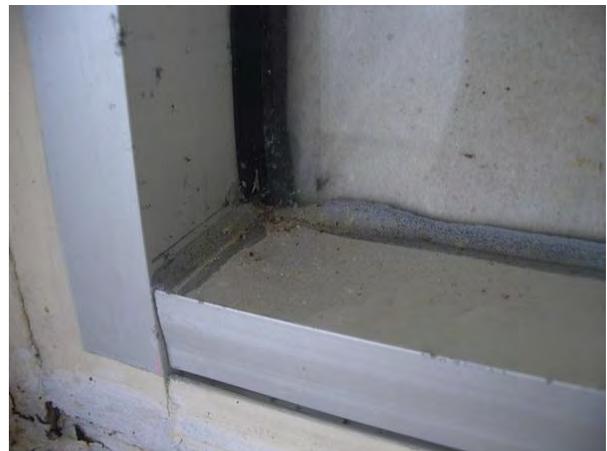
17
18 **FIGURE 268.** The frames have been cap sealed to the
19 glass.

- 6
- 7 ■ Several windows at the concessionaire
 - 8 component of the building are exterior glazed
 - 9 aluminum-framed storefront assemblies with
 - 10 monolithic glass infill; several glazing stops are
 - 11 disengaged from the frame. In addition, the
 - 12 frames have been cap sealed to the glass;
 - 13 typically an indication of past water leakage
- (Figure 267 and Figure 268).

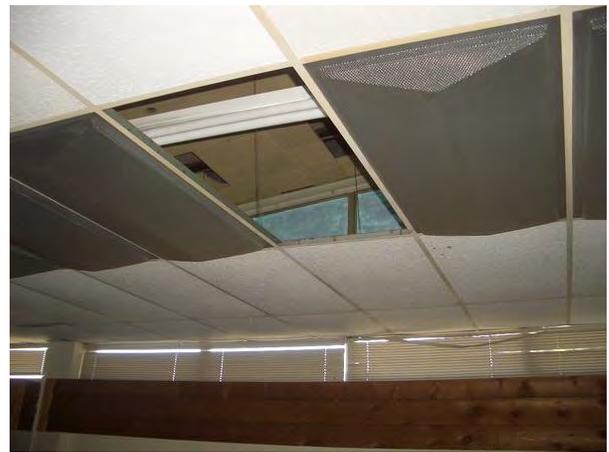
- 1 ■ At the vertical strip window at the north elevation of the stair tower of the concessionaire component of the building, much of the assembly is missing and plywood has been installed to protect the openings. The steel lintel at the head of the window assembly is corroded, which appears to be contributing to cracking and displacement of the stone above (Figure 269 and Figure 270).
- 2
- 3
- 4
- 5
- 6
- 7
- 8
- 9
- 10 ■ Trapezoidal fixed aluminum-framed windows at the north elevation appear intact from the exterior but have been hidden from the interior by installation of a low suspended ceiling (Figure 271).
- 11
- 12
- 13
- 14

20
21 **FIGURE 271.** Trapezoidal windows at the north
22 elevation appear intact but have been hidden by
23 installation of a low suspended ceiling

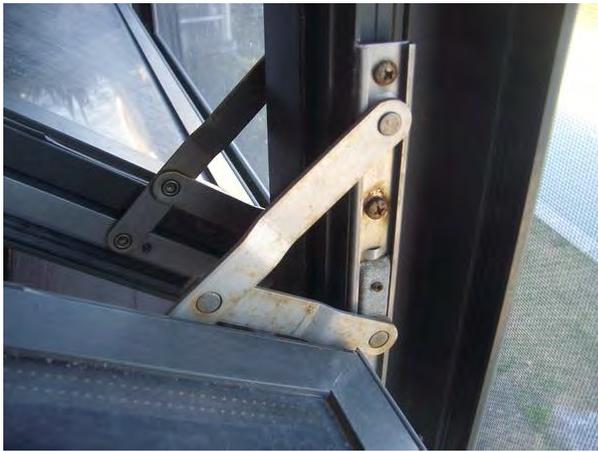
- 24 ■ New aluminum-framed thermally improved windows have been installed at the east and south elevations of the second floor of the concessionaire component of the building. These windows are configured with fixed units over bottom hinged inward projecting operable sash; both fixed and operable units have insulating glass infill. Despite the thermal improvements, these windows are unsympathetic to the original design due to their increased sightlines, dark bronze color, operation, and proportions. Despite the relatively young age of these replacement windows, minor corrosion has started to form on the operating hardware (Figure 272 and Figure 273).
- 25
- 26
- 27
- 28
- 29
- 30
- 31
- 32
- 33
- 34
- 35
- 36
- 37
- 38
- 39

1
2 **FIGURE 273.** Minor corrosion on operating hardware
3 of replacement units.

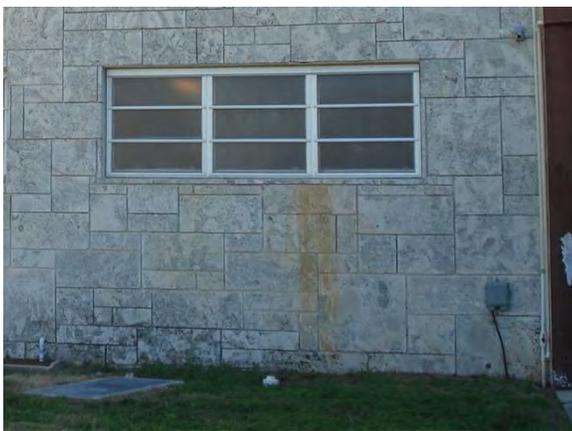
- 4 ▪ Corrosion and corrosion staining were noted
5 at isolated window locations (Figure 274). The
6 cause of the localized staining has not been
7 confirmed.
- 8 ▪ Aluminum entrances exist at the first and
9 second floor of the concessionaire component
10 of the building and at the first floor restrooms
11 and second floor office and museum area. The
12 entrance doors are considered to be in poor
13 condition; hardware (closers and hinges) is
14 corroded or missing, frames have been
15 repaired by application of topical metal plates,
16 and the aluminum finish is severely weathered
17 and pitted (Figure 275 through Figure 276).

18
19 **FIGURE 274.** Corrosion staining below metal-framed
20 window unit.

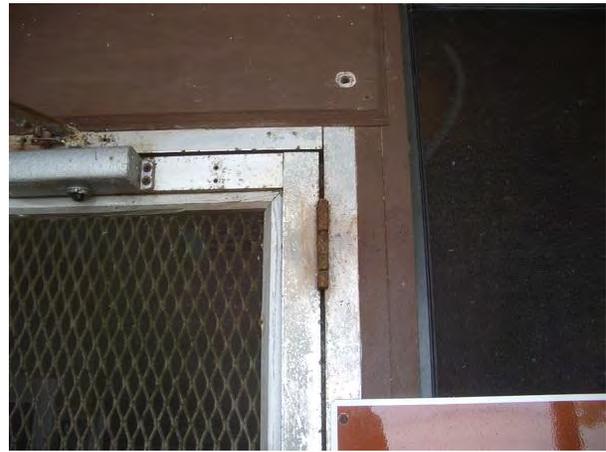
21
22 **FIGURE 275.** Corroded steel hinge, possibly a retrofit,
23 at aluminum door.

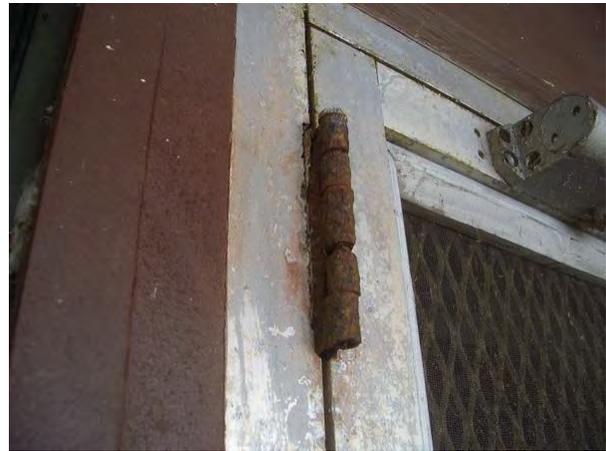
24
25 **FIGURE 276.** Detail of corroded steel hinge at
26 aluminum door.

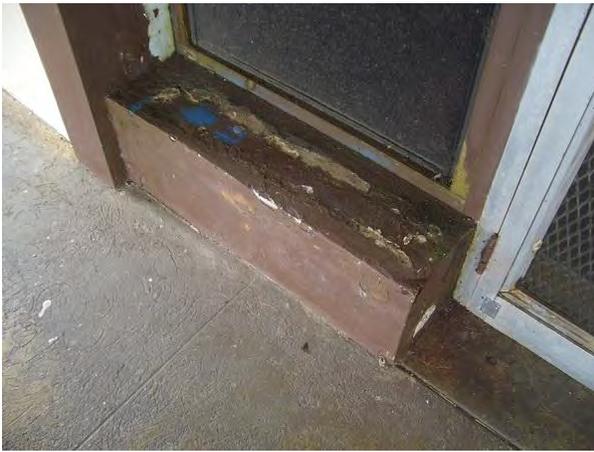
- 27 ▪ Aluminum- and wood-framed screens exist at
28 the first and second floor lobbies of the office
29 and museum portion of the building. The
30 aluminum-framed system at the second floor
31 lobby appears to be a relatively new
32 replacement system and is considered to be in
33 good condition. Narrow aluminum-framed
34 screens in wood frames enclose portions of
35 the first floor lobby; the aluminum frames are
36 severely corroded. Wood-framed screens also
37 enclose portions of the second floor lobby; the
38 wood is in varying degree of deterioration
39 (Figure 277 through Figure 281).

1
2 **FIGURE 277.** Failing paint coating and deterioration
3 of wood curb at screen framing.

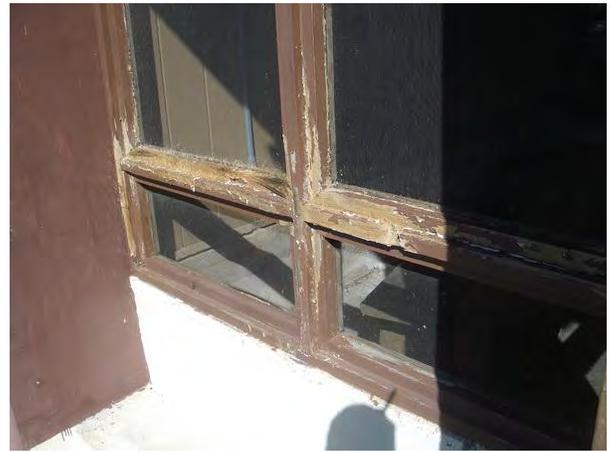
9
10 **FIGURE 280.** Deteriorated wood-framed screen
11 enclosure at the second floor.

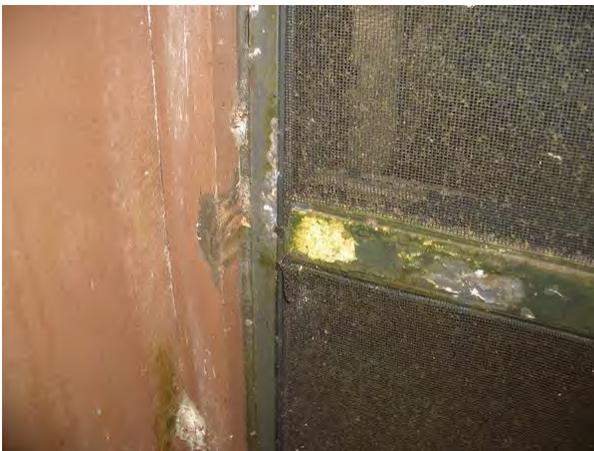
6
7 **FIGURE 279.** The frames of the first floor lobby screen
8 enclosure are corroded.

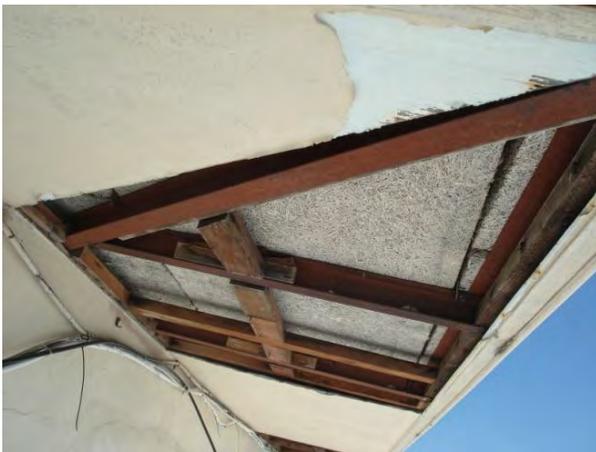
- 2 ■ Storm related damage and deterioration of the
3 plywood eave have led to openings in the
4 overhanging roof structure (Figure 283).
- 5 ■ Paint on the plywood eave is peeling
6 (Figure 284).
- 7 ■ Vegetation is growing in some roof gutters
8 (Figure 285).
- 9 ■ Deterioration of the wood fascia was noted at
10 the southeast corner of the building
11 (Figure 286). Portions of the historic wood
12 fascia are obscured by the application of a
13 contemporary metal fascia.
- 14 ■ At some areas, the membrane is not fully
15 adhered to the roof deck. A few isolated open
16 seams were observed, although most roof
17 seams appear well bonded (Figure 287).

18
19 **FIGURE 283.** Missing plywood eave and exposure of
20 the roof framing.

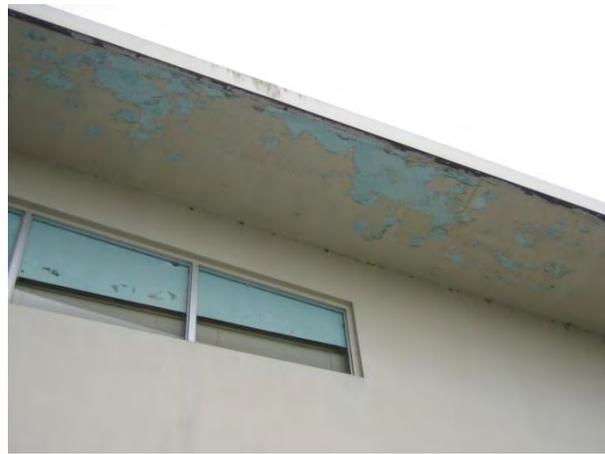
21
22 **FIGURE 284.** Peeling paint on plywood eaves.
23 (Repainting of the building exterior was undertaken
24 by Park Facility staff in 2010 after completion of the
25 site visit.)

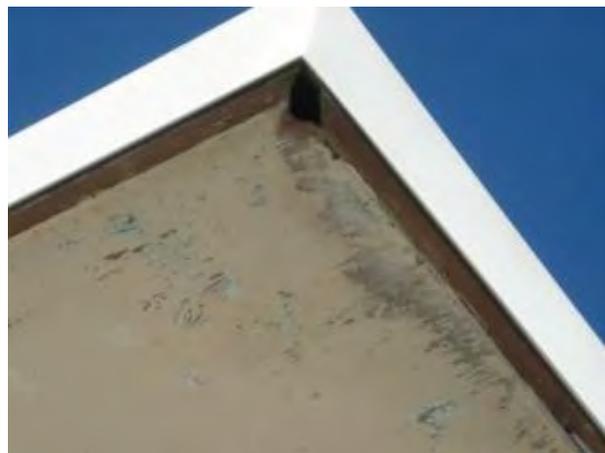
28
29 **FIGURE 286.** Wood fascia appears deteriorated and is
30 covered with metal cladding.
