Physical Description and Condition Assessment

3 Interior Condition Assessment

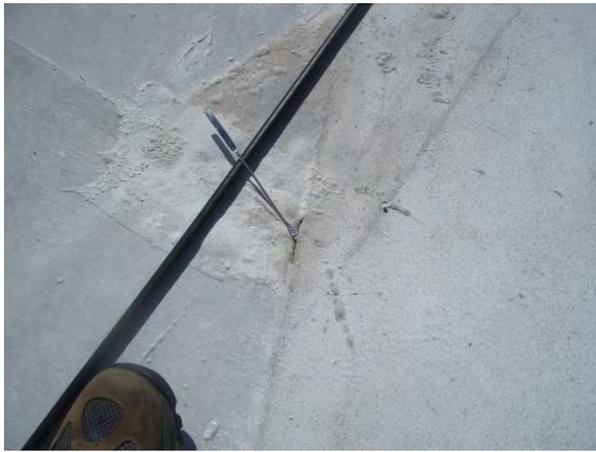
1
2 **FIGURE 287.** A few isolated split seams were
3 observed.

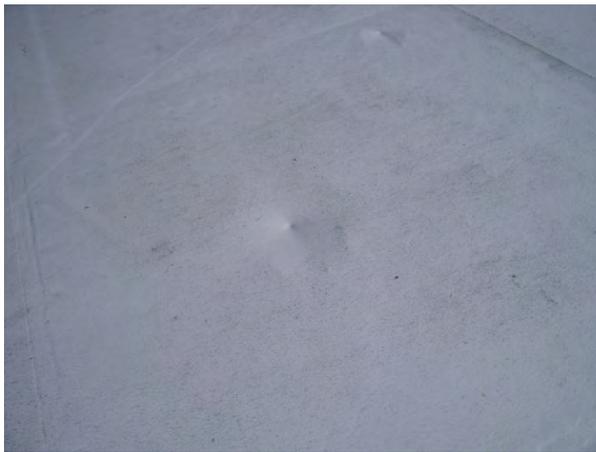
- 4 ▪ Backing out of fastener heads below the
5 membrane is resulting in tenting of the
6 membrane at isolated locations (Figure 288
7 and Figure 289).
- 8 ▪ Ponding was observed along the edges of the
9 breezeway roof (Figure 290 and Figure 291).

10
11 **FIGURE 288.** Fastener heads underlying the
12 membrane cause tenting.

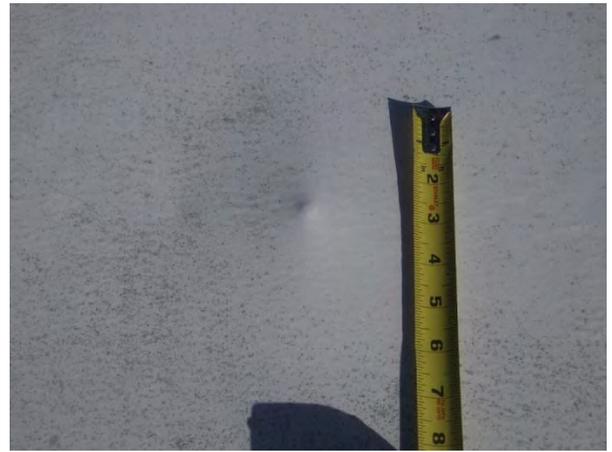
13
14 **FIGURE 289.** Detail of tented membrane at fastener.

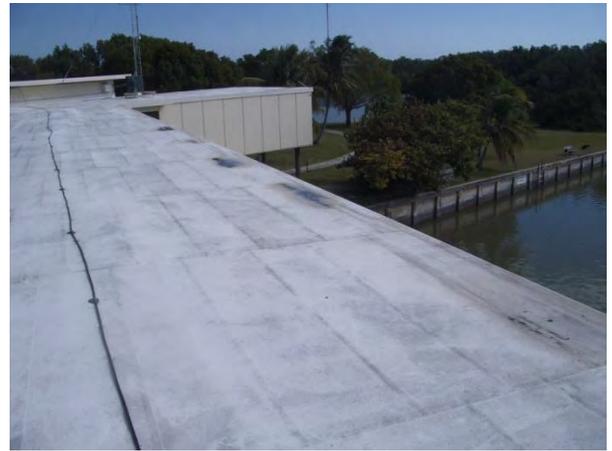
15
16 **FIGURE 290.** Ponding was observed along the edges
17 of the breezeway roof.

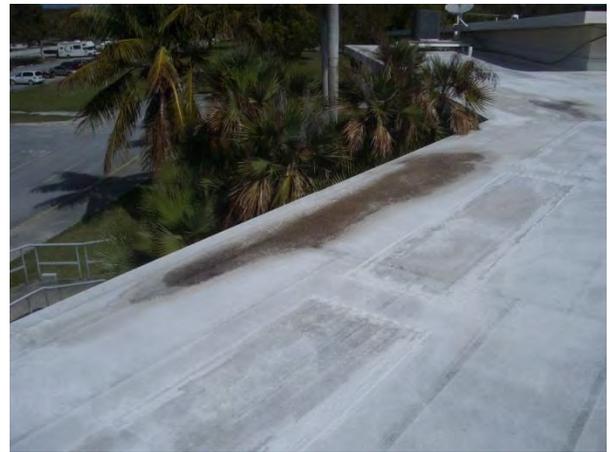
18
19 **FIGURE 291.** Ponding at the edge of the roof.

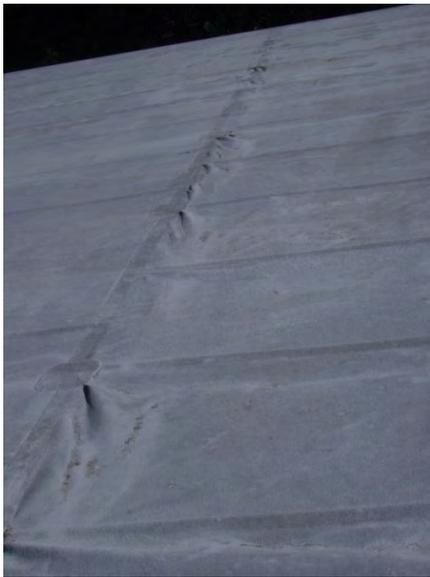
- 1 ▪ Especially at the museum wing, the membrane
2 is puckered at laps (Figure 292).
- 3 ▪ The existing exhaust fan curbs on the roof
4 over the concessionaire component of the
5 building have significant corrosion. One fan is
6 missing completely, resulting in an opening to
7 the kitchen below (Figure 293 and Figure 294).
- 8 ▪ The membrane is blistered adjacent to exhaust
9 fan locations at the concessionaire portion of
10 the building (Figure 295). At these areas,
11 additional layers of membrane were installed
12 previously as added protection against grease
13 splatter.
- 14 ▪ NPS staff indicated that vultures have been
15 observed eating the roof membrane. This
16 activity is less problematic since the grease
17 hoods/exhaust fans were removed from the
18 roof over the kitchen area.

19
20 **FIGURE 292.** Puckering of the membrane at a lap.

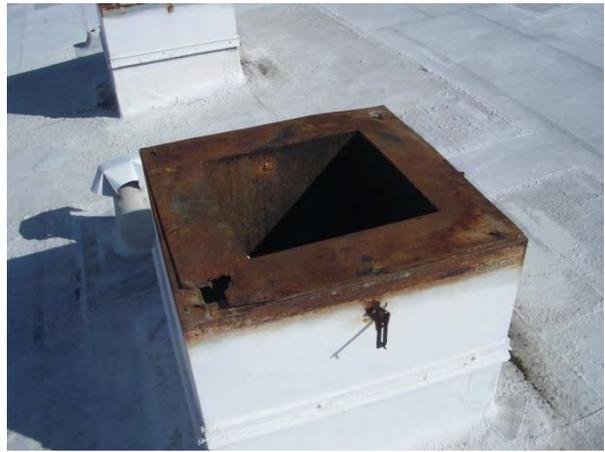
21
22 **FIGURE 293.** Corrosion of exhaust fan curb.

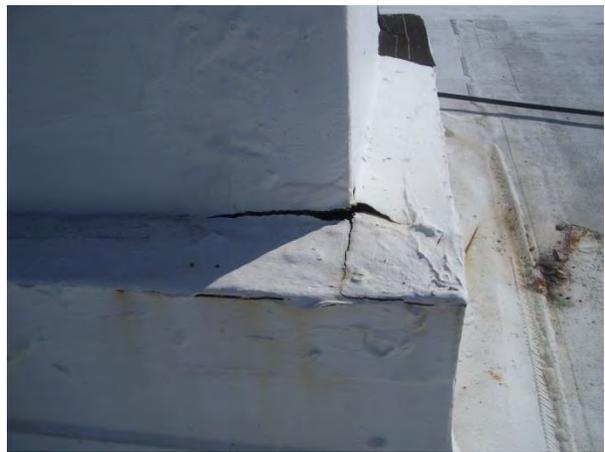
23
24 **FIGURE 294.** Splitting of the membrane at the
25 exhaust fan curb.

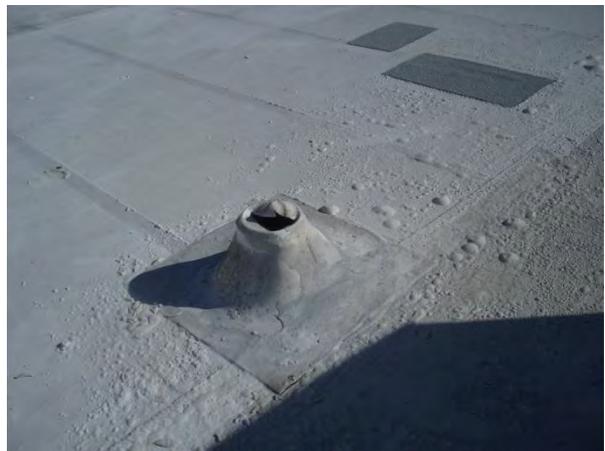
26
27 **FIGURE 295.** Blistering of the membrane.

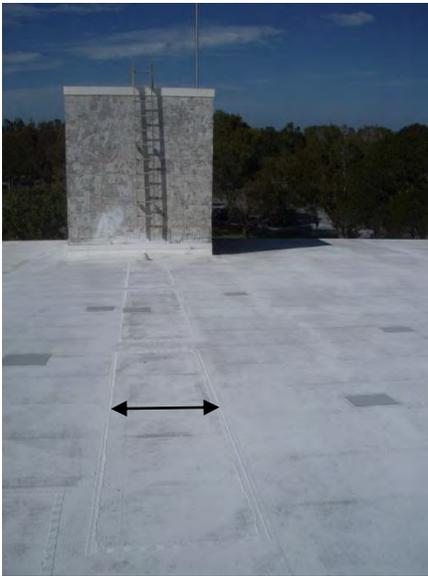
- 1 ■ Walking pads previously located on the
2 concessionaire area roof have been removed
3 (Figure 296). It is not clear if this removal was
4 intentional or due to past storm damage.
- 5 ■ At the stair tower roof, the counterflashing
6 along the west edge of the roof is detached
7 (Figure 297).
- 8 ■ The ladder at the east wall of the stair tower is
9 not adequately secured to the wall; it is
10 attached only at the top, with loose stand-off
11 brackets provided along the wall surface
12 (Figure 298 and Figure 299).
- 13 ■ Blistering of the roof coating was observed
14 above the museum (Figure 300). The blistering
15 may be caused by chemical attack due to bird
16 droppings from the nest atop the adjacent
17 communication tower (Figure 301).

18
19 **FIGURE 296.** Former walking pad strips have been
20 removed.

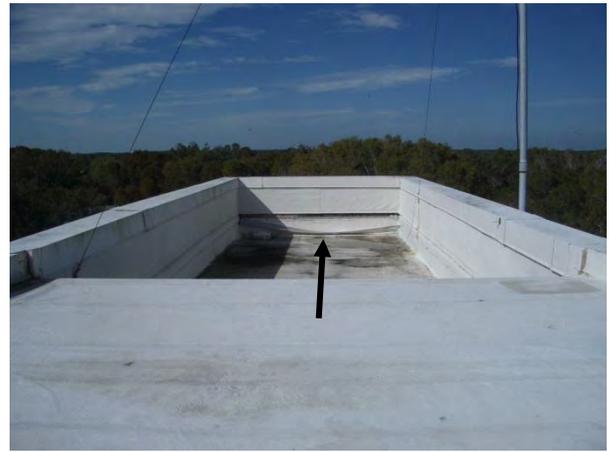
21
22 **FIGURE 297.** The west edge counterflashing is
23 detached.

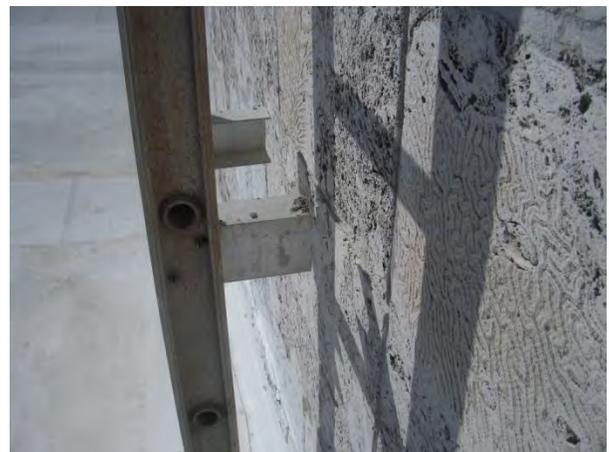
27
28 **FIGURE 299.** The ladder is secured only at the top and
29 rests loosely against the stone veneer.

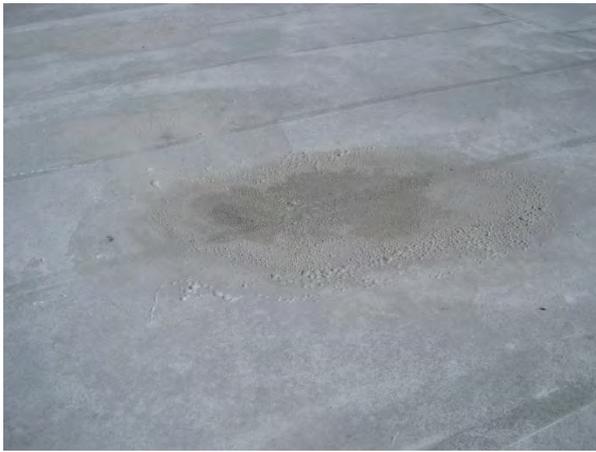
1
2 **FIGURE 300.** Blistering of the roof coating above the
3 museum.

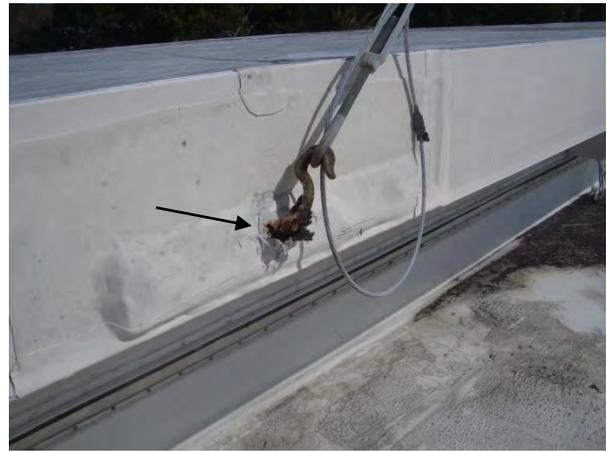
21
22 **FIGURE 302.** The guy wire anchorage is severely
23 corroded.

- 7
- 8 ▪ The anchorage for the communication
9 antenna guy wire at the south center fascia of
10 the office area is severely corroded
11 (Figure 302).
 - 12 ▪ At the museum roof, steel mechanical
13 equipment supports have significant corrosion
14 (Figure 303). Also, the roof membrane is not
15 adequately secured to the supports
16 penetrating the roof (Figure 304).
 - 17 ▪ Approximately half of the soffit cladding is
18 missing from south edge of office area roof
19 overhang, exposing the internal wood and
20 steel framing and the tectum roof deck to
 weather (Figure 305).

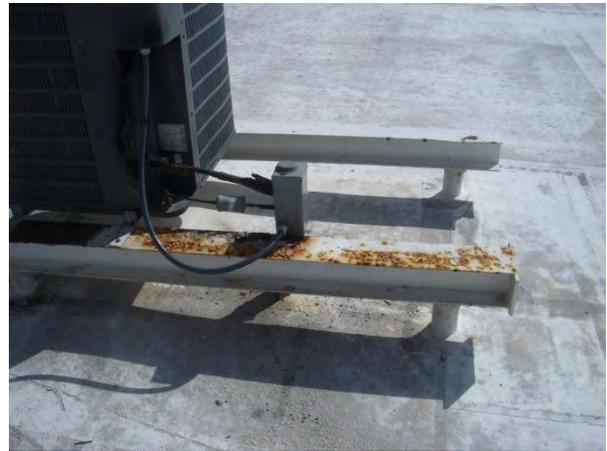
24
25 **FIGURE 303.** Surface corrosion of mechanical
26 equipment supports.

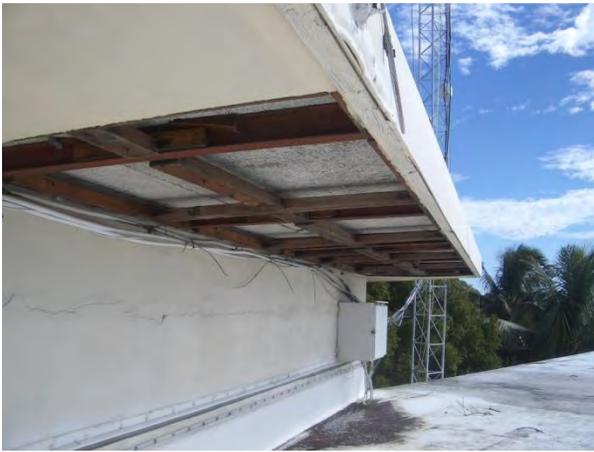
1
2 **FIGURE 305.** Missing soffit cladding.

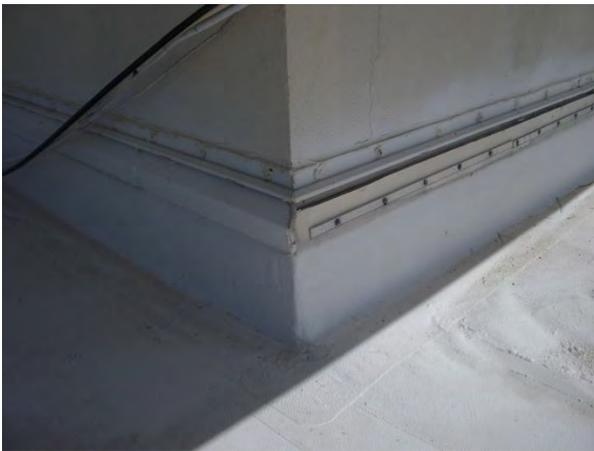
- 3 ■ Counterflashing is missing where the
4 museum/lobby roof meets the wall of the
5 office area; the edge of plywood underlayment
6 is exposed to weather (Figure 306).
- 7 ■ The office wing roof has a gooseneck sleeve
8 opening and support pipes for conduit
9 (Figure 307). The gooseneck is not well
10 integrated with roof membrane; also, a newer
11 communication cable has punctured the
12 gooseneck sleeve (Figure 308 and Figure 309).
13 This opening is located directly above an
14 office area where water damage is visible at the
15 interior ceiling.

16
17 **FIGURE 306.** Missing counterflashing (right side of
18 view).

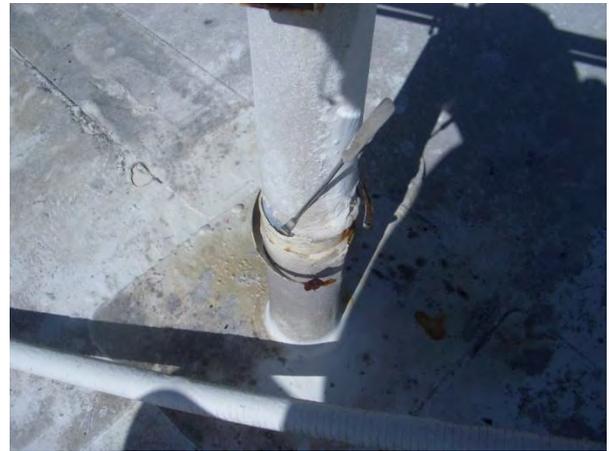
22
23 **FIGURE 308.** The membrane is detached from the
24 pipe support.

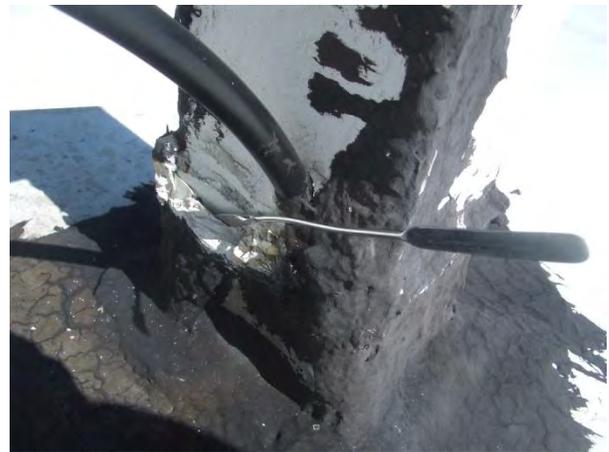
25
26 **FIGURE 309.** There is a gap in the membrane at a
27 recently installed conduit penetration.

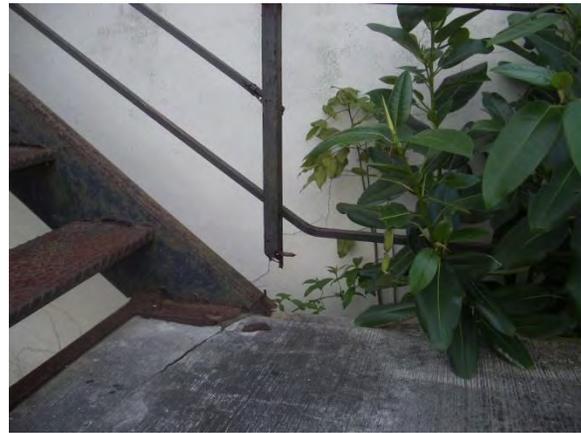
20
21 **FIGURE 312.** Severe corrosion of exterior metal stair
22 supports.

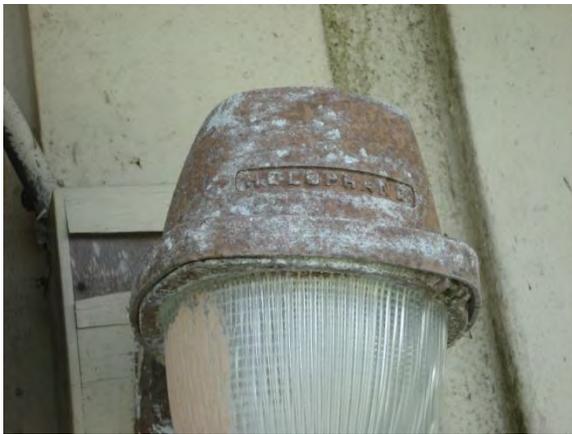
14
15 **FIGURE 310.** Corrosion of metal exterior light fixtures.

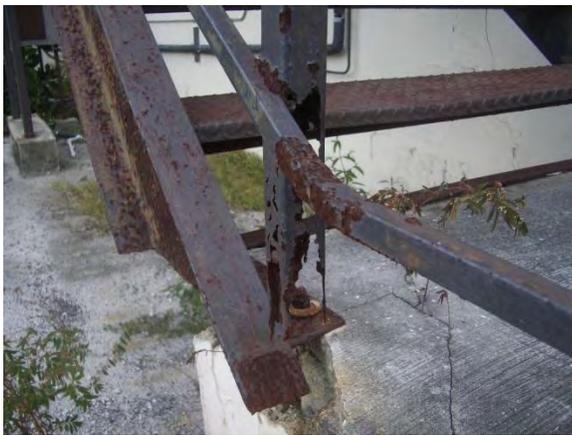
16
17 **FIGURE 311.** Severe corrosion of the exterior metal
18 handrail and stringer at the base of the service yard
19 stairs.

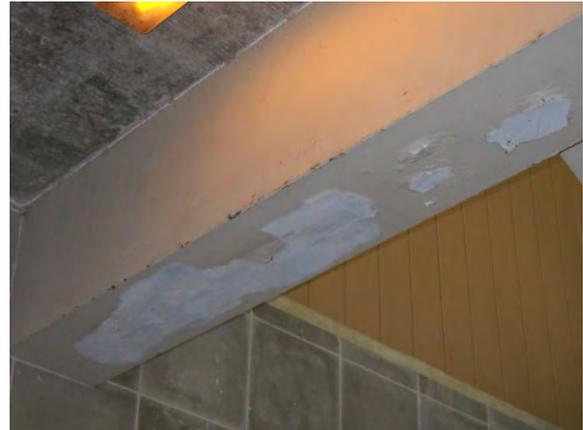
20
21 **FIGURE 396.** Peeling paint as a result of water
22 damage at first floor soffit in office and museum
23 component.

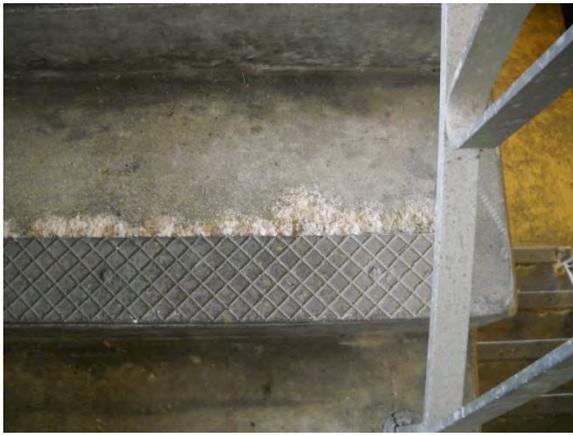
1
2 **FIGURE 397.** Spalling of concrete treads on main stair
3 in office and museum component.

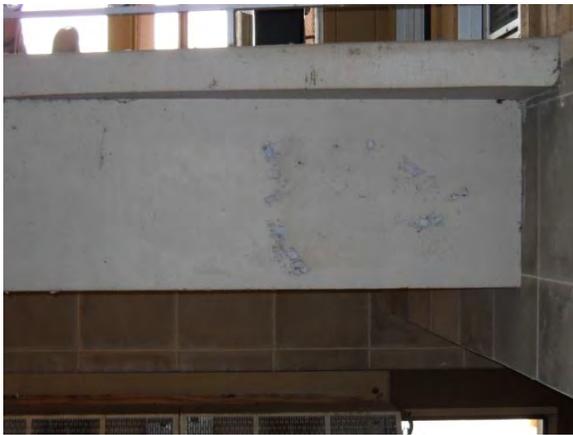
4
5 **FIGURE 398.** Visible moisture damage to fascia above
6 stairs in office and museum component.

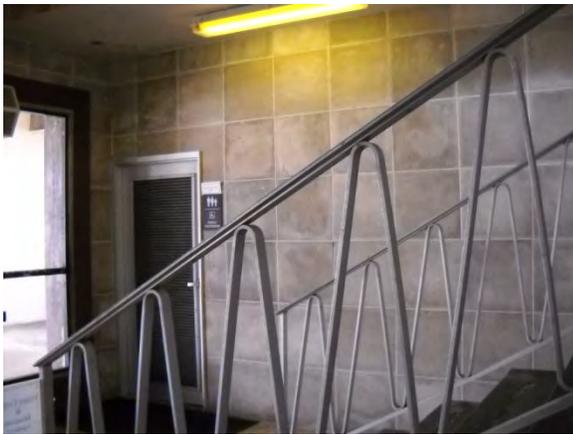
7
8 **FIGURE 399.** Cracking of grout joints between wall
9 tiles in ground floor entrance area.

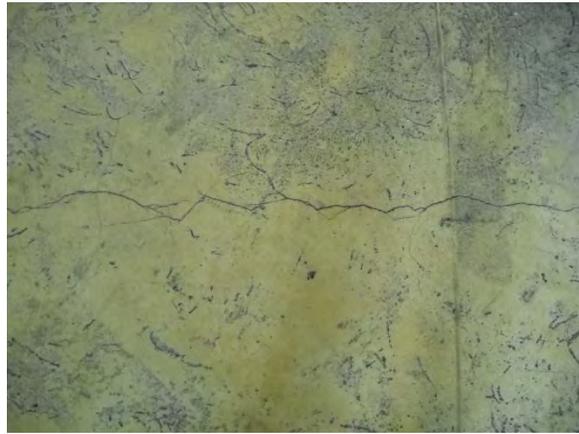
21
22 **FIGURE 400.** Cracking in the second floor concrete
23 slab in the office and museum component.

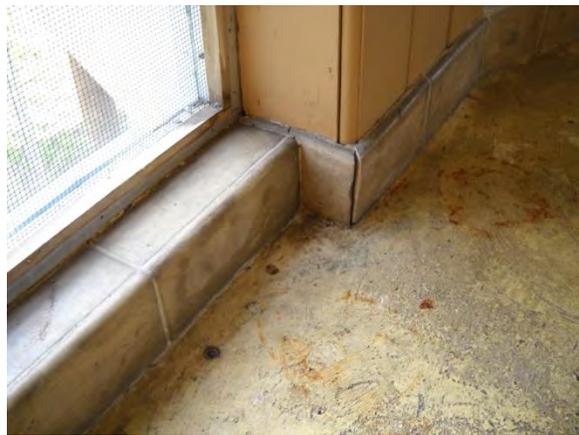
24
25 **FIGURE 401.** Staining on the concrete floor slab.

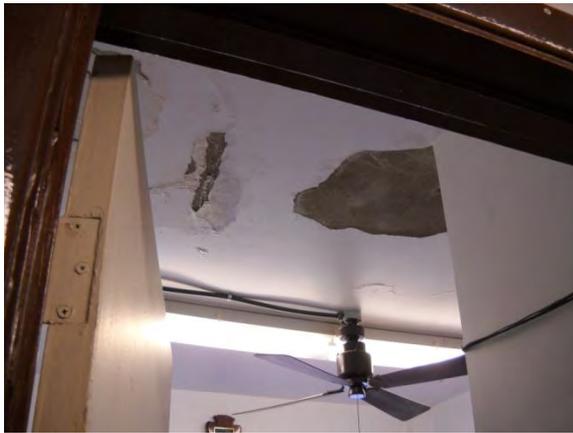
1
2 **FIGURE 402.** Moisture damage to ceiling materials in
3 offices.

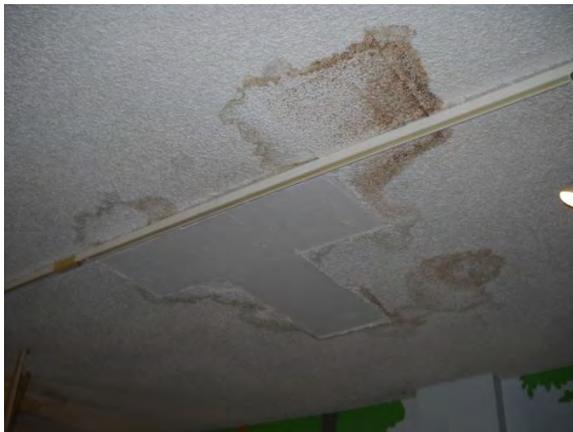
4
5 **FIGURE 403.** Visible moisture damage to acoustical
6 tile ceiling in the museum.

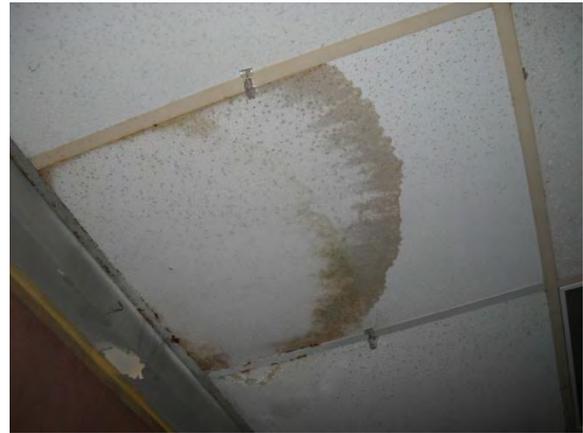
24
25 **FIGURE 404.** Moisture damage to suspended
26 acoustical tile ceiling in gift shop.

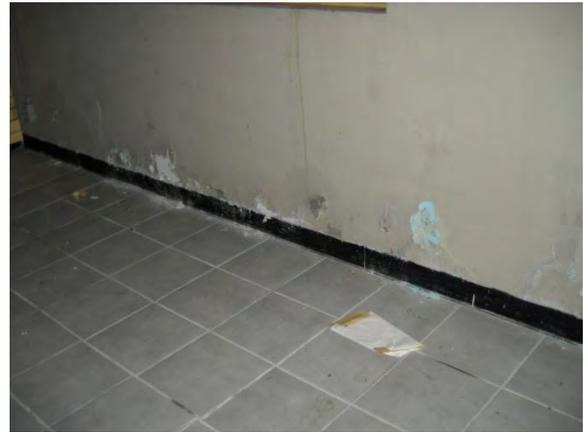
FIGURE 405. Peeling paint and moisture damage to
plaster walls in gift shop.

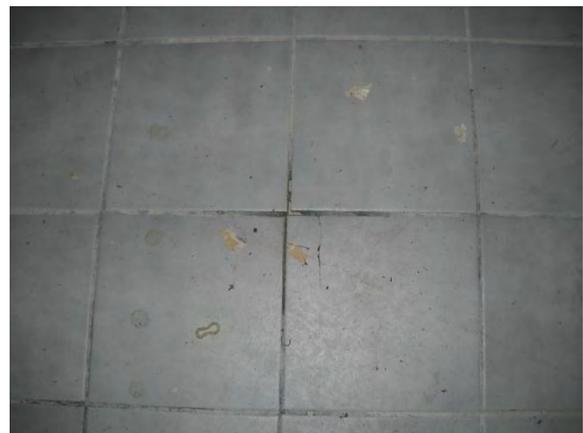
FIGURE 406. Visible heaving in floor tiles.

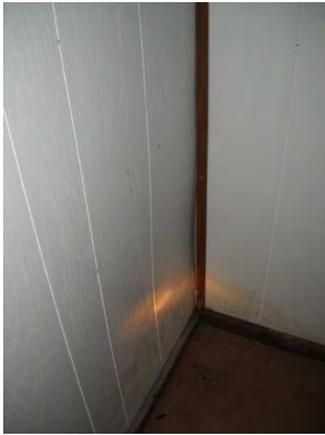
FIGURE 407. Moisture damage to wood paneled walls in concessionaire component.

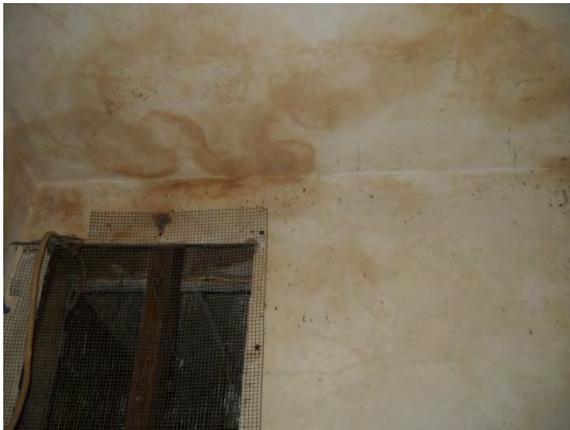
FIGURE 408. Moisture damage and staining at ceilings in concessionaire component.

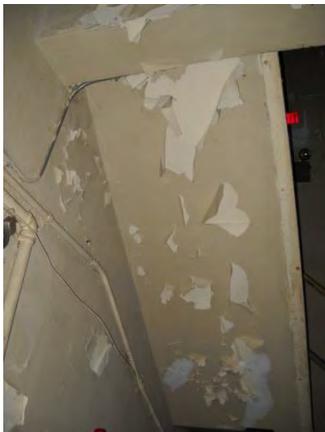
- 21 ■ The paint coatings are peeling throughout the
22 office and museum and concessionaire
23 components of the building (Figure 409).

FIGURE 409. Peeling paint at plaster soffit below service stair.

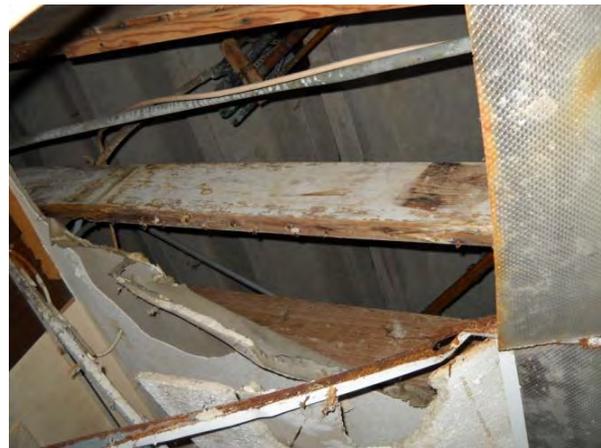
- 2 ▪ The suspended ceiling in the former
- 3 concessionaire offices west of the gift shops is
- 4 deteriorated, with the rails of the ceiling
- 5 significantly corroded (Figure 410).

19
20 **FIGURE 410.** Deterioration of suspended ceiling
21 framing and panels.

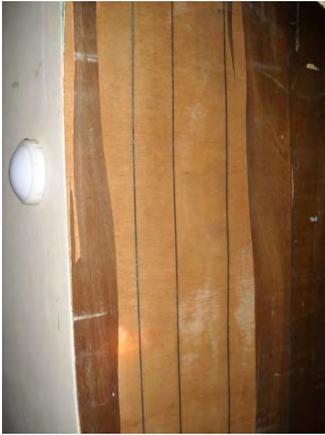
- 6 ▪ At several locations, delaminated wood
- 7 paneling was observed (Figure 411).

1
2 **FIGURE 411.** Delaminated wood paneling.

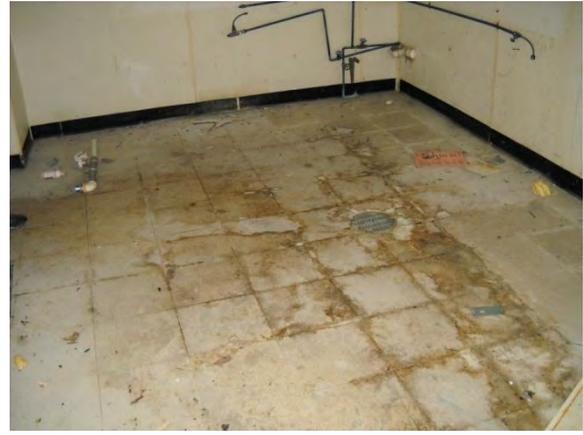
- 17 ▪ The vinyl tile floor in lounge kitchen shows
- 18 signs of moisture damage (Figure 414).

FIGURE 414. Moisture damage to vinyl tile flooring.

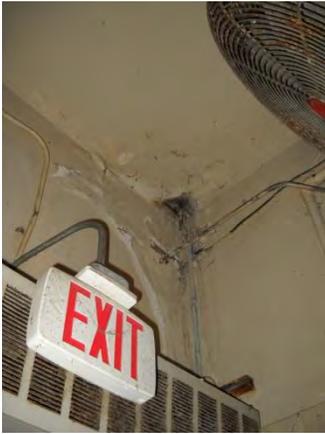
- 11 ▪ Exposed, corroded conduit was observed in
- 12 the back hallway on the first floor of the
- 13 concessionaire component (Figure 412).

FIGURE 412. Surface corrosion on exposed electrical conduit.

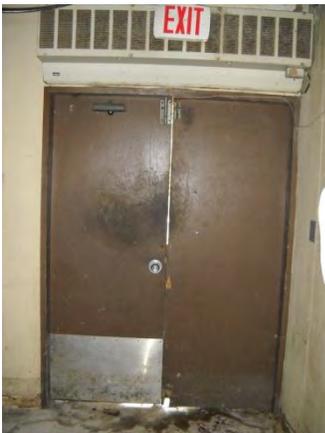
- 14 ▪ The double doors at loading dock are
- 15 damaged. Evidence of corrosion is visible at
- 16 the bottom of the doors (Figure 413).

FIGURE 413. The loading dock doors are damaged with evidence of corrosion visible at the foot of the doors.

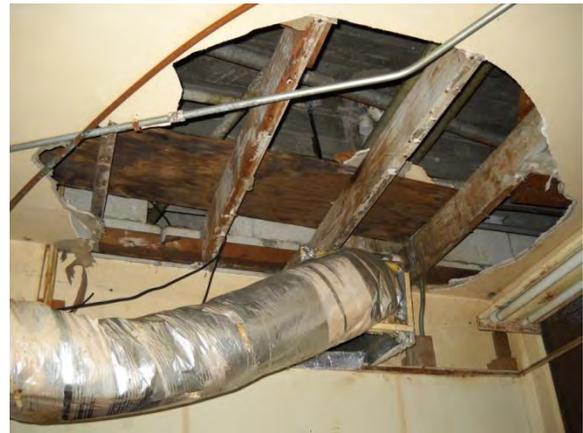
FIGURE 415. Deterioration of ceiling in lounge kitchen.
