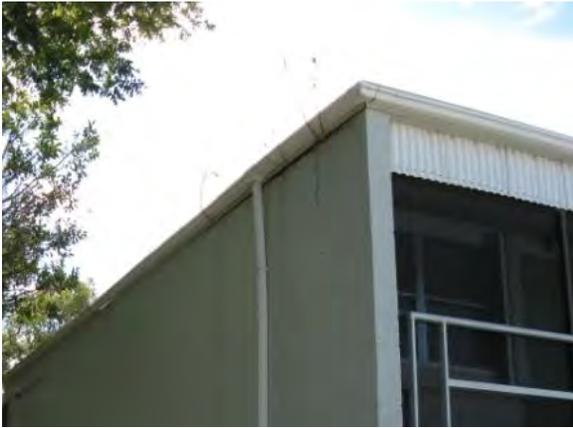
- 4 ▪ Plant growth was observed in the gutter on the
5 northeast corner (Figure 512).
- 6 ▪ There is a significant gap between two sections
7 of gutter on the east elevation (Figure 513).
- 8 ▪ The galvanized steel stairs extending from the
9 wood porches show signs of corrosion.

FIGURE 512. Organic growth at roof gutters.

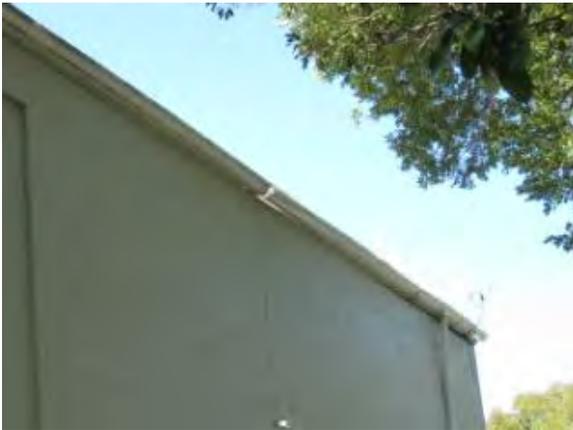
FIGURE 513. Gap between gutter seams.

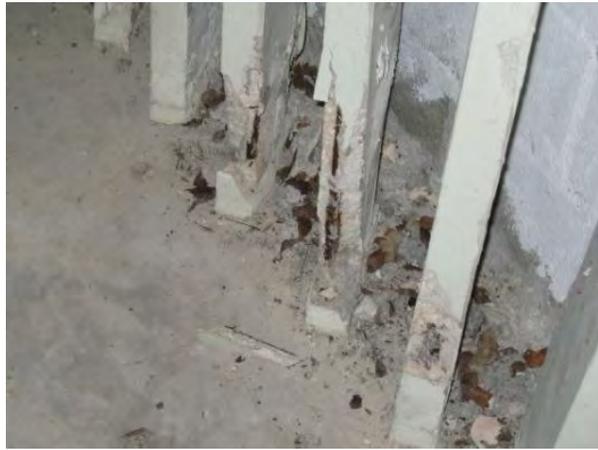
- 4 ▪ Water damage was observed on the ceiling of
5 the bathroom adjacent to a skylight
6 (Figure 522).
- 7 ▪ The fan unit in the ceiling of the bathroom
8 shows signs of corrosion (Figure 523).
- 9 ▪ Original concrete louvers, now enclosed in
10 ground level storage rooms, exhibit significant
11 deterioration, including corrosion of
12 reinforcing steel and severe spalling of
13 concrete (Figure 524).

14
15 **FIGURE 524.** Corroded reinforcing bar and spalling of
16 concrete at vertical concrete louvers in the ground
17 floor storage rooms.

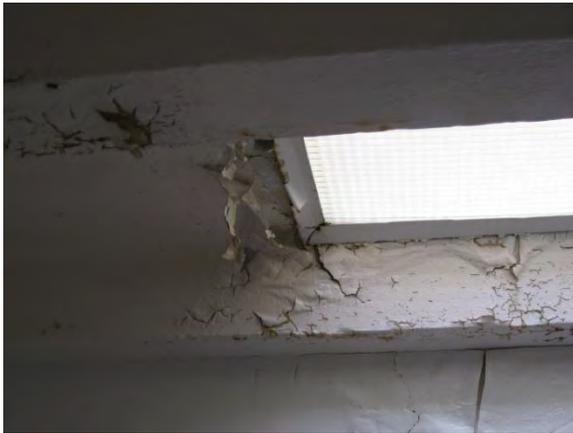
FIGURE 522. Moisture damage to ceiling
surrounding bathroom skylight.

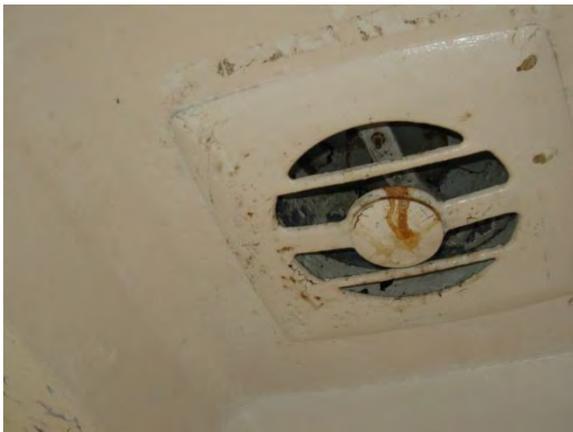
FIGURE 523. Surface corrosion on bathroom vent
fan.

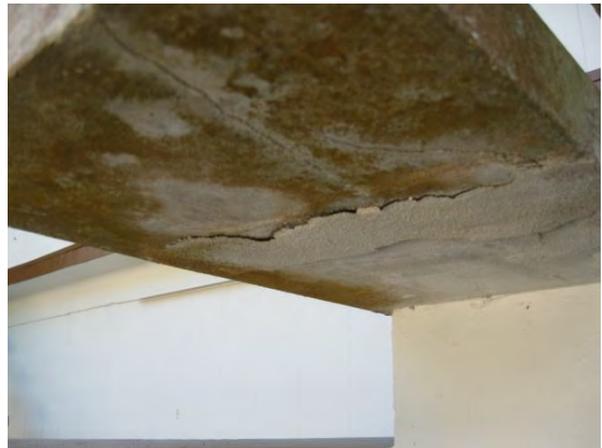
- 36 ▪ Spalling was observed at many locations on
 37 the concrete stairs (Figure 526 and
 38 Figure 527).
- 39 ▪ Exposed, corroded rebar is present on some
 40 areas of the underside of the concrete stairs
 41 (Figure 528).
- 42 ▪ The steel deck ties on the underside of the
 43 wood porch show signs of surface corrosion
 44 (Figure 529).

45
 46 **FIGURE 526.** Spalling concrete under stair landing.

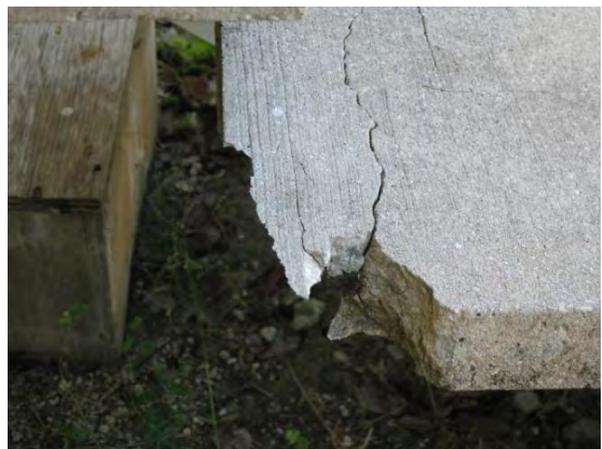
47
 48 **FIGURE 527.** Cracked and spalled concrete at exterior
 49 stair.

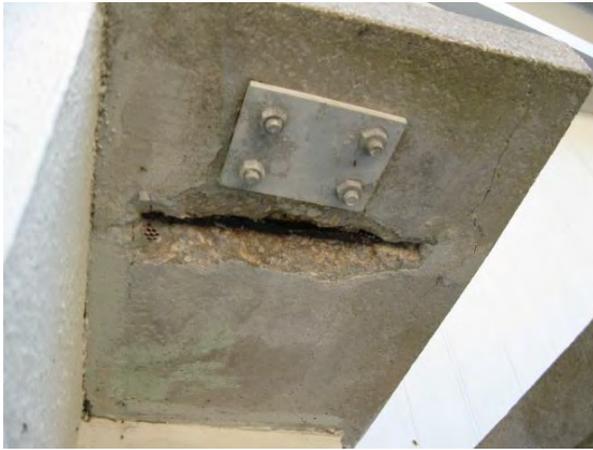
1
2 **FIGURE 528.** Exposed and corroded reinforcing bar.

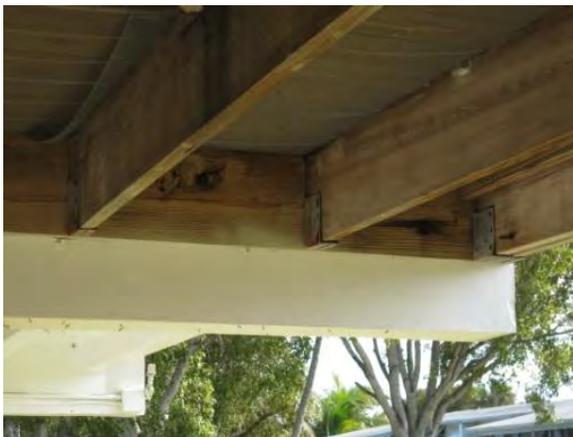
3
4 **FIGURE 529.** Surface corrosion on wood deck joist
5 hangers.

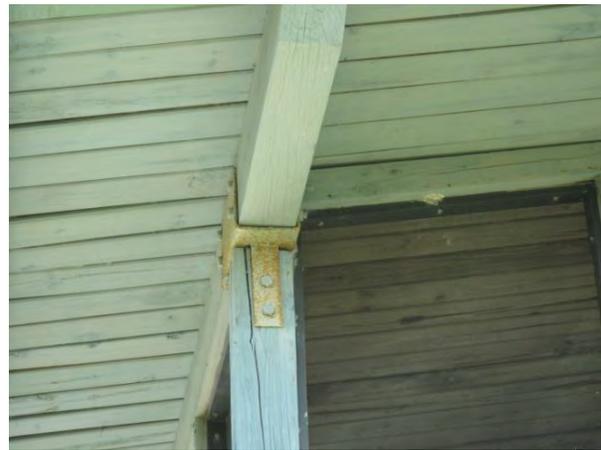
- 4 ■ Wood rot was observed at several locations on
5 the wood stairs (Figure 539).
- 6 ■ Cracking is present on wood columns and
7 beams on elevated porches (Figure 540).
- 8 ■ Corrosion of deck ties was observed on the
9 underside of the elevated porches
10 (Figure 541).

16
17 **FIGURE 541.** Corrosion of deck ties.

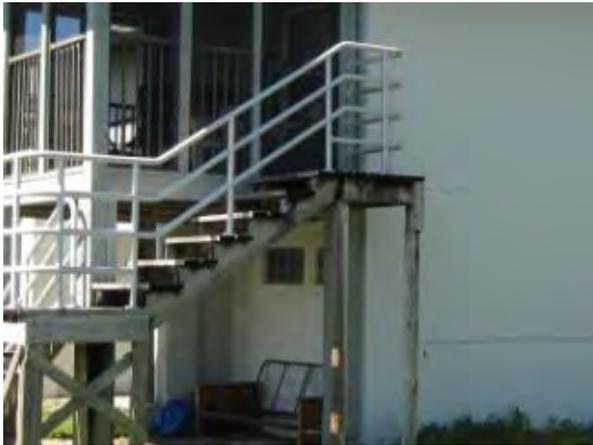
11
12 **FIGURE 539.** Wood rot at wood-framed stairs.

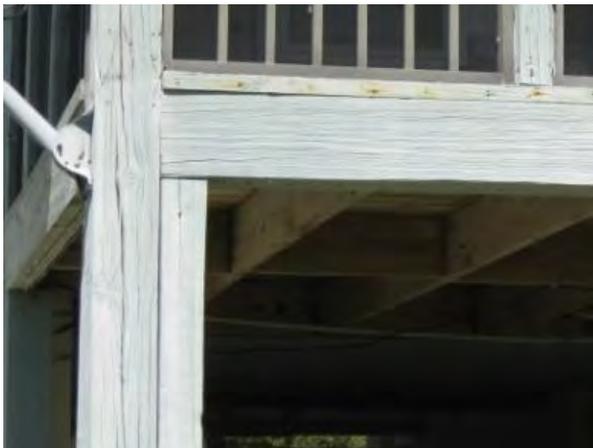
13
14 **FIGURE 540.** Cracking of wood porch framing
15 members.

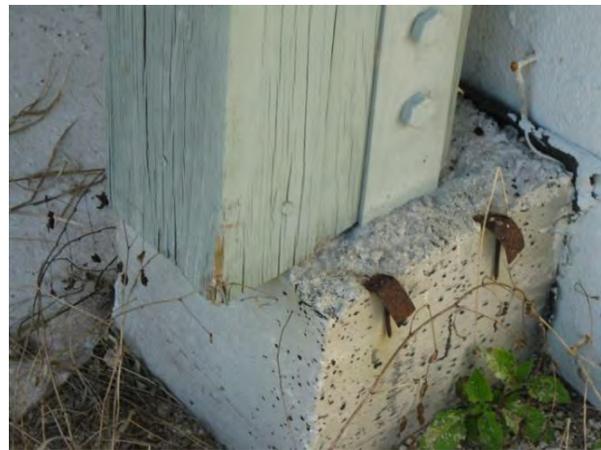
- 18 ■ At the elevated porches, the wood columns are
19 not centered on concrete footings
20 (Figure 542).
- 21 ■ The wood soffit shows signs of deterioration
22 (Figure 543).
- 23 ■ Concrete spalling was observed at through-
24 wall air conditioner supports on the south
25 elevation (Figure 544).

26
27 **FIGURE 542.** Wood columns are not centered or fully
28 bearing on concrete foundation.

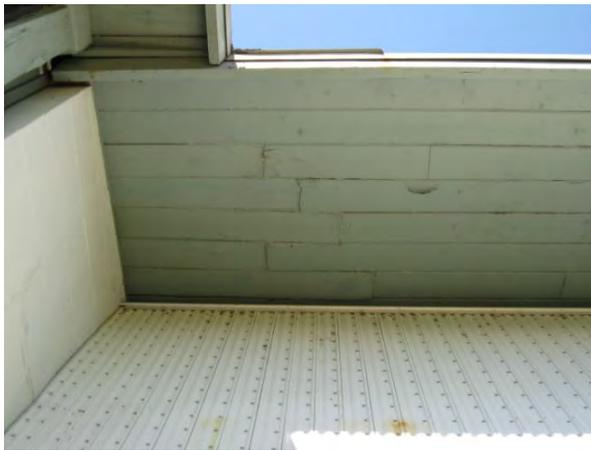
1
2 **FIGURE 543.** Deterioration of wood soffit.

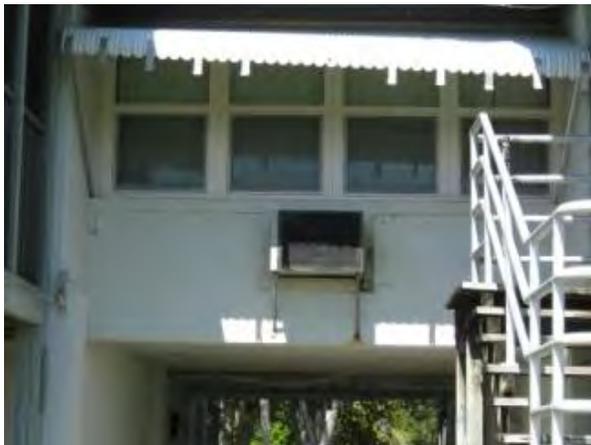
3
4 **FIGURE 544.** Spalling of concrete at exterior support
5 for air conditioning unit.

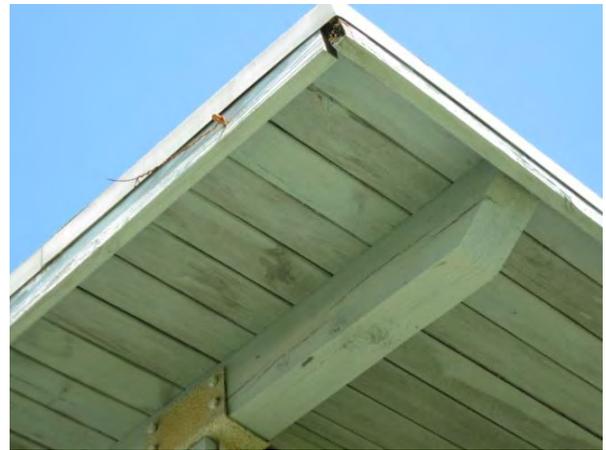
- 12 ▪ The wood soffits exhibit deterioration
13 including discoloration and splitting of the
14 wood (Figure 556).
- 15 ▪ Wood rot was observed at several locations on
16 the exterior stairs (Figure 557). The wood
17 elements of these stairs are not coated.
- 18 ▪ Organic growth was observed on the wall
19 adjacent to the through-wall air conditioner
20 on south elevation (Figure 558).
- 21 ▪ Light surface corrosion was observed on
22 brackets at the rear porch rafter and beam
23 connections.

24
25 **FIGURE 556.** Deterioration at wood soffit.

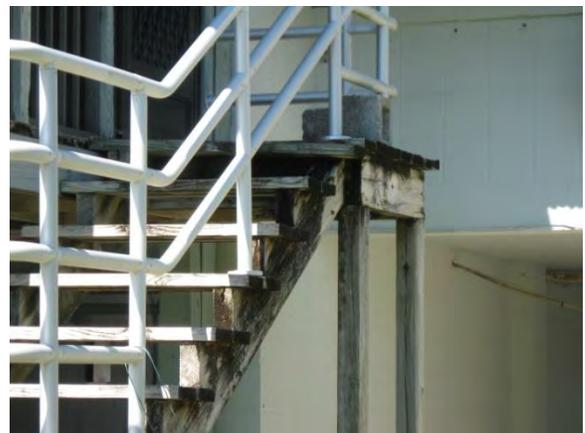
26
27 **FIGURE 557.** Wood rot at wood-framed stairs.

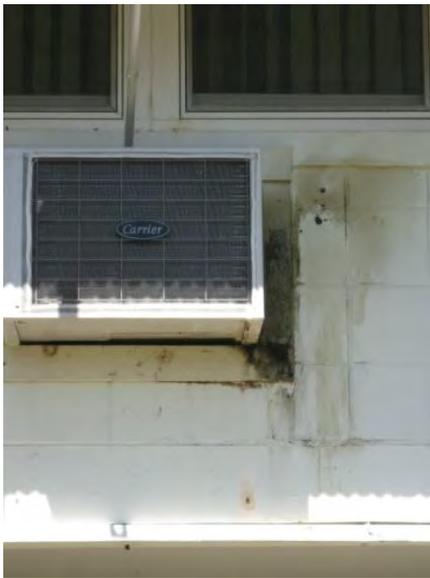
1
2 **FIGURE 558.** Organic growth adjacent to air
3 conditioning unit.
4
