Paintings Survey

Glacier National Park, Montana

September 27 - October 5, 2005

M. Randall Ash & Associates
Denver, Colorado

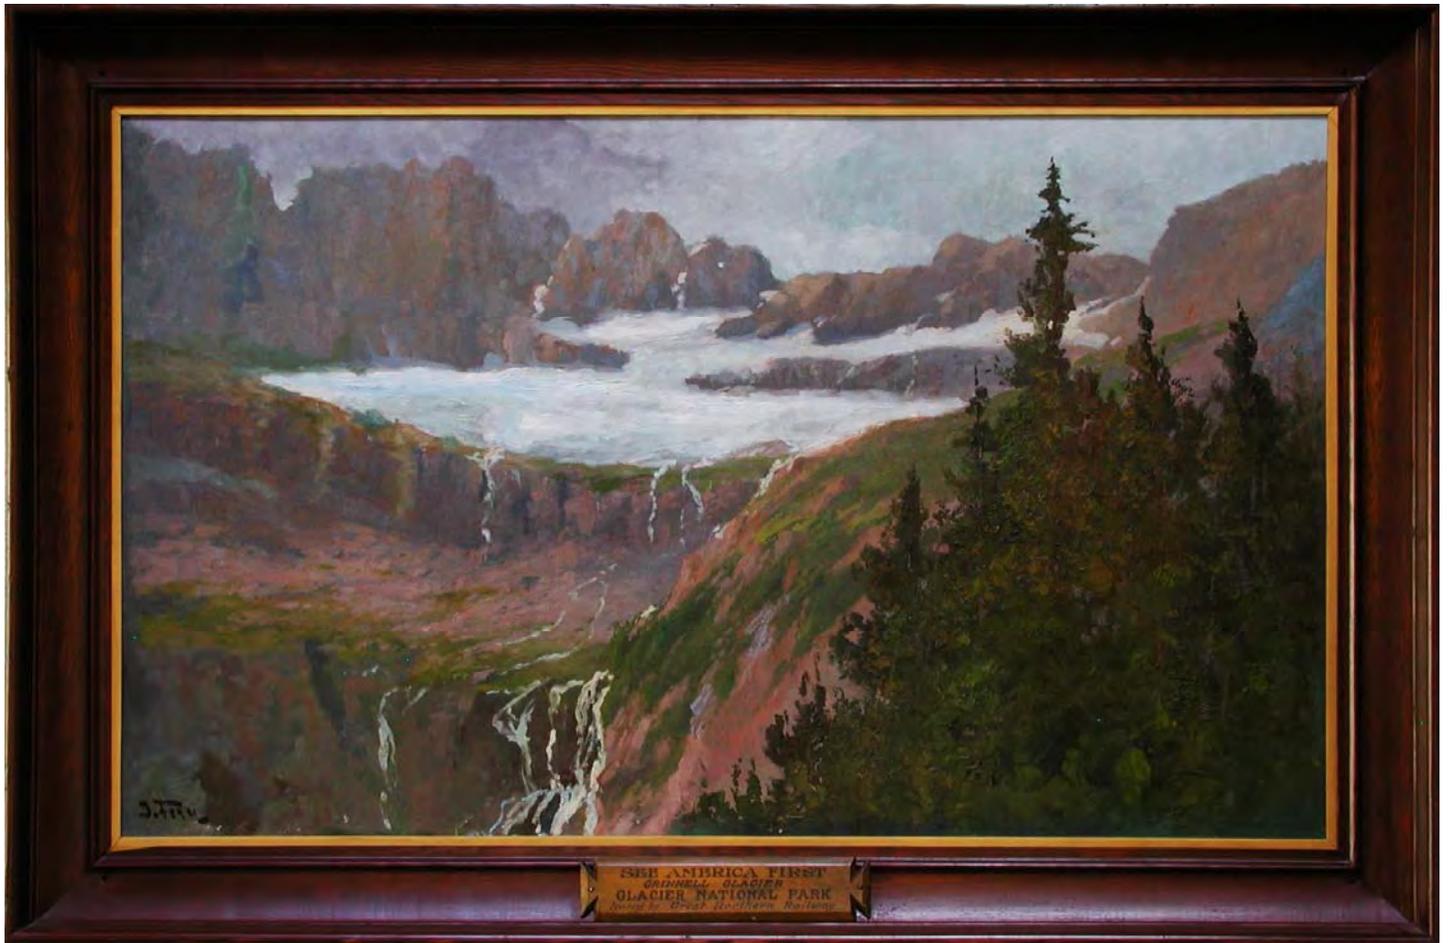
"Grinnell Glacier"

- This ptg. was attached to a panel at an earlier date - The panel is masonite w. 3 vertical and perimeter soft wood supports attached to the masonite -
- The canvas appears to be securely attached except along the lower horizontal, left half -

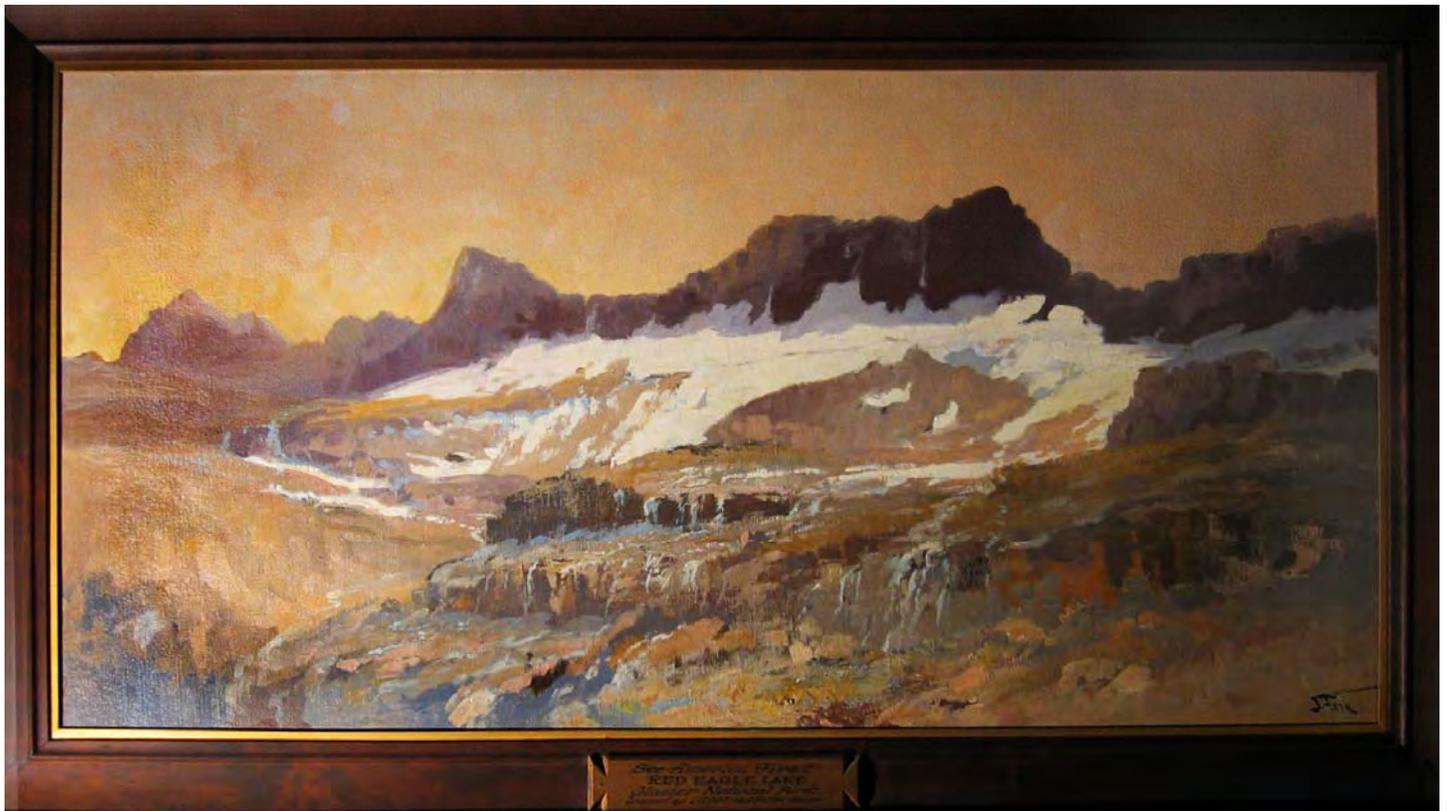
"Red Eagle Lake"
Artist: John Fery

The painting is a traditional oil on canvas, mounted onto a non-expandable strainer with one vertical cross-bar. This auxiliary support is not sufficient to the needs of the painting and should be replaced.

The canvas is a very heavy weave, presumably burlap. There is one small hole in the canvas in the bottom center and the possibility of an old damage in the upper right (examining conditions prevented certainty), but otherwise the canvas appears to be sound. Nevertheless, the canvas is very fragile and desiccated, and has never been reinforced with a lining. There is a draw, or sag, extending into the picture from the upper right corner. The reverse of the canvas is very dirty.

The canvas appears to have a commercially prepared ground layer. The paint film is oil based. The paint and ground layers are unstable, having a widespread pattern of small scale flaking associated with the heavy weave of the support fabric. There are small scattered losses associated with this flaking, and without treatment the condition will only worsen. For its preservation, this painting will need a consolidating lining.

The painting has a large and heavy plain wooden frame. The frame is in reasonably good condition. The painting is held in the frame with nails instead of the recommended brass plates, and there is no protective backing. It is recommended that the hanging wires and screw eyes be checked for strength, as the painting is large and the frame is heavy.

The major element detected in laboratory examination is the presence of overpaint lavishly painted over old areas of flaking. This overpaint is especially heavy on generally vertical passages on each side of the picture. The overpaint is oil, and, as with similarly previously restored passages on other paintings in the Glacier Park collection, is tenacious. Solvent tests indicate that it may not be possible to remove the overpaint without undo damage to the original.

Recommended treatment: Painting should be cleaned as required, consolidated, lined, remounted onto a new stretcher, old losses filled and inpainted, and revarnished. The painting should be backed and properly reframed.

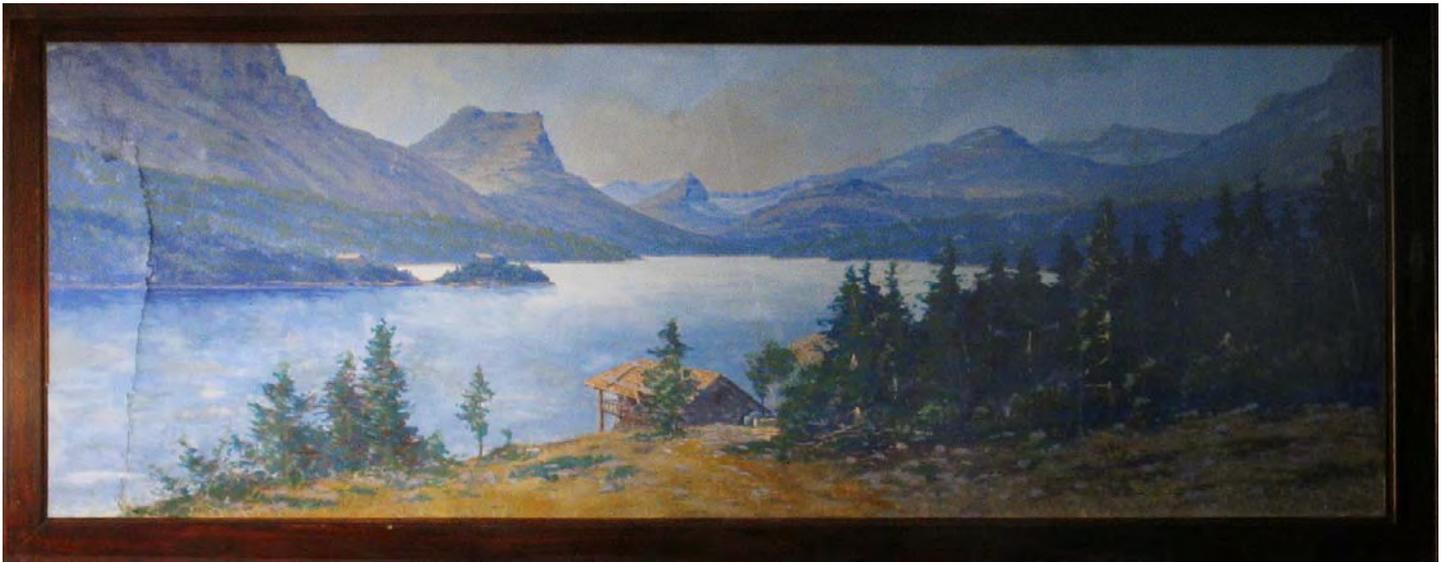
Going to the Sun Chalet
Artist: Unknown

NOTES:
Masonite screwed to frame from reverse
on left vertical a large water "drip" w. extending tide lines - the area is top to bottom & is very dark vertical line

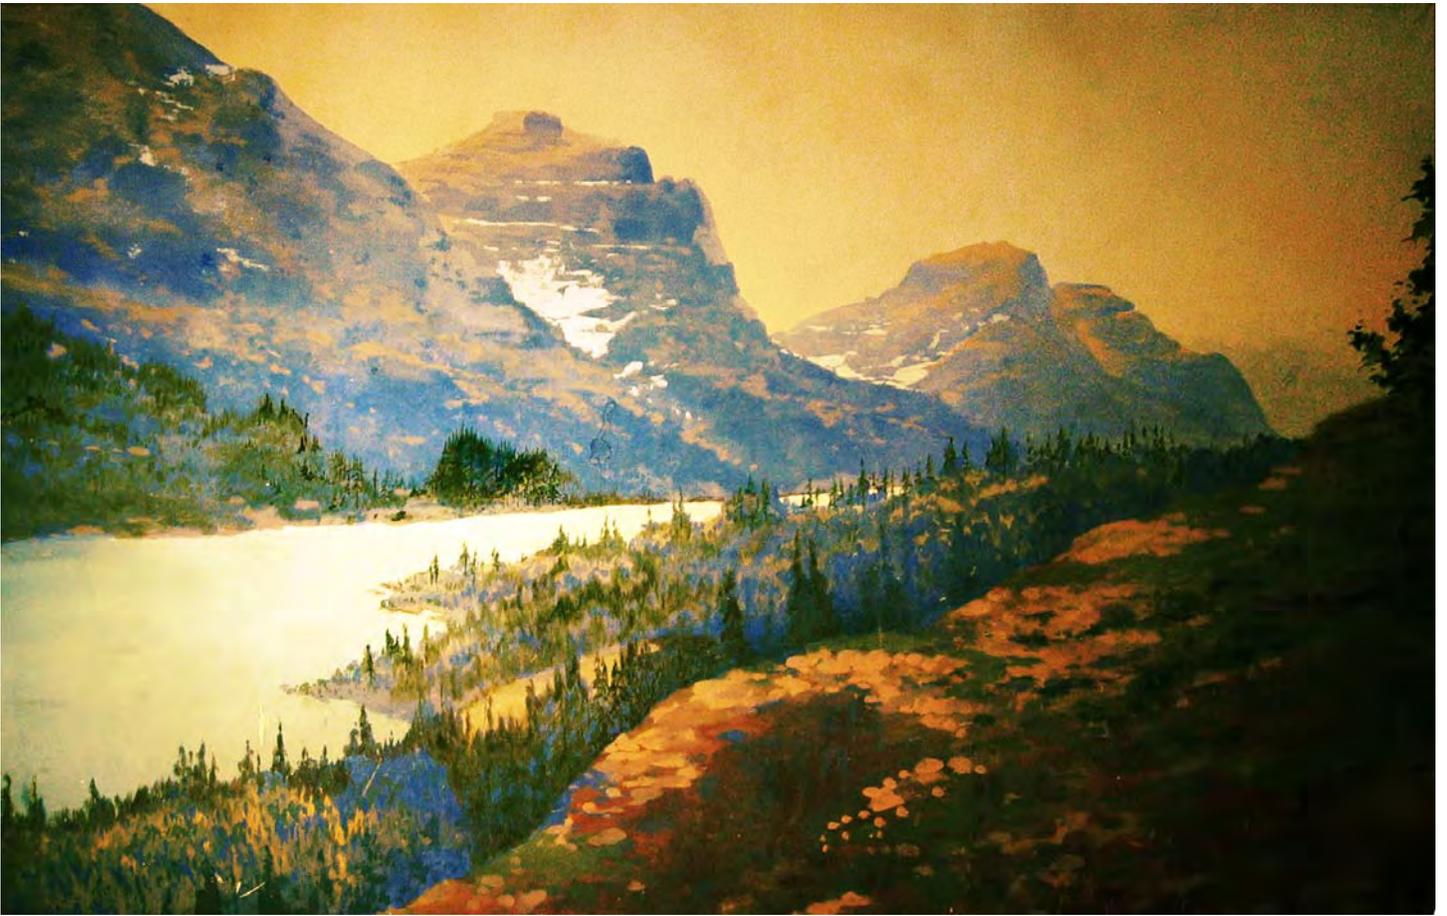
“St. Mary Lake”
Artist: Unknown

- masonite strips used as a frame rabbet - top rt half missing but lodged on lower rt half

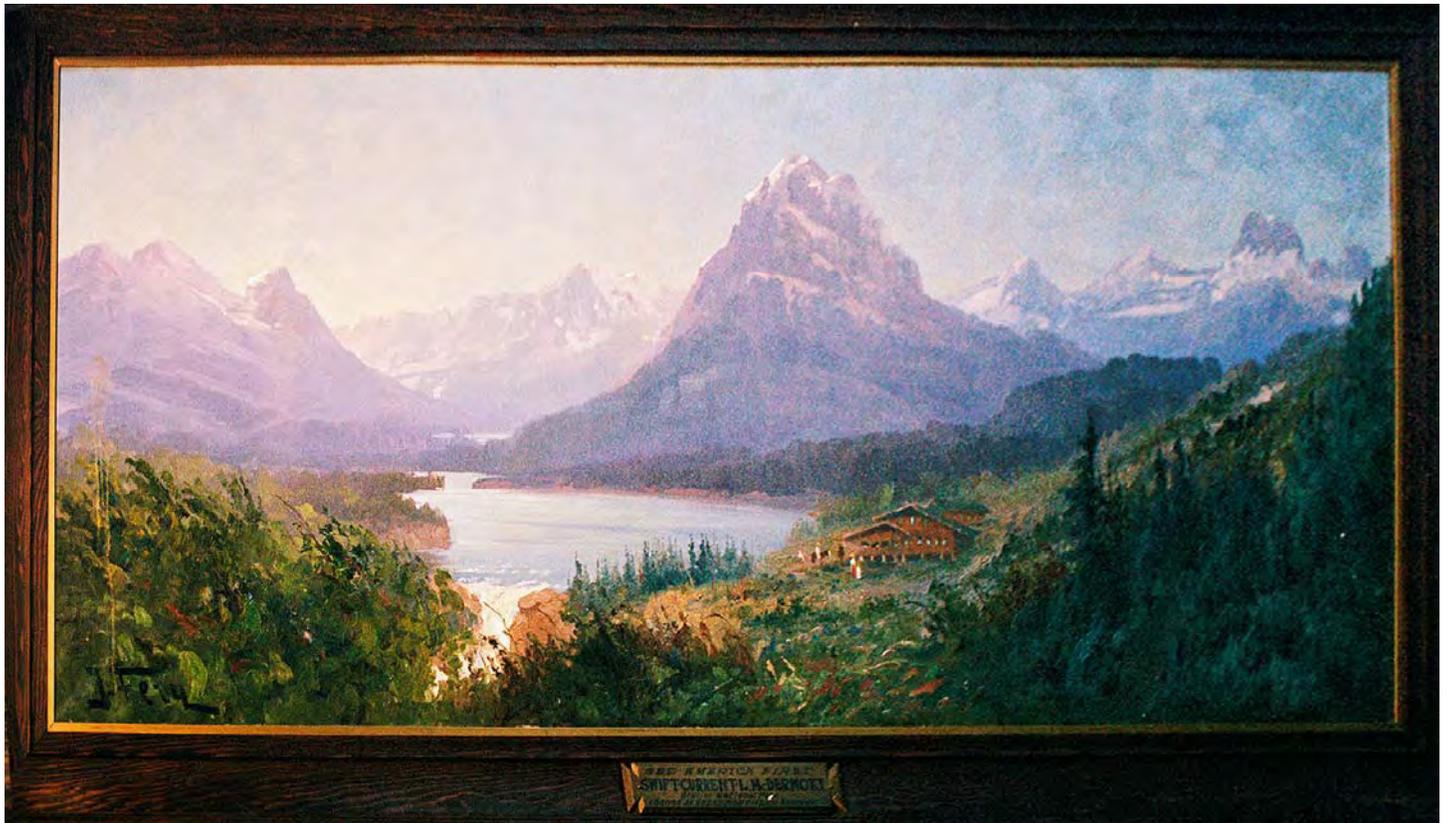
"Swiftcurrent and Lake McDermott"
Artist: John Fery

NOTES:
 → Bulges along the bottom between strainer bar & canvas - they are located
 6 1/2" from right
 29" from right
 52" from right } there are many but these are the most obvious.
 5 1/2" from left
 20" from left

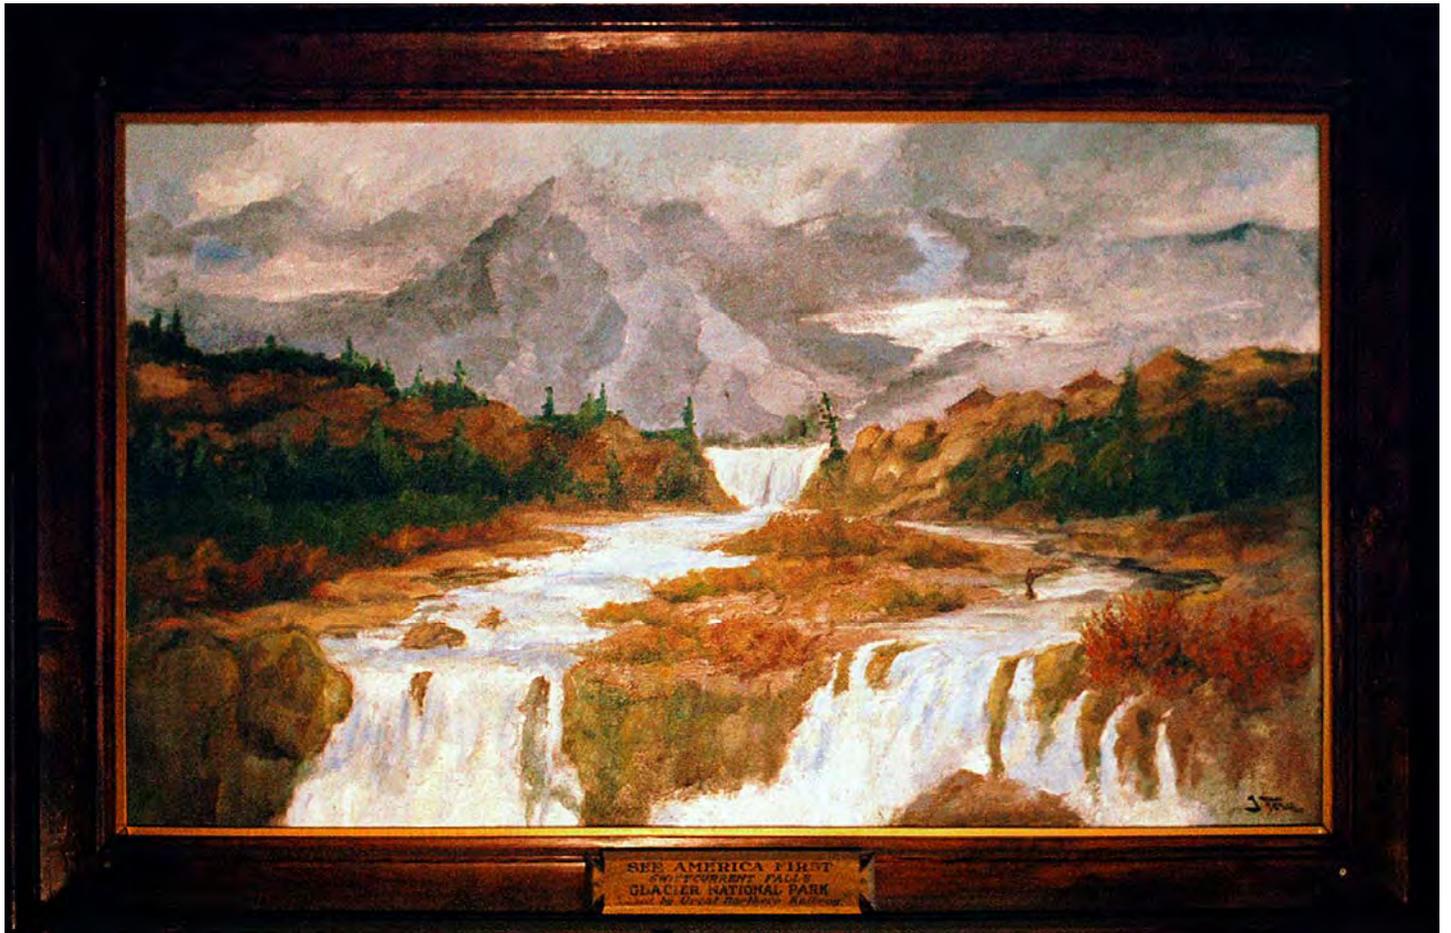
"Swiftcurrent Falls"
Artist: John Fery

- There is one John Fery painting, *Swiftcurrent Falls*, which is on a wall next to the front entrance of the Lodge. The front doors seem to be left open regularly with hotel traffic. There is also a wall heater below it. It is most advisable to move this painting, as there is no stable environment, either climate or light. The painting is definitely being affected by its present location.

- This ptg. is hung by a front cleat that is usually open. Not the best placement for any art object
 - There was an earlier restoration attaching the heavy canvas to a masonite support.

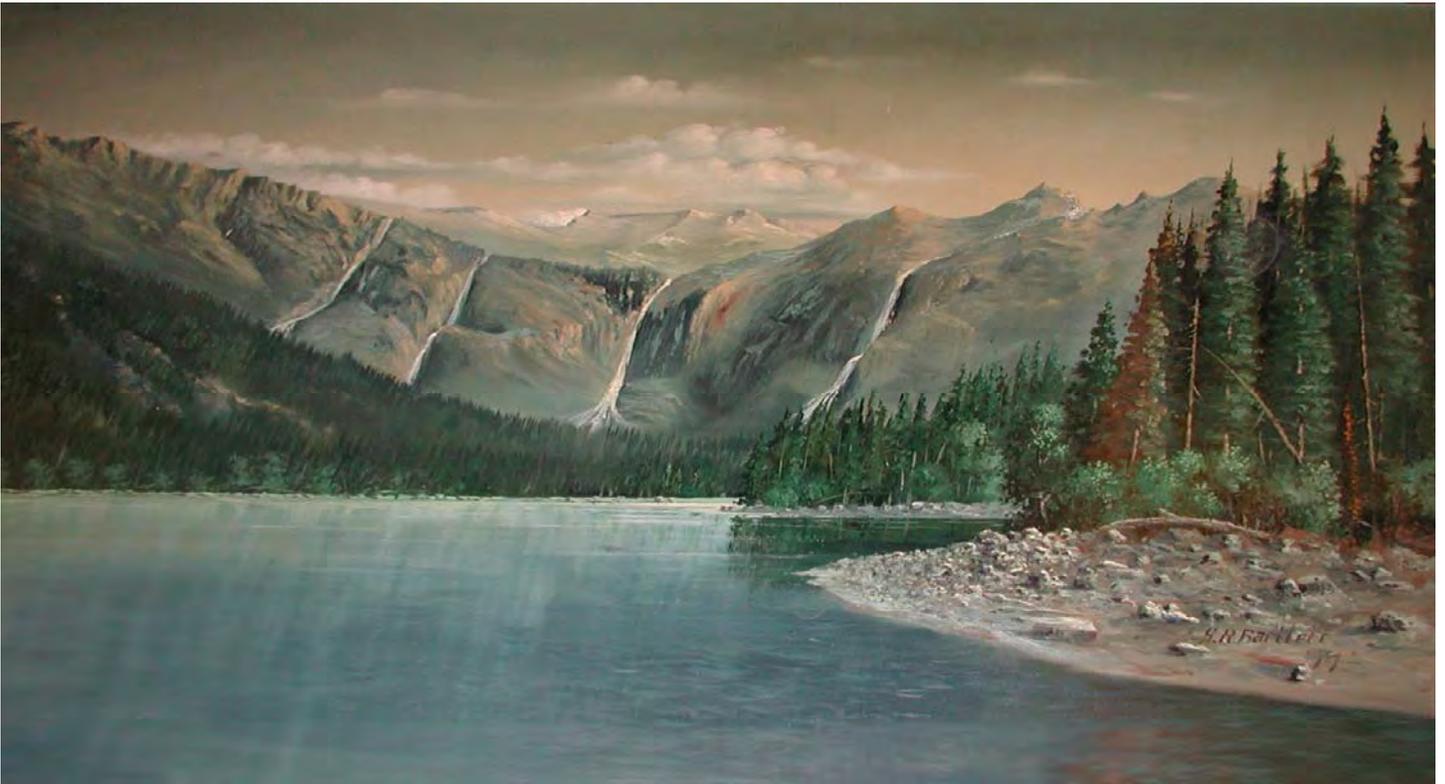
Avalanche Lake
Artist: H.R. Bartlett

— There is canvas puckering/buckling along both vertical sides. The left side is the most obvious. It almost appears that the canvas could be somewhat adhered to the strainer bar on scattered areas.

— On the u.l. corner, a nail is protruding through the canvas coming from the reverse.

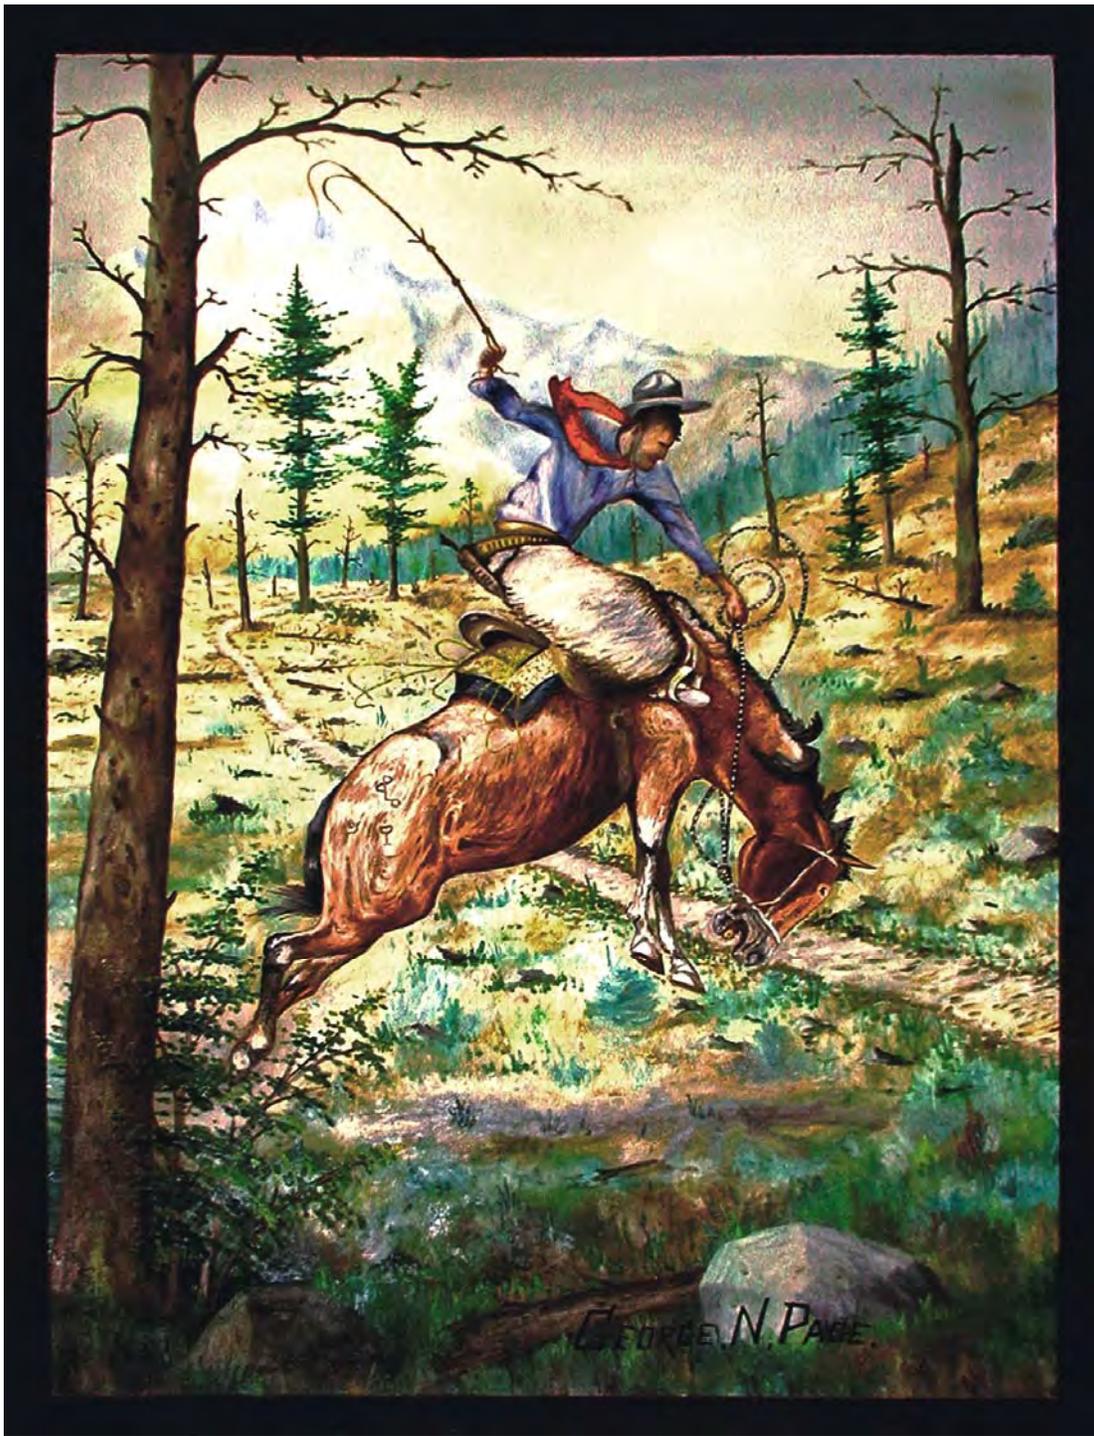
“Bucking Horse With Rider”

Hole vt - 10" down x 1/4" from vt / 3/8" up x 2 2/8" from left
Tear 3" vertical, 2 1/4" up x 8 1/4" from vt.
 Missing Part

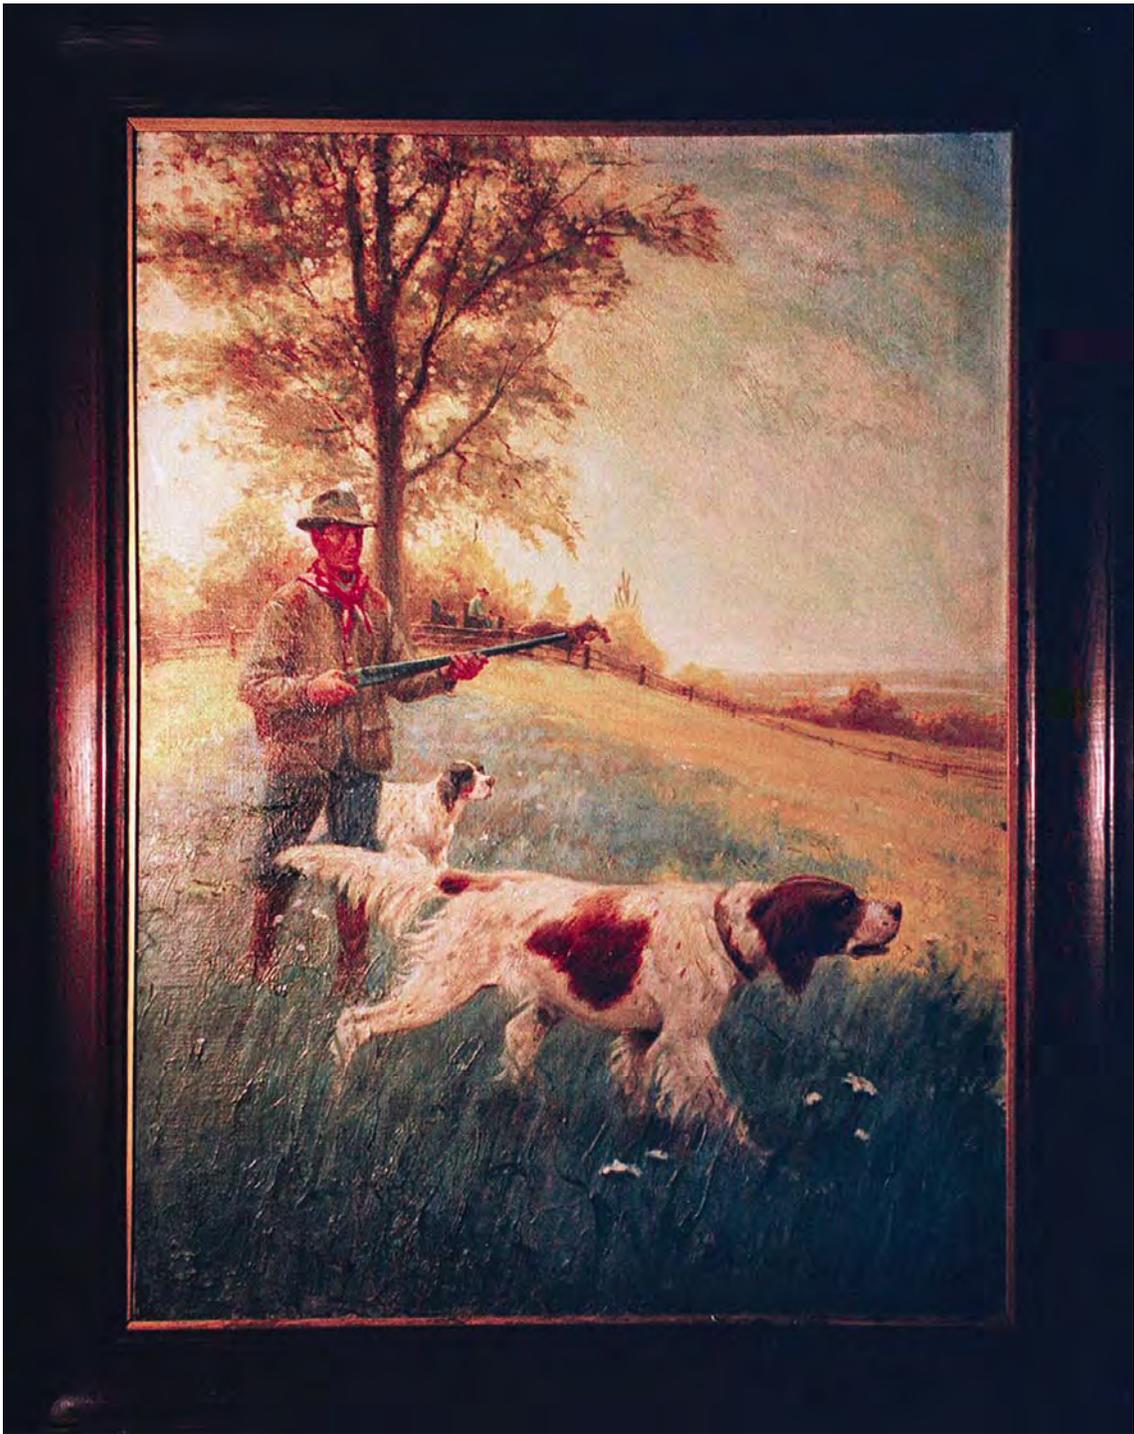
Hunter with Gun and Two Dogs
Artist: Frank Stick

* holes on verticals indicate another hanging -
* only one hanger - not adequate - need 2, always

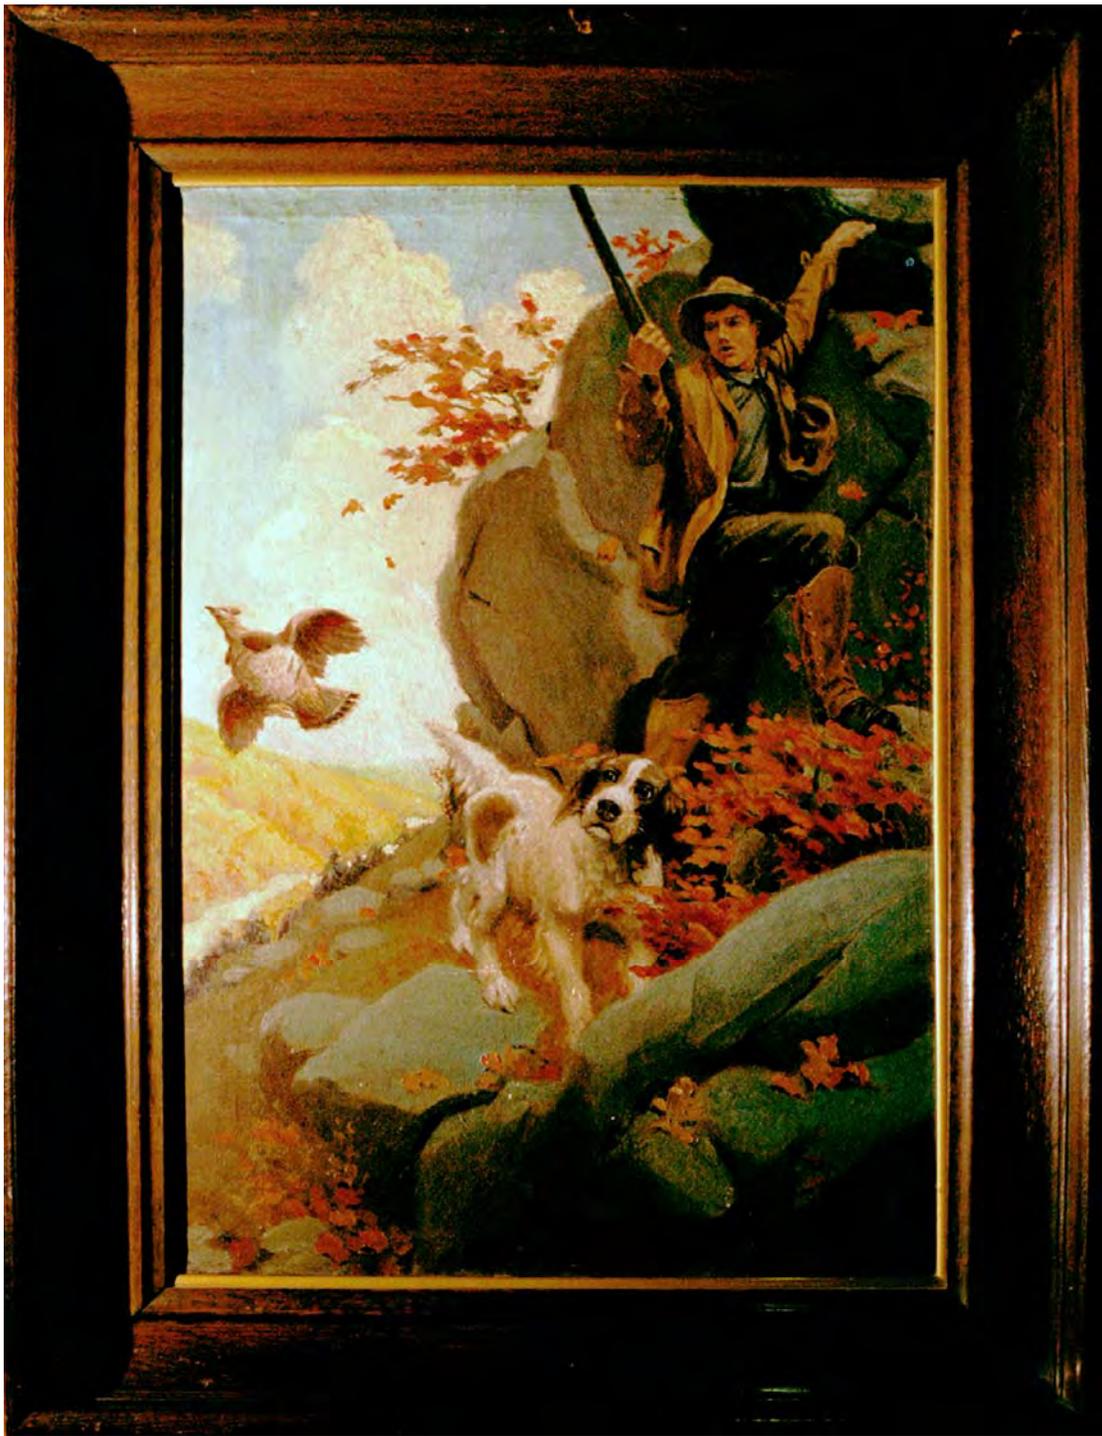
Man and Dog Hunting Birds
Artist: Frank Stick

- 10) Frame Condition**
- Loose Joints
 - Insect Damage
 - No Proper Backing
 - Glazed
 - Broken
 - Chipped
 - Weak Rabbet Edge
 - Insecurely Installed
 - Nailed in
 - Loose/Missing Ornaments
 - Missing Parts
 - Scratch
 - Distortion of plane
- * nail protruding from reverse - hole in front lower horizontal*

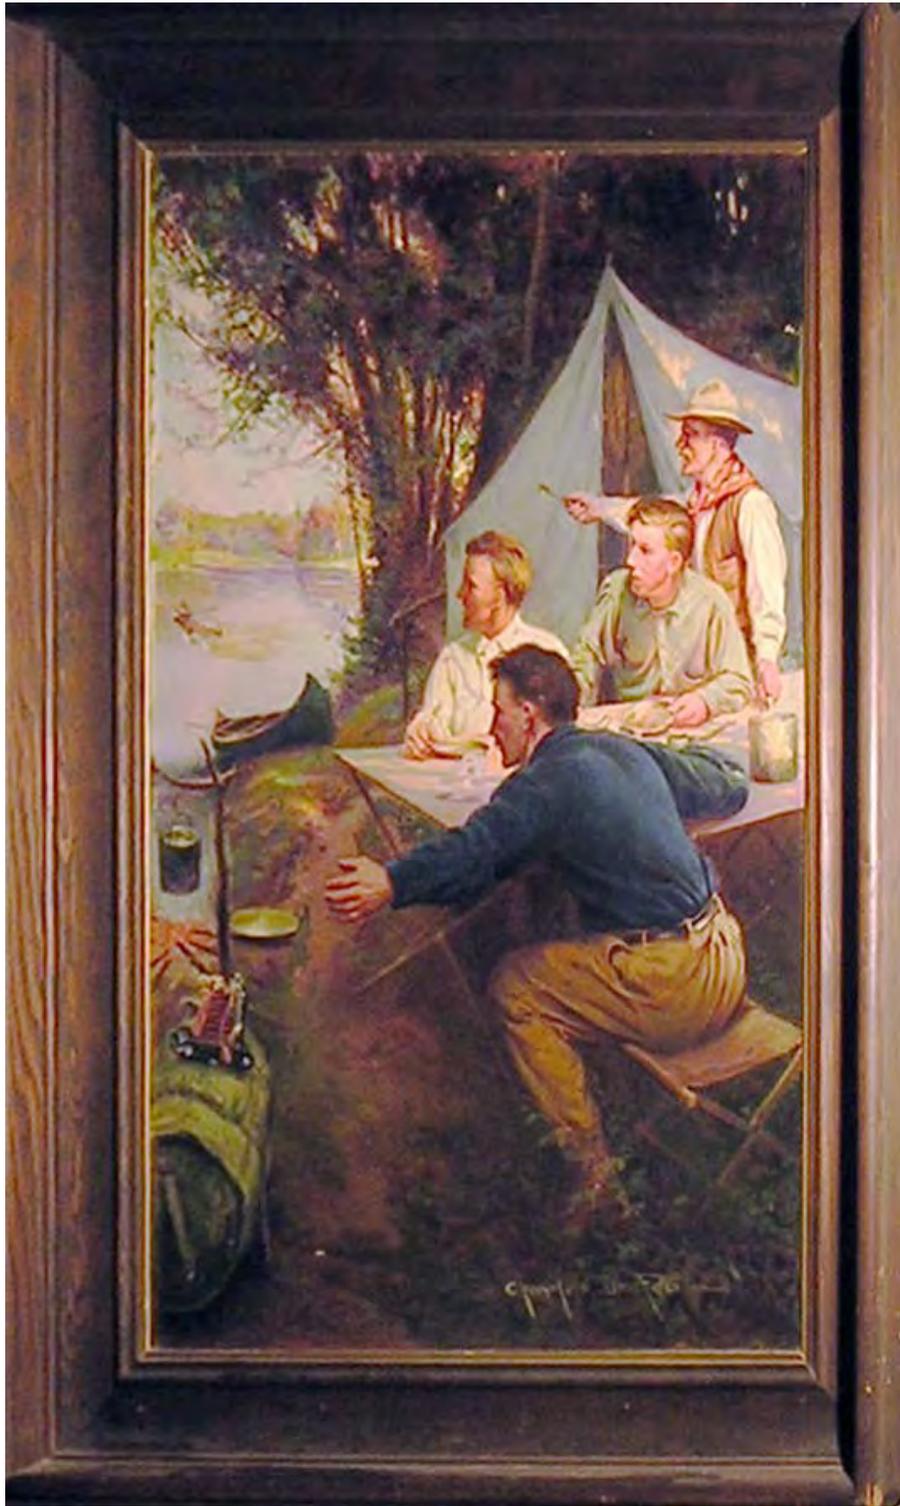
Four Men Seated at Table

*w. paint loss 1/2 from left x 3" up.

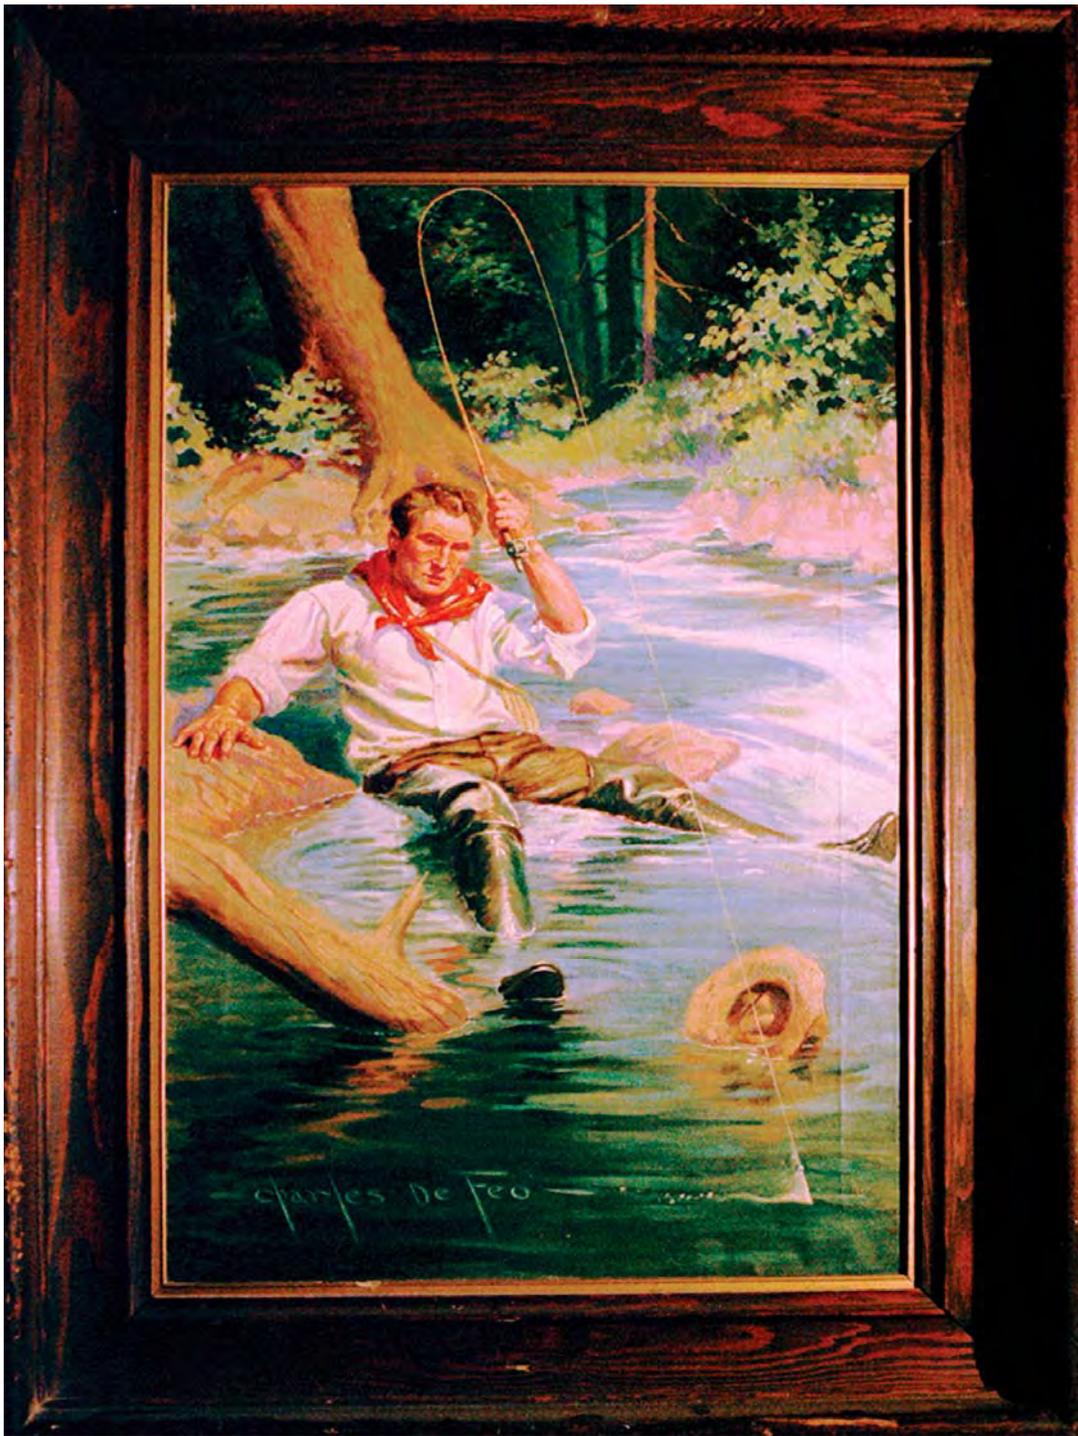
Fly Fisherman
Artist: Charles DeFeo

only one hanger - this is NOT adequate or secure

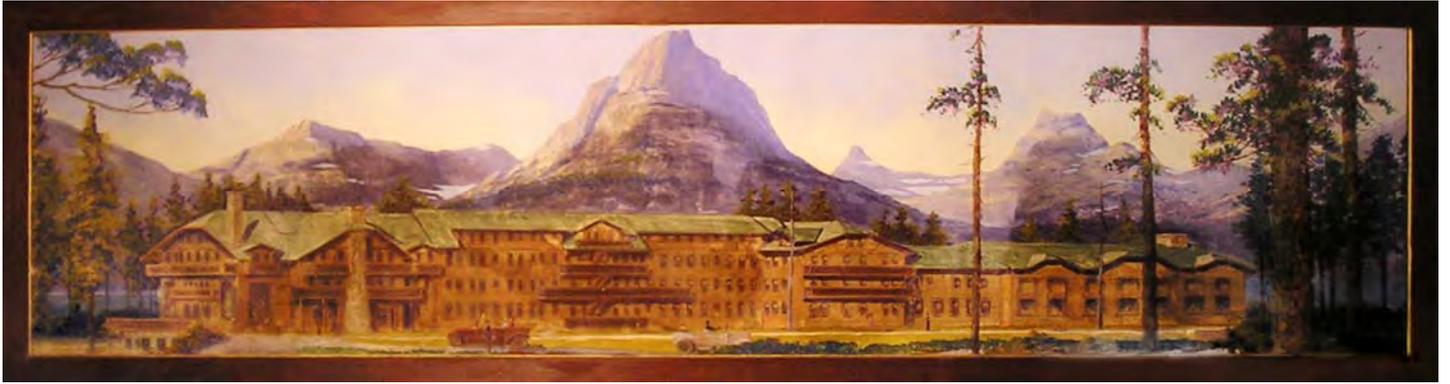
Many Glacier Hotel
Artist: Unknown

- The one painting, *Many Glacier Hotel*, artist unknown, is near the kitchen entrance and what appears to be a service station. The painting is unvarnished and susceptible to servers and possible food splashing. Keeping the food station farther from the painting and eventually applying a protective coating would be recommended.

- see info on Many Glacier Valley
- ptg. attached to wall/board
frame attached over ptg. -

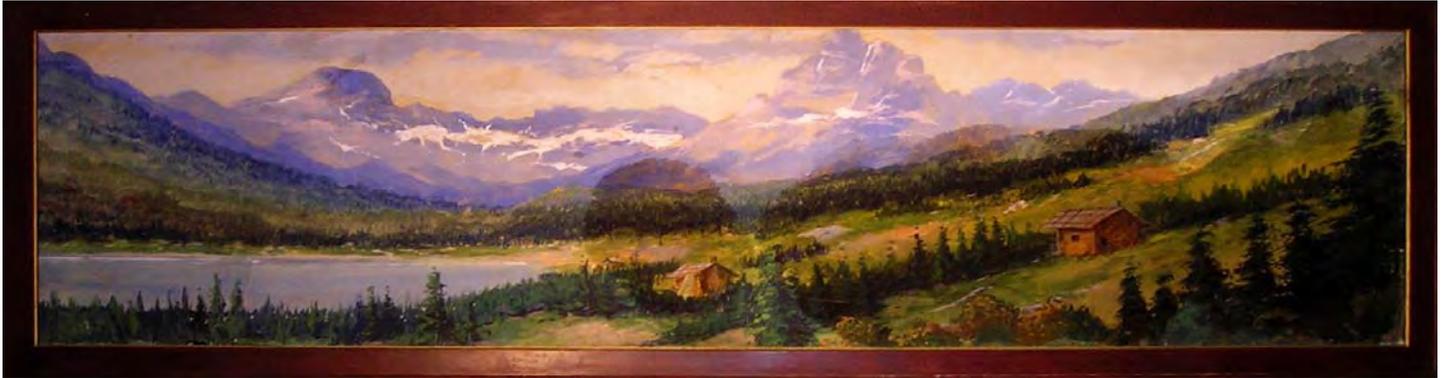
Many Glacier Valley
Artist: Unknown

- the canvas is laid over a solid support possibly masonite -
 - the most amount of damage is located in a 16" vertical band going across the entire lower horizontal - this is an area most accessible to the public
 - appears the pt. was first attached to wall/board & then the frame put over & screwed into wall -

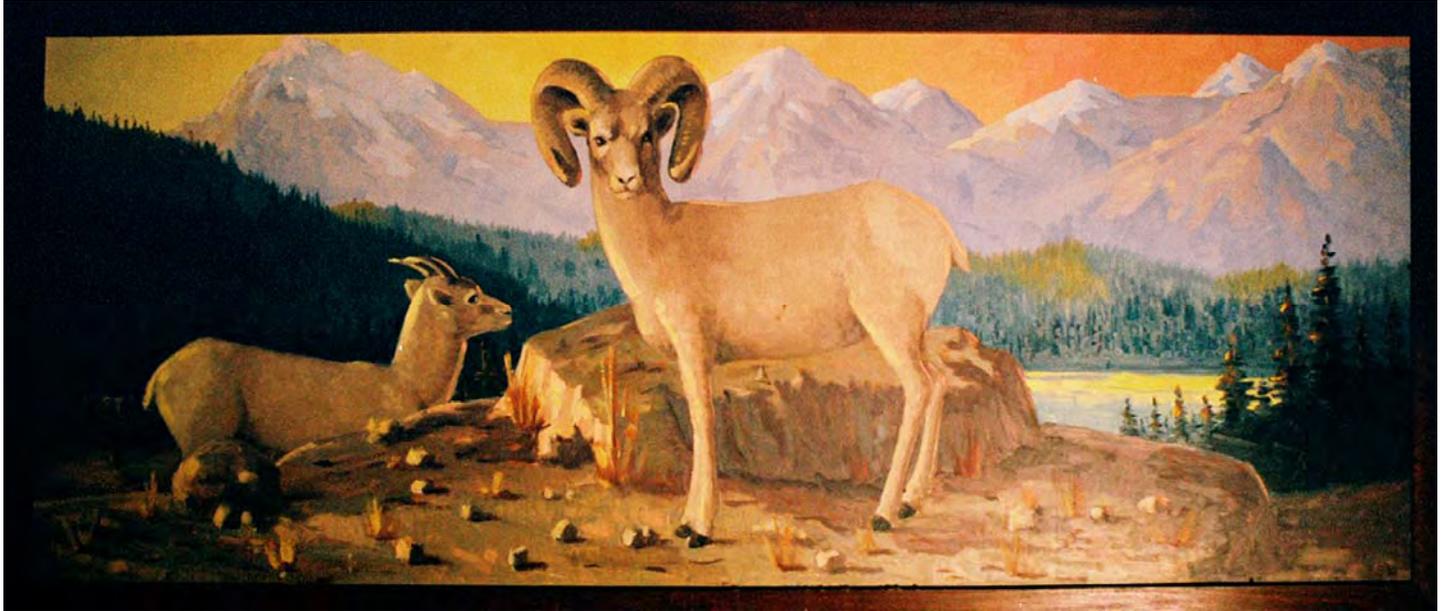
Big Horn Sheep
Artist: Richmond

*ptg. attached to wall w/ screws through str/board

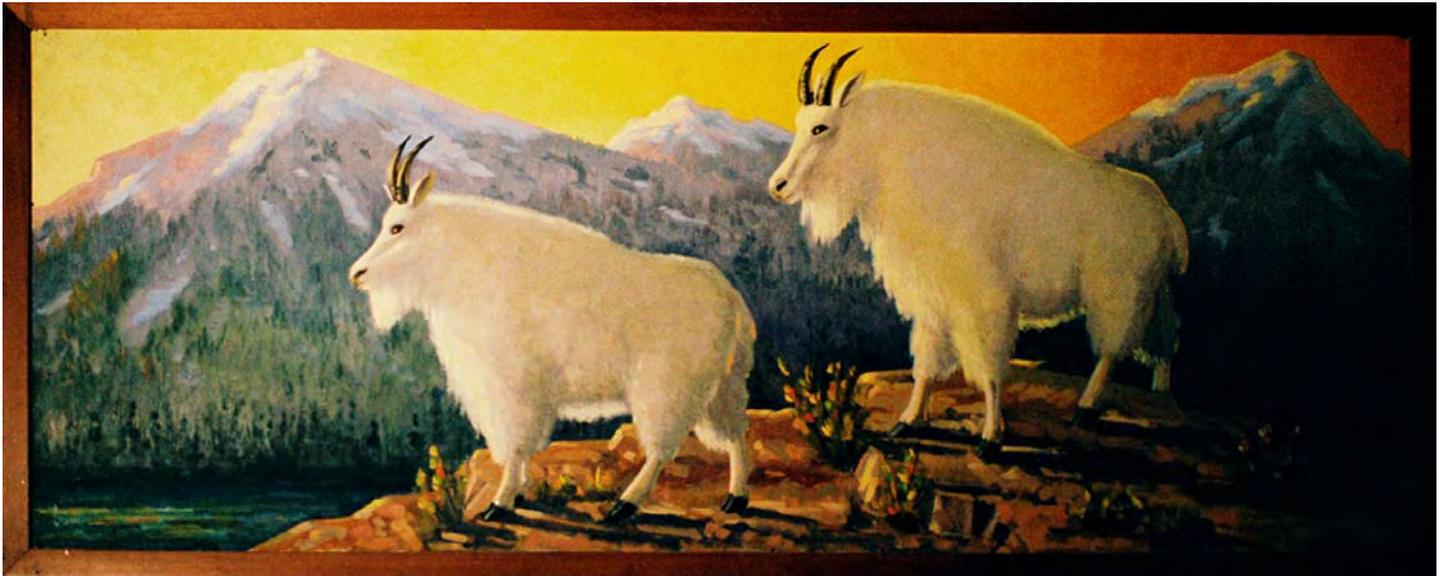
Mountain Goats
Artist: Richmond

NOTES: - pt. screwed into wall frame over it nailed into wall.

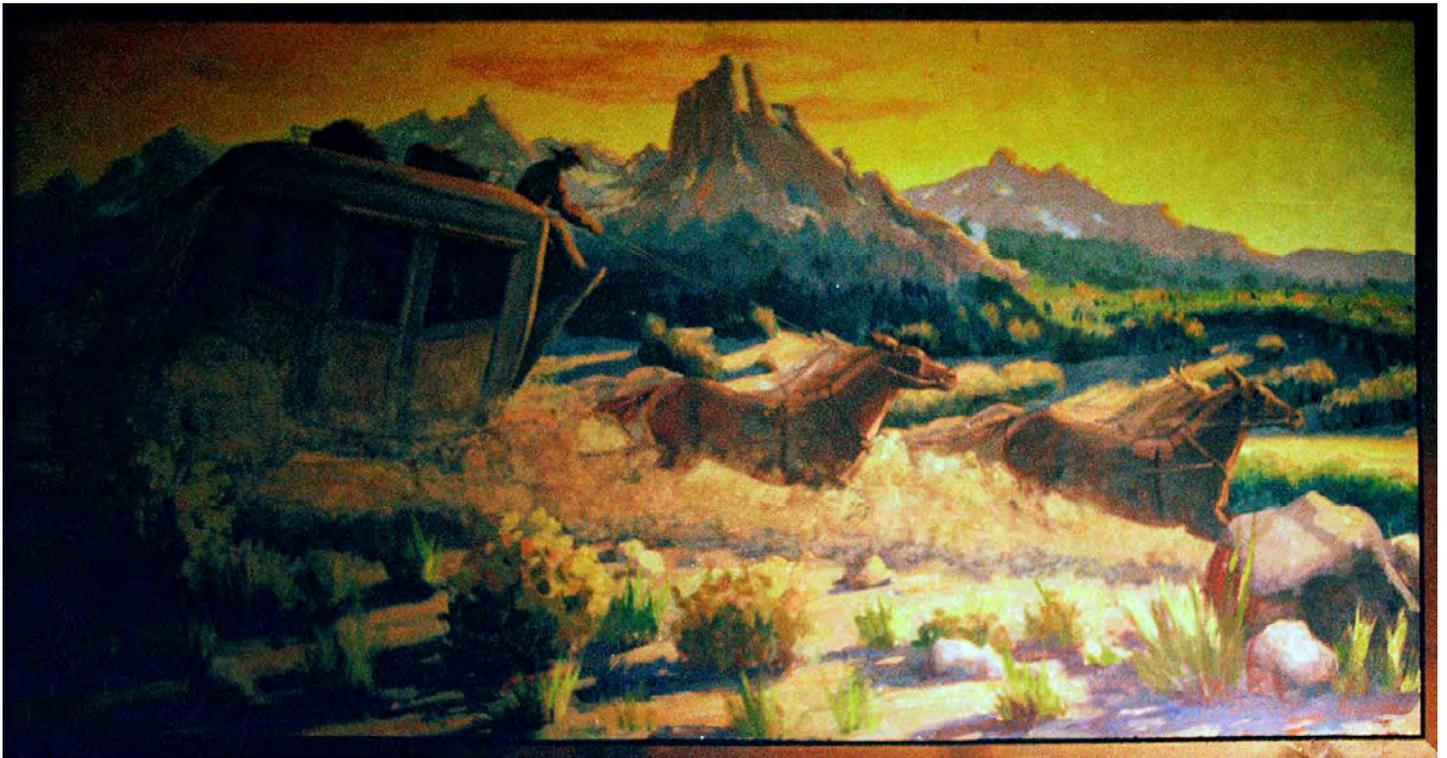
Stagecoach
Artist: Richmond

NOTES:
 - Relatively good condition
 only needs cleaning and a
 protective surface cleaning.
