## **Golden Gate Dairy (Lopes Brothers Dairy, Ranch M)**

### **Cultural Resource Reports and Site Treatments: Cultural Landscape Report Historic Structure Reports Archeological Assessment and Treatment Report**

June 10, 2013  
United States National Park Service,  
Golden Gate National Recreation Area  
Division of Cultural Resources

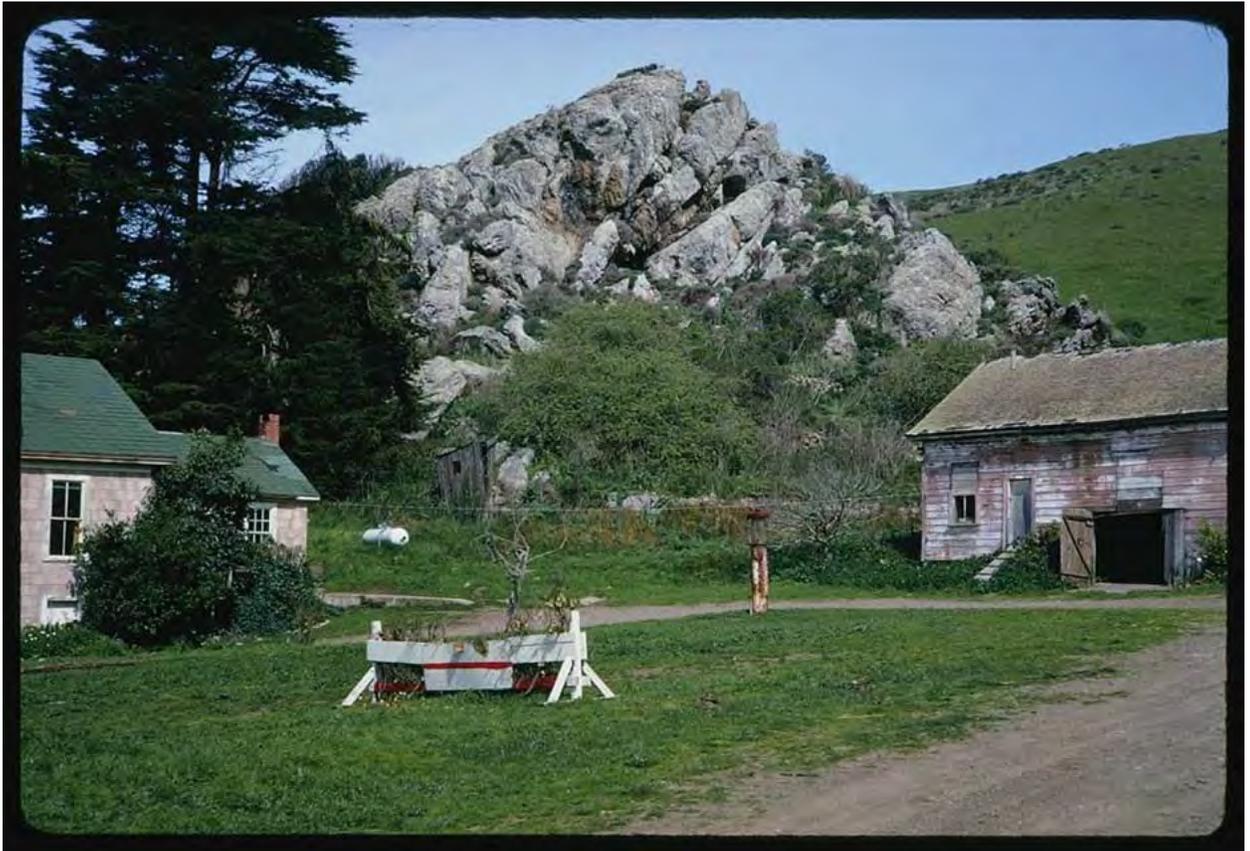
Recommendations include removing structures from the central core. This photograph from 1968 shows the internal road encircling an area free of structures. The Main House is to the left and the Creamery is to the right.

- Restore the central open space to its historic condition.
  - Remove all non-historic structures within this area, including horse stalls and sheds.
  - If possible, retain the use of the central, open area as a single space, with only a perimeter fence and no interior divisions.

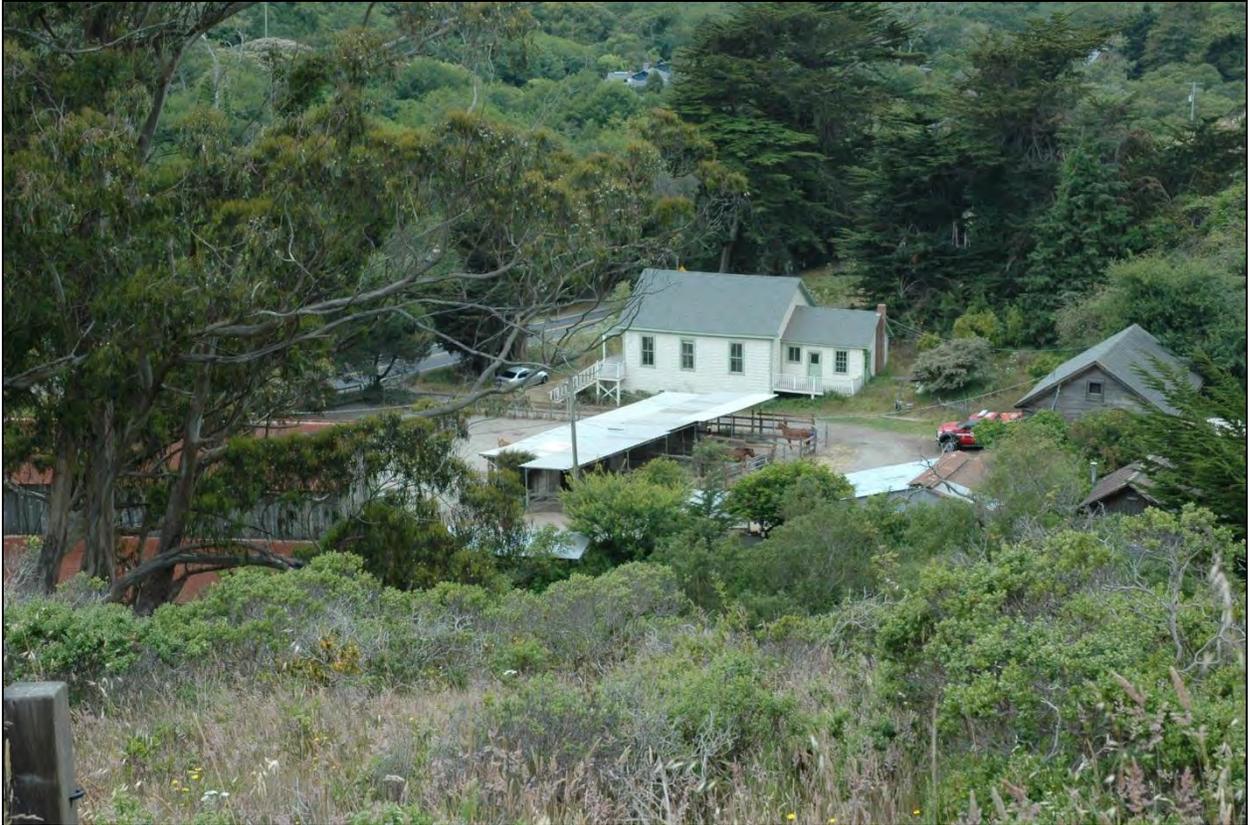
With the cessation of grazing, vegetation surrounding the core building area has evolved from grassland to coastal scrub.

- Preserve and maintain the natural systems and features that specifically include vegetation types, topography, and watercourse.
  - Remove non-native trees that may have escaped from the windbreaks.
  - Manage open grasslands and coastal scrub plant communities that surround the developed area and contribute to the historic character of the site.
  - Insure that all resident or guests horses are fed only weed-free feed to reduce the risk of invasive plant introduction.
  - Retain and manage the riparian corridor as a natural system.
  - Observe the riparian corridor set back of 50' for all structures and parking facilities.
  - Major changes to existing grades should be avoided, especially retaining walls in the historic core area.

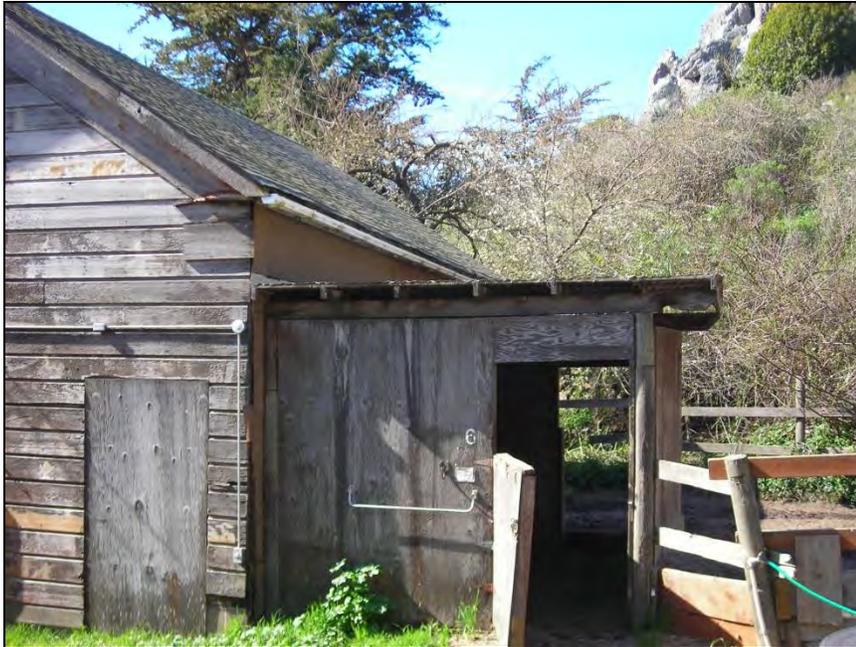
Recommendations include removal of non-historic attachments to historic buildings, such as this plywood stall behind the Creamery.

- Remove all non-historic additions to the historic buildings, including the outhouse on the south side of the Sanitary Barn.
  - Plywood stalls in the will be removed. Stalls outside of the historic core may be replaced in the same general location, with an emphasis on organization of the space available. This may result in a less than one for one replacement.

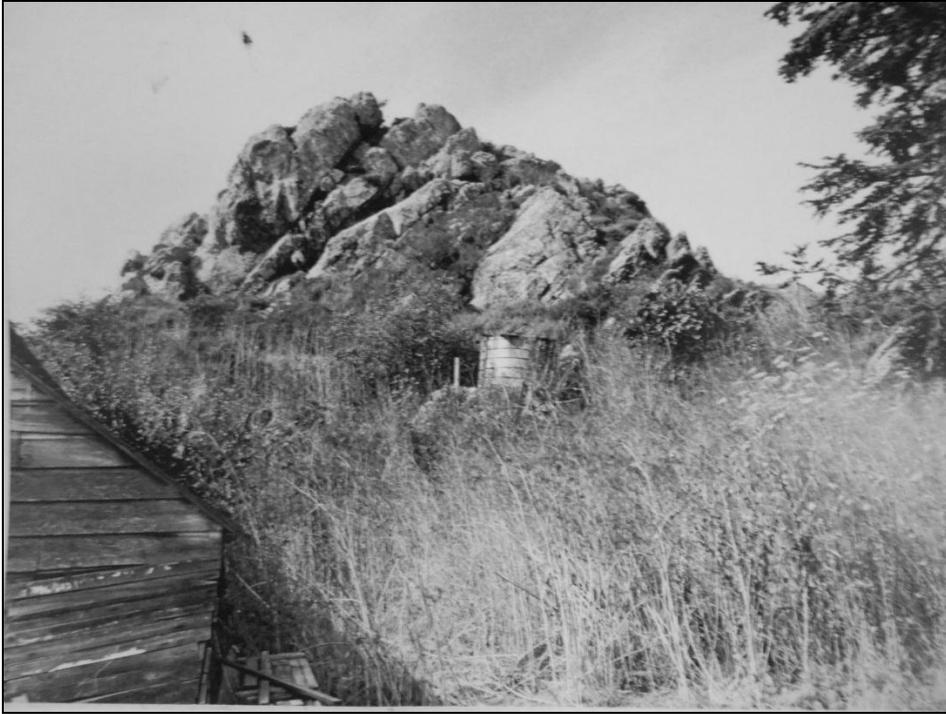
Watertank visible below the rock outcrop, north east of the Main House. Consideration should be given to locating a new watertank in this location, if at all feasible.

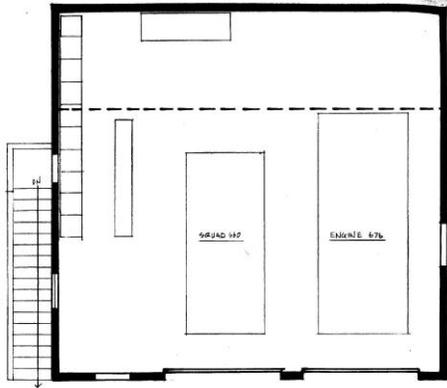
MBVFD Barn Remodel Concept Floor Plan

*Not Recommended:* Changing the building form and shape by adding a stair on the west where there was not one historically; altering the original footprint with an addition along the whole of the north wall, modifying the roofline.

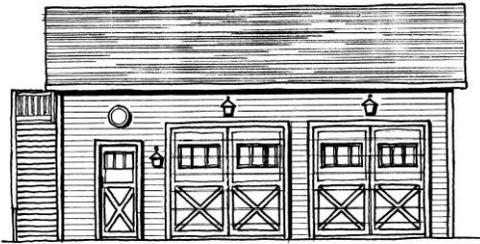
MBVFD Barn Remodel Concept Front (South) Elevation

*Not Recommended:* Changing the building form and shape by adding a stair on the west where there was not one historically; changing the character of the main façade by the addition of contrasting stylistic treatments and appurtenances; altering important elements of the building style (rake boards and corner returns).

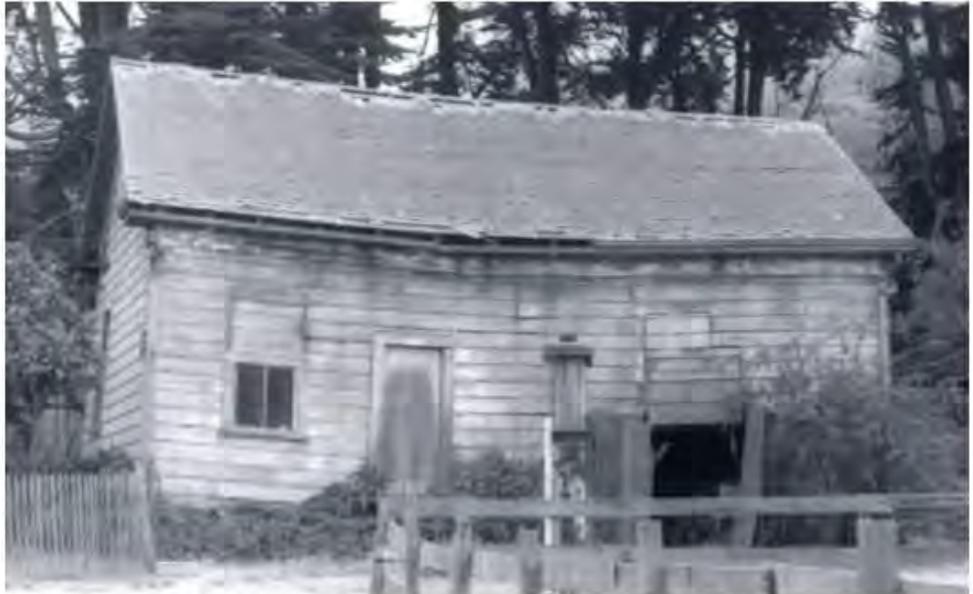
**Golden Gate Dairy Creamery Building South Façade ca. 1970**

Note the window penetration on the west, the in-filled window penetrations on the south, and the door penetrations. There is no exterior porch. The window at photo left matches windows extant on the Main House. Object in foreground is believed to be a gasoline pump.

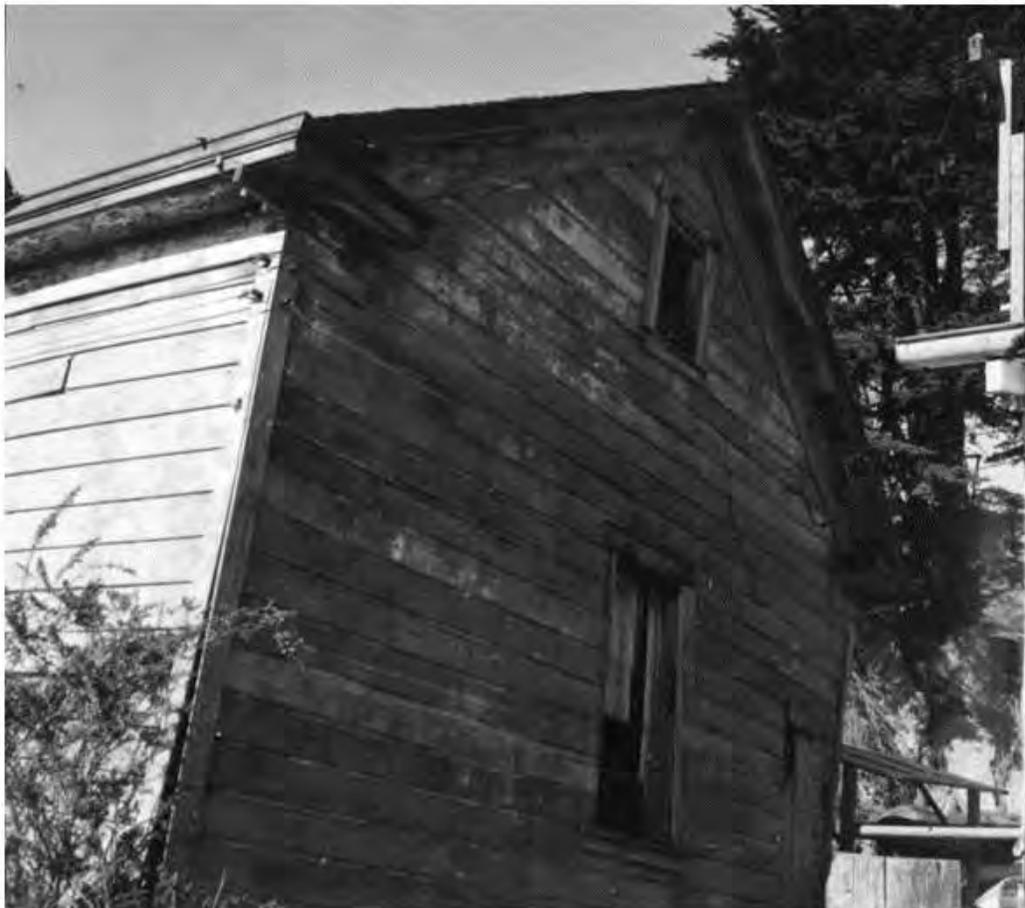
**Two Views of the Golden Gate Dairy Creamery Building East Façade 1970**

Note the window that appears to have been closed off but has shelves on the interior. Note also the lack of (or extreme foreshortening) of the door penetration in this location.

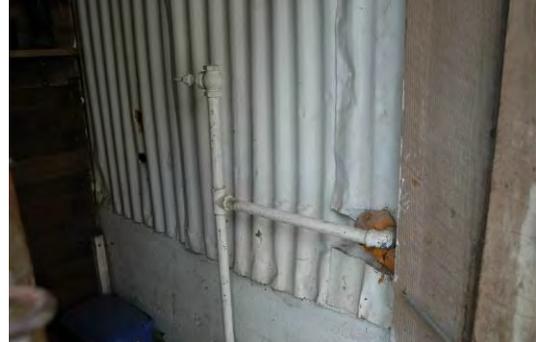
<p>Northeast corner inside outhouse; abandoned water piping possibly from boiler or heater on opposite side; north room (NPS Photo, 2012)</p>	<p>Capped ridge vent detail (NPS Photo, 2012)</p>
