Tennessee Valley Stables (Cunha/Rapozo Ranch, Ranch A/B)

Cultural Resource Reports and Site Treatment: Cultural Landscape Report Historic Structure Reports Archeological Assessment and Treatment Report

June 10, 2013
United States National Park Service,
Golden Gate National Recreation Area
Division of Cultural Resources

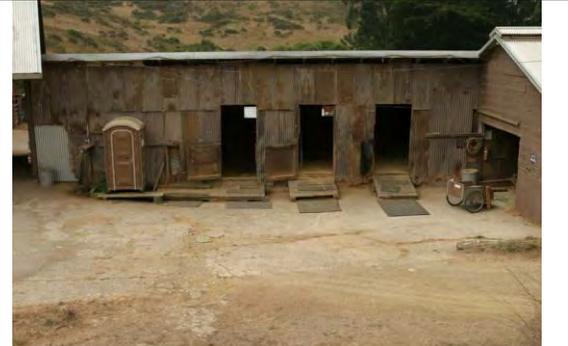
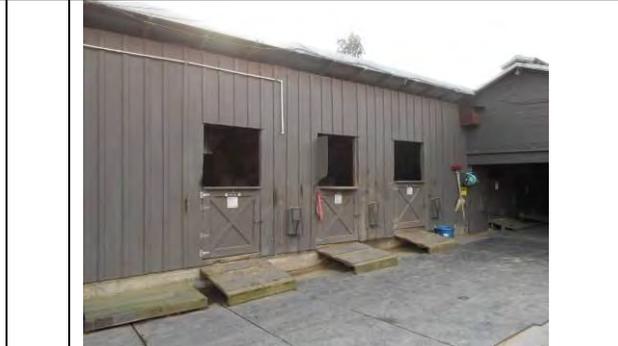
<p>North wall of Milk House Shed Addition (Stables Annex) (NPS Photo, 2008)</p>	<p>North wall of Milk House Shed Addition (Stables Annex) (NPS Photo, 2012)</p>

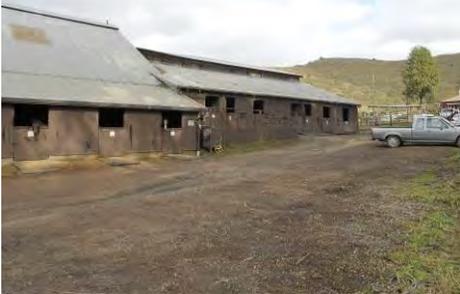
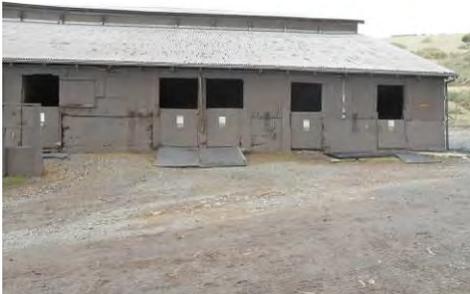
<p>Looking northeast at south wall of Milking Barn (Hay Barn) stables (NPS Photo, 2012)</p>	<p>East end of south wall of Milking Barn (Hay Barn) roof with missing louvers (NPS Photo, 2012)</p>

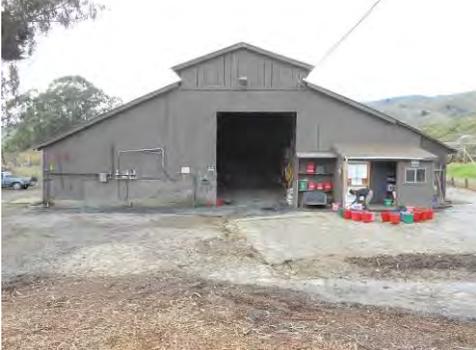
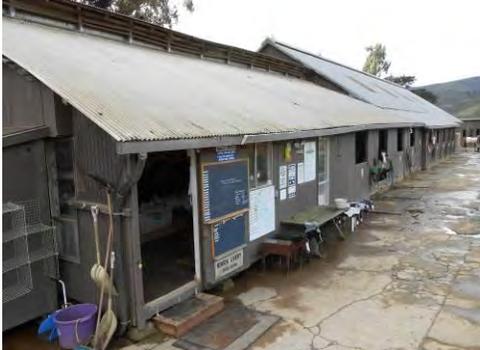
<p>East wall entry to Milking Barn (Hay Barn) (NPS Photo, 2012)</p>	<p>Looking east from northeast corner of Milking Barn (Hay Barn) roof with louvers extant (NPS Photo, 2012)</p>

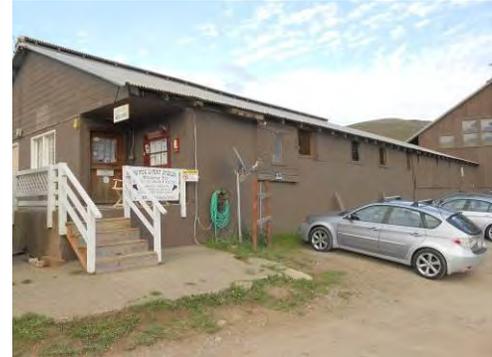
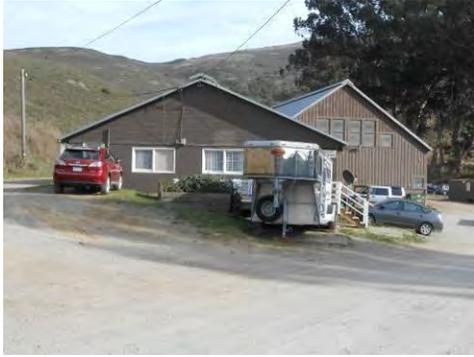
<p>Milk house loading dock with modern Office entry clutter (NPS Photo, 2012)</p>	<p>Looking east at milk house of Main Barn Complex (NPS Photo, 2012)</p>

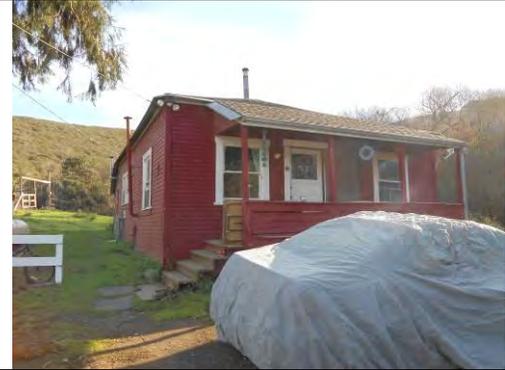
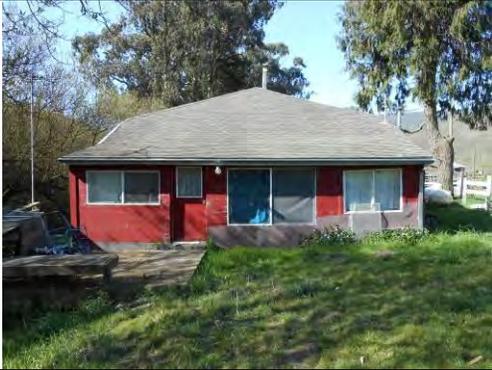
- One roughly 4'-0 x 2'-0" window opening boarded with 1x vertical boards
- One 4'-4"x 2'-3" sliding aluminum sash window in poor condition in the shed addition at the east end of the wall.

<p>Bunkhouse (Auxiliary Residence) looking east (NPS Photo, 2012)</p>	<p>East Wall of Bunkhouse (NPS Photo, 2013)</p>

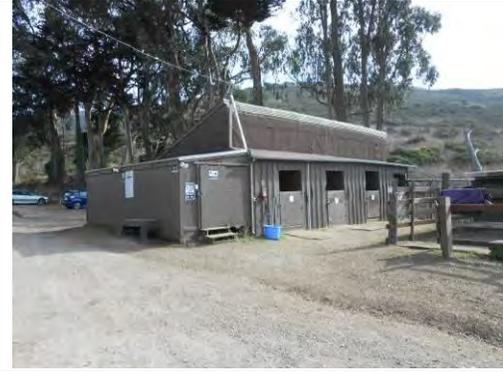
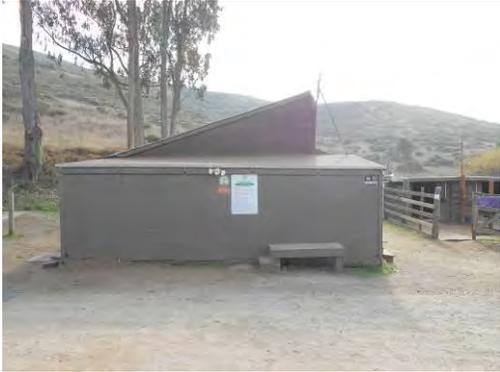
- Wood framed west wall has four horse stall doors spaced irregularly. A large portion of the framing does not appear to be original and includes pressure treated lumber. This makes it difficult to discern where and how the building was altered from dairy to equestrian use. The west wall is actually a partial height (roughly 10'-0" tall) 3'-8" deep shed addition to the enclosed original half-gable of the barn, has 1x12 vertical board siding with 1x4 battens and is in fair condition.

<p>Calf Barn (Auxiliary Stables) looking southeast (NPS Photo, 2012)</p>	<p>Calf Barn (Auxiliary Stables) north façade (NPS Photo, 2013)</p>

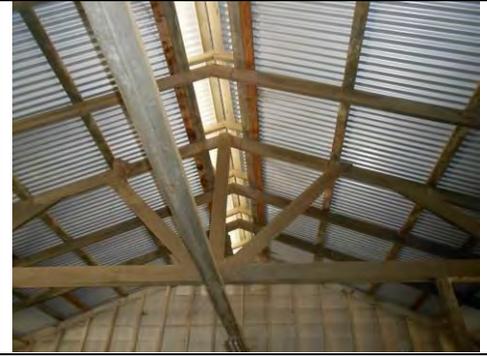
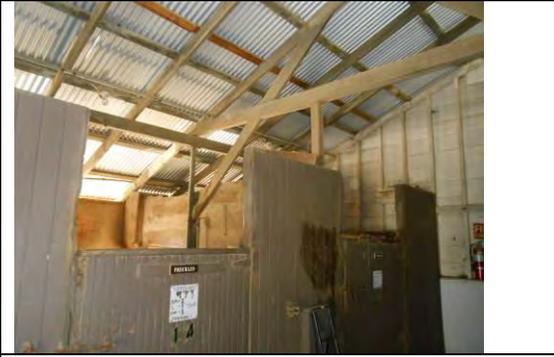
bay, covering the louvered ventilation features that support the gabled roof. The diagonal braces appear to be older than the recent work yet not as old as the original construction and brace the column lines together in two directions. Bracing at the lower column line, between the column and the outer walls is mostly missing, and the few extant braces are discontinuous. This creates a unique and somewhat unorthodox structural system of unknown evolution.

<p>Sanitary Barn interior detail of roof structure (NPS Photo, 2013)</p>			<p>Sanitary Barn interior structural framing detail (NPS Photo, 2013)</p>

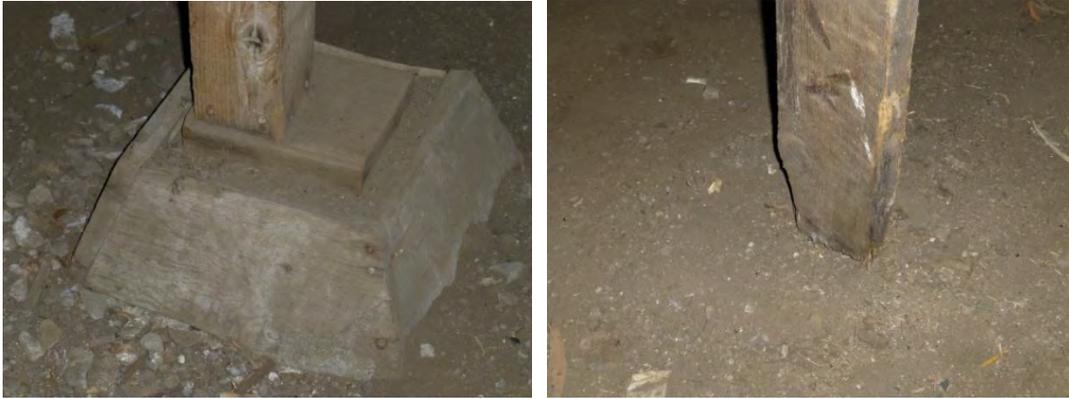
Eccentrically loaded pier footing at centerline of building and column in connection with dirt. (NPS Photos 2013)

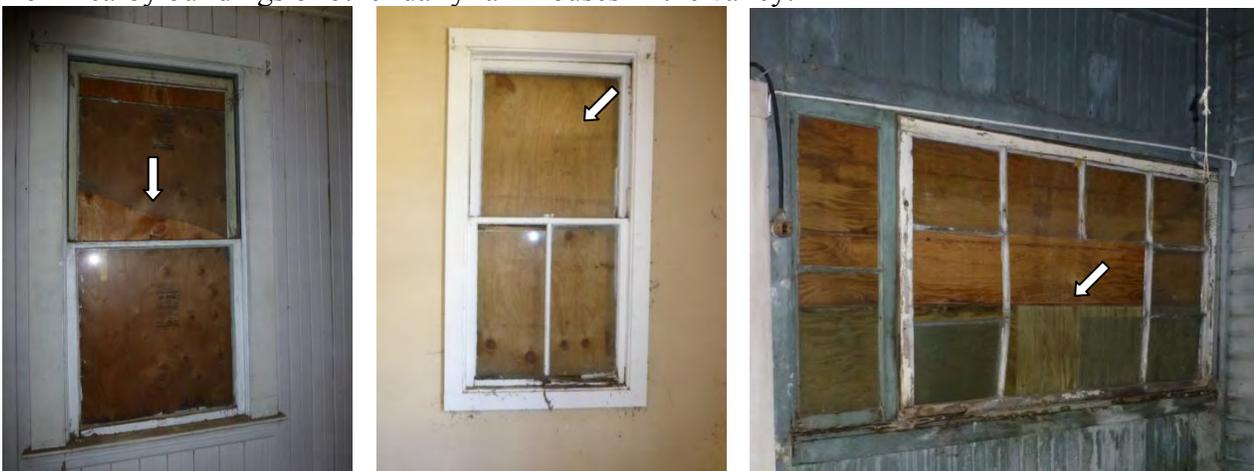
Various conditions of windows – shifted glazing, rotted stile, missing mullions (NPS Photos 2013)

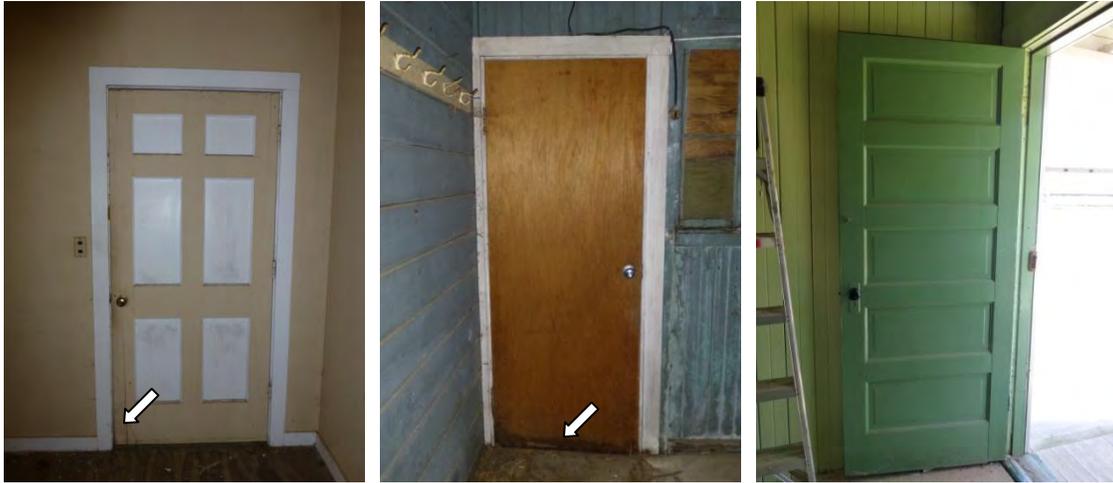
Various conditions of exterior doors- crack at north door, rot at south door, east door in good condition (NPS Photos 2013)

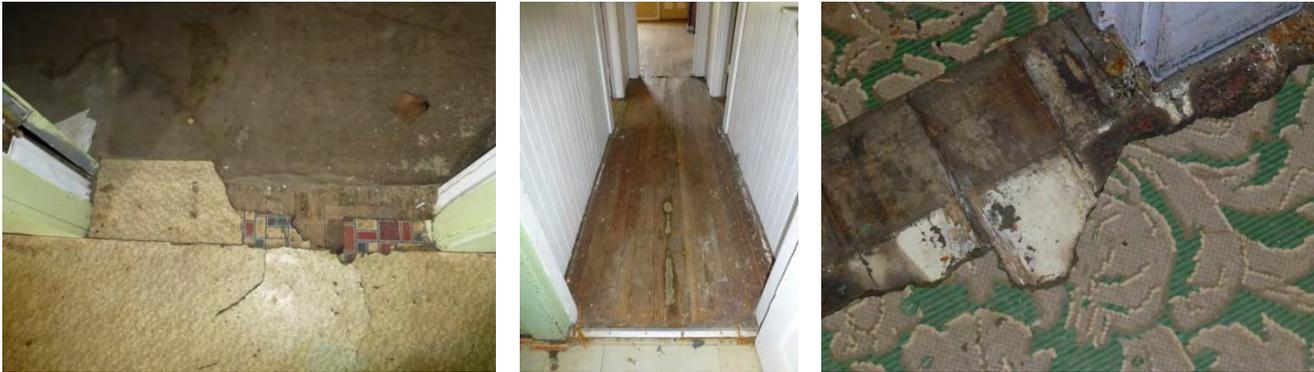
Two layers of laminate (Room 205), wood floor condition (room 211), painted wood floor under laminate (Room 213) (NPS Photos 2013)
