Treatment and Use

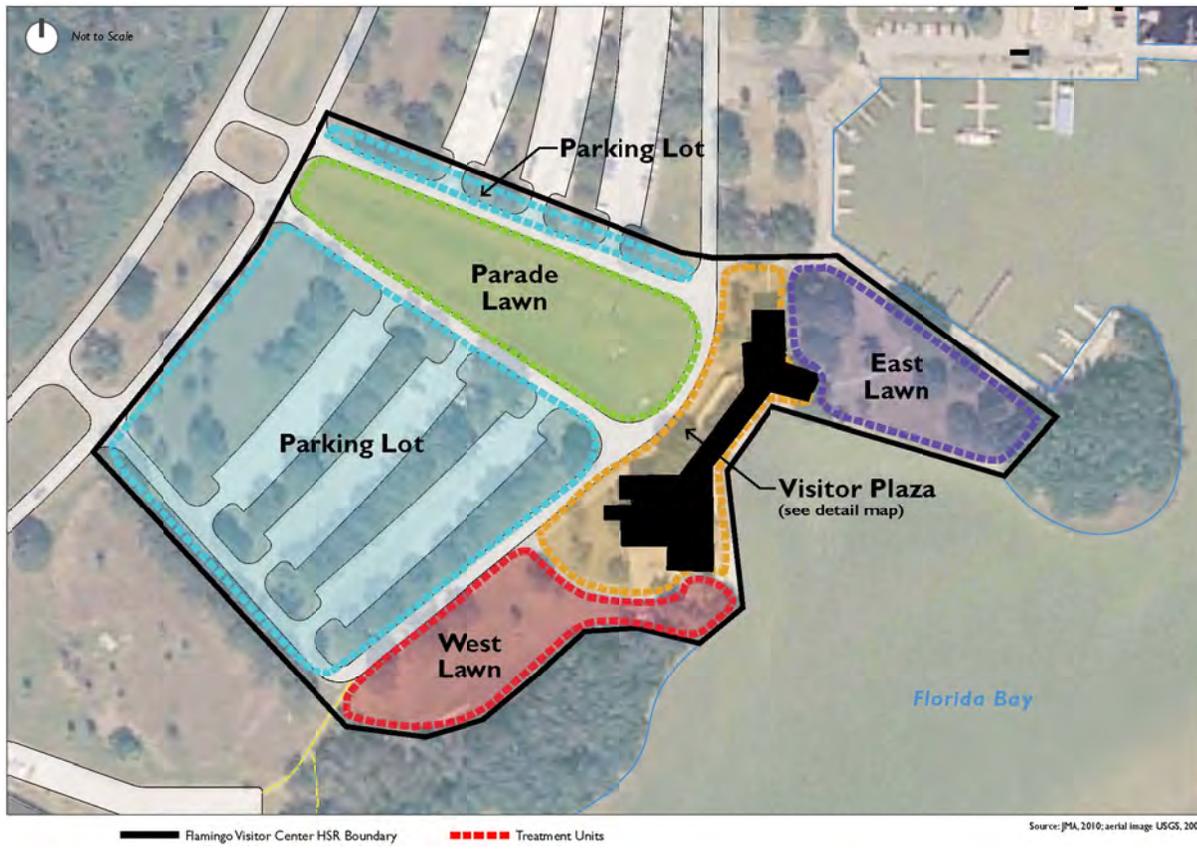
FIGURE 565. Landscape treatment units overview.

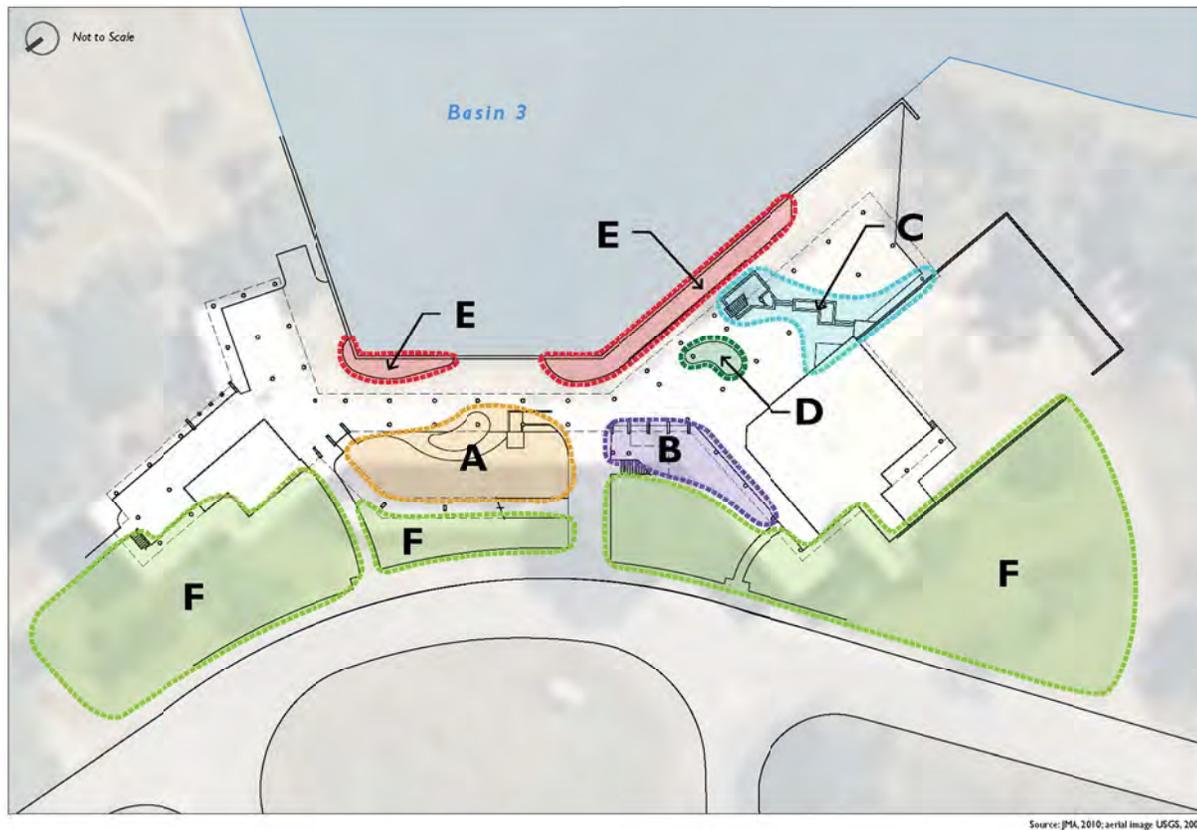
FIGURE 566. Visitor center plaza sub-units.

- 47 ▪ In Area A, thin Paurotis palms within curving
48 planter to restore transparency of view;
49 remove strangler figs; remove vegetative
50 overgrowth from curved walk; retain low
51 vegetation (less than thirty inches: crinum,
52 etc.) and accent rocks; replace grouping of
53 three palms as it appears on 1958 planting
54 plan, using palm with similar habit and form to
55 coconut palm, preferably the Maypan variety.

- 67 ▪ Repair planter walls in Area C. Prior to
68 commencing repair, remove all affected
69 vegetation and store healthy palms and other
70 plants (such as crinum, rubber plant, and
71 Hawaiian ti) and in pots or ball and burlap for
72 reuse in that area or elsewhere. Replace the
73 soil with an amended planting mix and
74 develop new planting plan using low or
75 understory plants that will survive with low
76 light and poor soil conditions (refer to list,
77 below).

- 78 ▪ In Area D, palm stumps, amend the soil, retain
79 accent stones for reuse in the same bed, and
80 develop new planting plan using low or
81 understory plants that will survive with low
82 light and poor soil conditions (refer list,
83 below). Reset accent stones in the same
