# Physical Description and Condition Assessment

## 1 Site

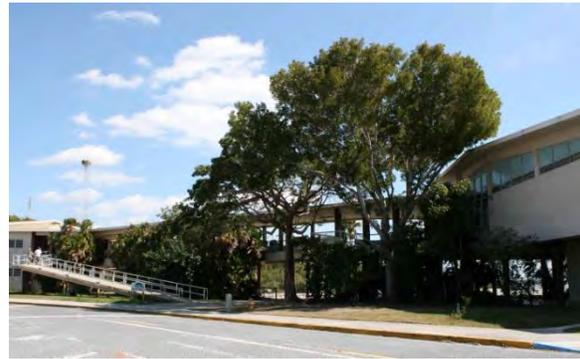
27  
28 **FIGURE 95.** Volunteer native and naturalized  
29 vegetation has filled in open spaces between planted  
30 vegetation.

1 Some of these plants are volunteers, such as the  
2 large gumbo limbo growing at the front of the  
3 visitor center next to the main walkway (refer to  
4 Figure 95), a few smaller gumbo limbos, a large  
5 mahogany, and the strangler fig. It is not known if  
6 the buttonwood, rubber tree, and Hawaiian ti  
7 plant were deliberately planted or were animal-  
8 seeded, but they were not included in the original  
9 planting plan. It is also important to note that  
10 some of the plants in the 1960 plan were not  
11 placed by the designer in the best locations for  
12 their overall health and the safety of visitors. Many  
13 of the plants located under the building and on its  
14 north side would have not received enough sun for  
15 optimum growth. In addition, a hedge of natal  
16 plum was planned for an area adjacent to the main  
17 visitor path to the water's edge, but the plant has  
18 vicious thorns and grows to at least six to ten feet

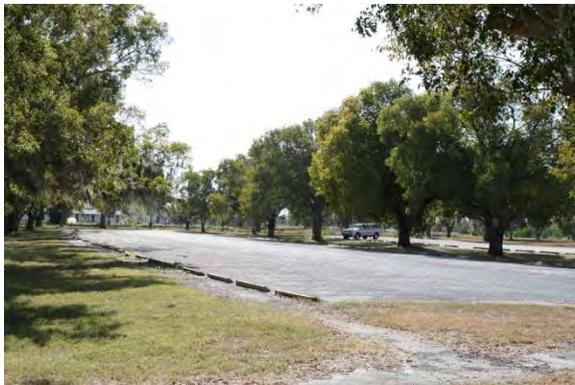
10 The parking lot of the visitor center was originally  
 11 planted with West Indies mahogany and gumbo  
 12 limbo trees, which both provide dense shade  
 13 (Figure 96). Most of the trees from the period of  
 14 significance are extant and in good condition  
 15 (Figure 97). However, although many coconut and  
 16 sabal palms were planted in 1958, particularly to  
 17 line the drives in this area and ornament the ends  
 18 of the parking islands, very few survive from that  
 19 period (Figure 98).

20  
 21 **FIGURE 97.** West Indies mahogany and gumbo limbo  
 22 trees provide dense shade in the parking areas.

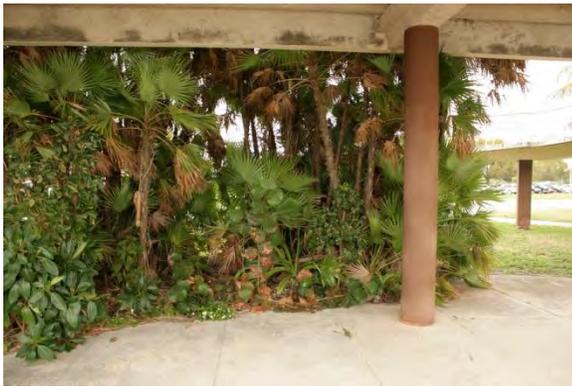
26 At least three campaigns of ornamental plantings  
 27 in the developed area around the visitor center  
 28 have been documented. The first was in 1958, but  
 29 a second was required only a few years later to  
 30 repair the damage to the site caused by Hurricane  
 31 Donna in September 1960. A comparison of  
 32 historic planting plans with existing conditions  
 33 suggests that a number of plants around the  
 34 Flamingo visitor center have survived from the  
 35 1958 campaign, including several Paurotis palms,  
 36 at least two sea grapes, one specimen that was part  
 37 of an original cluster of six Jamaica thatchpalm  
 38 (*Thrinax parviflora*), and at least one coco-plum  
 39 (*Chrysobalanus icaco*) (Figure 99). The integrity of  
 40 these plantings is threatened by volunteer  
 41 vegetation, such as gumbo limbo trees and  
 42 strangler figs, which are shading out and otherwise

43 affecting the growth of the original plantings  
 44 (Figure 100).

45 Two of the Paurotis palm are growing in their  
 46 original location in the kidney-shaped planting  
 47 bed in the center of the breezeway area. Originally  
 48 they stood alone as single-trunked specimens, but  
 49 have since been joined by both invasive and  
 50 planted species, including sea grape, crinum lily,  
 51 and strangler fig, and their own seedlings, all of  
 52 which have created a thicket and obscured the  
 53 original design intent (Figure 100 and Figure 101).

4  
5 **FIGURE 100.** Volunteer vegetation, such as gumbo  
6 limbo trees and strangler figs, are crowding out the  
7 original plantings adjacent to the visitor center  
8 breezeway.

20 In general, the vegetation around the visitor center  
21 is in only fair condition, being either overgrown or  
22 entirely absent from planting beds. Paurotis palms  
23 have been allowed to develop thickets and  
24 volunteer growth has established, blocking views  
25 to Florida Bay (Figure 105). In general, with the  
26 exception of the taller palms, the vegetation  
27 around the visitor center no longer expresses the  
28 original design intent.<sup>115</sup>

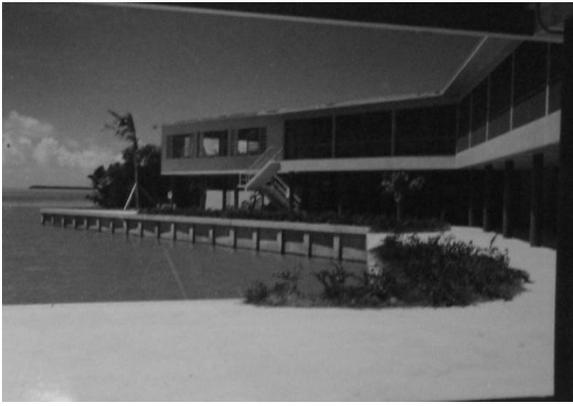
54 The two linear planting beds along the edge of  
 55 basin no. 3 were originally planted with natal plum  
 56 (*Carissa grandiflora* syn. *Carissa macrocarpa*) and  
 57 saltwort (*Severinia buxifolia*) (Figure 102). Natal  
 58 plum tolerates heavy winds and both species are  
 59 known for their salt-tolerance. It is not known  
 60 when and why these plantings were removed, but  
 61 today the planting beds host only Bermuda grass  
 62 (Figure 103).

1  
2 **FIGURE 102.** Planting beds along the edge of basin  
3 no. 3 were originally planted with natal plum and  
4 saltwort.

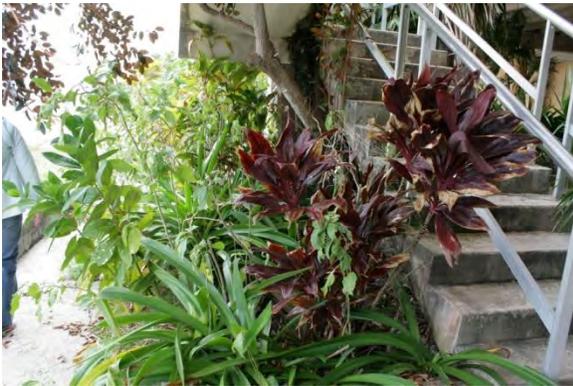
9  
10 **FIGURE 104.** The raised planter on the east side of the  
11 concessionaire wing contains an assortment of  
12 tropical plants.

25 No planting plans were located for the raised  
26 planter on the east side of the concessionaire's  
27 building. This planter currently contains an  
28 assortment of tropical plants, including a rubber  
29 tree, a Hawaiian ti plant, crinum lilies, a  
30 buttonwood, and a palm tree (Figure 104). It is not  
31 known if this was an original planting, but it is  
32 overgrown and many of the plants intrude on the  
33 building fabric. There is no vegetation growing in  
34 the other planters and planting beds in that area.

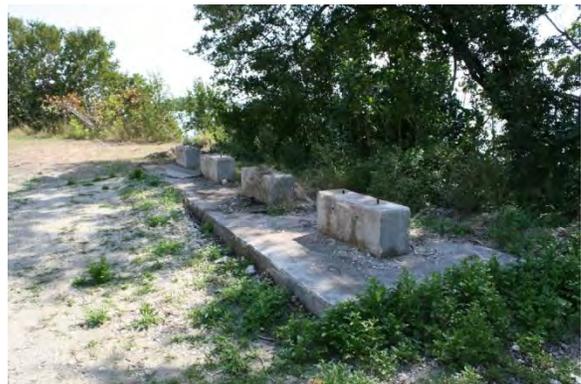
59 A concrete masonry wall, painted white,  
 60 surrounds the service yard at the south end of the  
 61 building. Outside the wall on the south end of the  
 62 service yard is a concrete structure that once  
 63 supported fuel tanks. It is no longer in use and  
 64 appears to be in good condition (Figure 115).

65  
 66 **FIGURE 115.** Outside the wall at the south end of the  
 67 service yard is a concrete structure that once  
 68 supported fuel tanks.

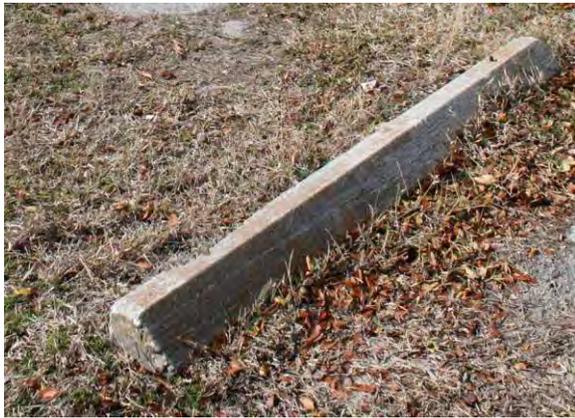
39 The only furnishings that are known to survive  
 40 from the Mission 66 period are the concrete  
 41 wheelstops in the parking areas (Figure 118).  
 42 These features were not detailed on the 1958  
 43 plans, but do appear in 1958 photographs  
 44 (Figure 119). The wheelstops that currently exist  
 45 on the site appear to be of the same design as those  
 46 shown in the 1958 photographs.

11  
 12 **FIGURE 118.** Wheelstops in the parking lot may be  
 13 original.

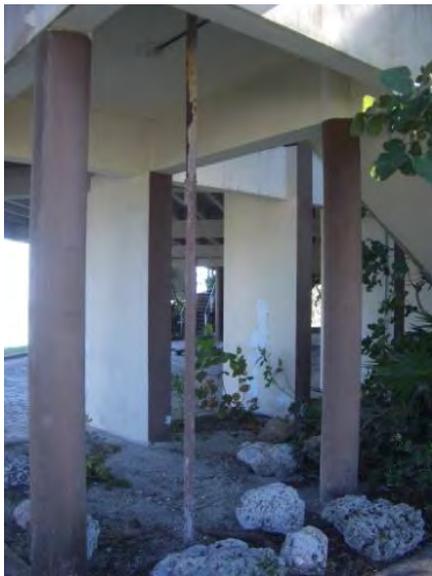
48 The west elevation is similar to the east elevation  
 49 in its organization of exposed structural elements.  
 50 However, much of the elevation is obscured by  
 51 extensive plant growth and vegetation  
 52 (Figure 124). Large masonry piers, orientated at a  
 53 45 degree angle to the column grid, are located at  
 54 the north and south ends of the breezeway and a  
 55 U-shaped exterior stair, similar to the stair  
 56 described above at the east elevation, is located at  
 57 the south end of the west elevation. Mounted to  
 58 the underside of the stair is a metal pipe, which is  
 59 exposed to view and extends from the bottom of  
 60 the concrete landing to grade. Corroded fasteners  
 61 suggest that interpretive signage was at one time  
 62 mounted to the pipe (Figure 125).

3  
4 **FIGURE 125.** Metal signpost under stair landing.

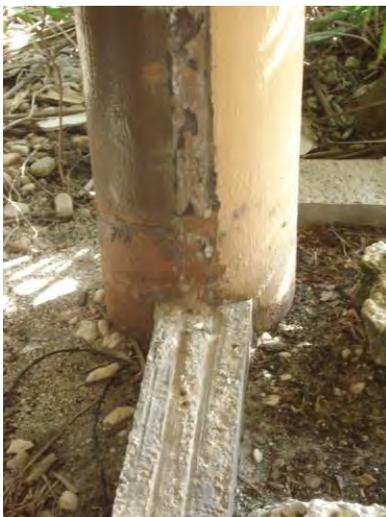
28 The east elevation of the south wing consists of a  
29 covered plaza with an upper and lower level. The  
30 lower plaza is located to the south and the upper  
31 plaza to the north, with a difference in elevation of  
32 1 foot. Two sets of concrete stairs and elevated  
33 Keystone-clad planting beds separate the two  
34 plaza levels. The plaza is defined by a grid of  
35 concrete circular columns and ochre-colored  
36 textured concrete pavement. The pavement is  
37 divided into 4 foot by 4 foot sections with the  
38 pavement grid oriented at a 45 degree angle to the  
39 column grid (Figure 165). The lower plaza level  
40 planting beds are elevated, clad in Keystone  
41 veneer, and have a rectilinear shape (refer to  
42 Figure 165). At the upper plaza, the planting beds  
43 have a curvilinear shape and are flush with the  
44 concrete pavement (Figure 166). Ghosting and  
45 corroded anchors are evident on the columns and

46 along the wall and floor plane where metal-framed  
47 insect screening was at one time located  
48 (Figure 167).

7  
8 **FIGURE 167.** Ghosting on columns and planting bed  
9 retaining wall indicating location of previously  
10 existing metal-framed screen wall.
