Physical Description and Condition Assessment

10 **Exterior Condition Assessment**

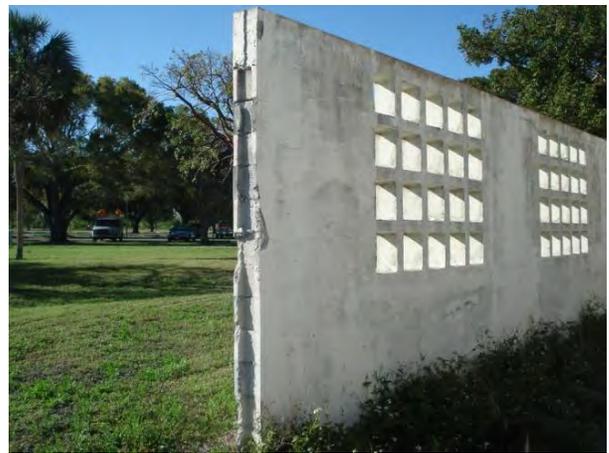
32
33 **FIGURE 174.** Exposed masonry indicating alteration to
34 original wall construction.

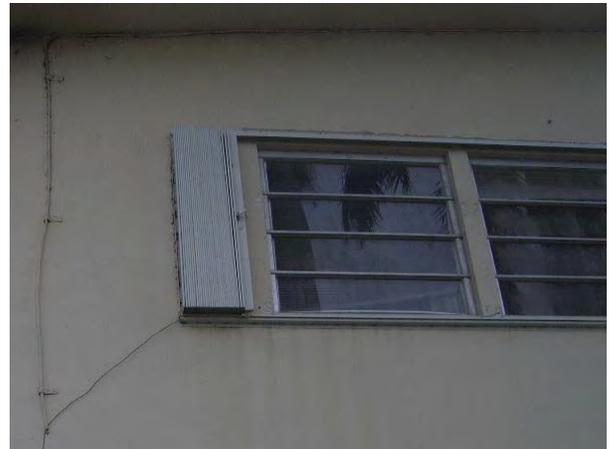
52 At the second floor offices at the north portion of
 53 the building, aluminum hurricane shutters have
 54 been added at the building exterior. These shutters
 55 fold back for storage on the wall beyond the
 56 window openings, and slide into place on
 57 aluminum tracks mounted to the building wall
 58 above and below the window openings
 59 (Figure 189).

14
15 **FIGURE 189.** Non-original hurricane shutters at the
16 second floor office windows.

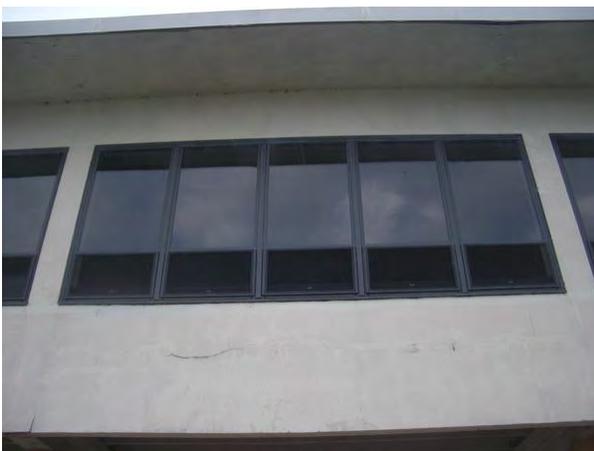
45 At the southern portion of the second floor of the
 46 concessionaire portion of the building, the original
 47 windows have been replaced with new aluminum

48 units finished in a dark bronze color with fixed
 49 upper lights and hopper-style operable lower
 50 lights (Figure 187). These windows were installed
 51 in 2002 (Figure 188).

8
9 **FIGURE 187.** Non-original window units at the
10 concessionaire component of the building.

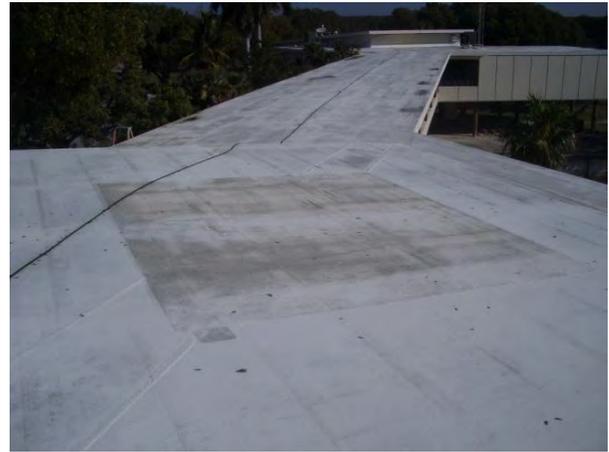
23 The existing roof membrane is judged to be in fair
 24 condition, exhibiting un-bonded wrinkled areas,
 25 tenting at presumed insulation fasteners, open
 26 seams, and numerous patches from previous
 27 repairs. Patches were formed with both matching
 28 thermoplastic membrane and granule surfaced
 29 modified bitumen (Figure 194 through
 30 Figure 196). Many of the existing membrane
 31 patches were installed in late 2003 (Figure 197).

46
 47 **FIGURE 194.** A large roof membrane patch near the
 48 breezeway.

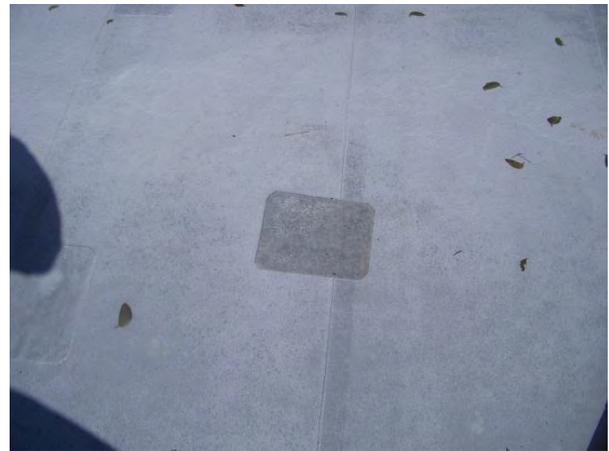
49
 50 **FIGURE 195.** An example of a small membrane patch.

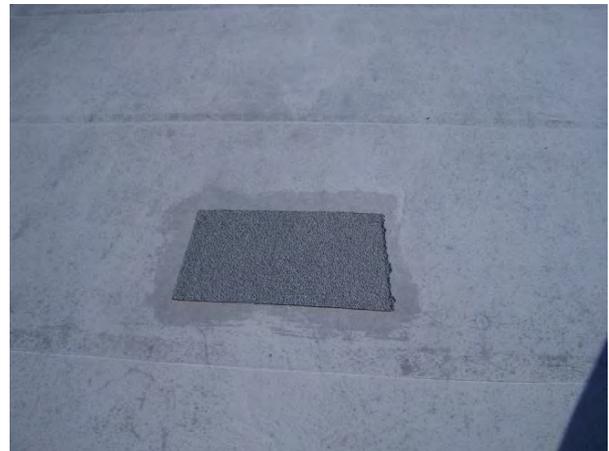
51
 52 **FIGURE 196.** An example of a roof patch using
 53 modified bitumen membrane.

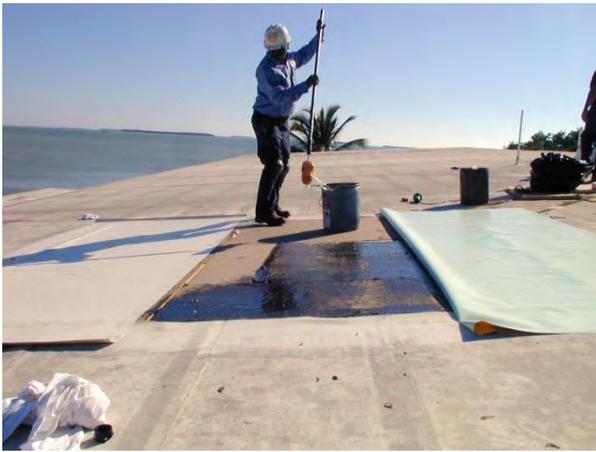
1
2 **FIGURE 197.** Installing a patching at the visitor center
3 roof, 2003. This location is shown in Figure 194.

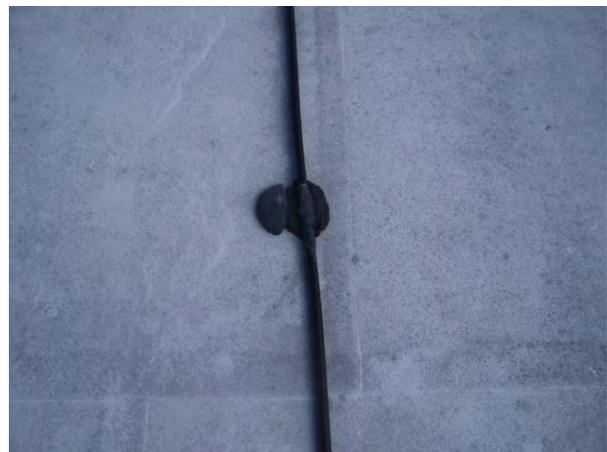
4 A telecommunications cable runs across the roof
5 surface from one end of the building to the other.
6 The cable is secured to the membrane with spots
7 of mastic (Figure 199).

43
44 **FIGURE 199.** A telecommunications cable, secured
45 to the membrane with spots of mastic, runs across the
46 roof surface.

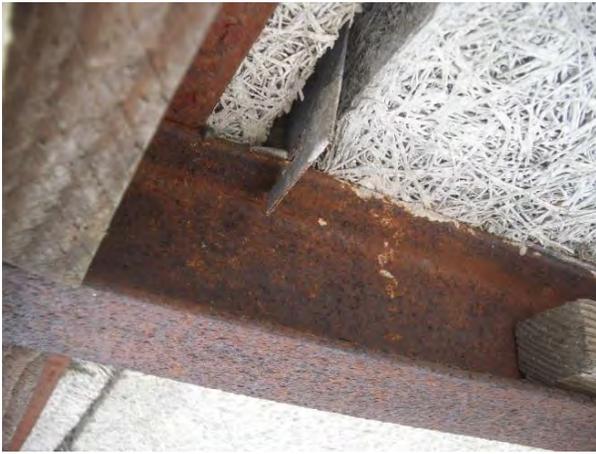
8 The roof structure is exposed to view at some
9 areas of the museum and office component of the
10 building due to the loss of the plywood soffit. At
11 these openings, the galvanized clips used in the
12 original construction to secure the tectum roof
13 deck to the steel framing were observed
14 (Figure 200). Where observed, the steel roof
15 structure exhibited minor corrosion; the
16 galvanized clips were in good condition as was the
17 tectum deck.

1
2 **FIGURE 200.** In the original construction, galvanized
3 clips secure the tectum decking to the steel framing
4 elements.

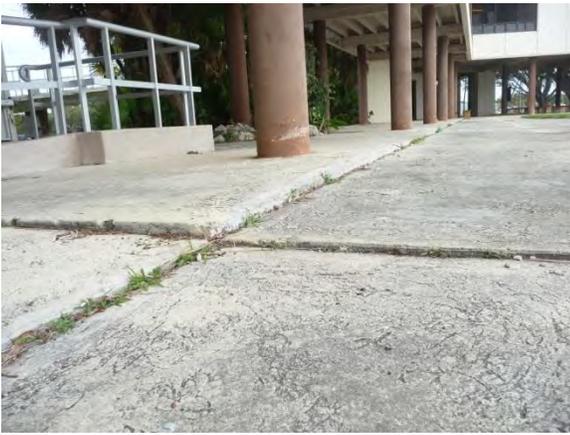
- 19 ▪ Differential settlement at the control and
20 construction joints in the concrete paving
21 slabs were noted at the first floor patio. The
22 differential settlement ranged from 1/2 inch to
23 3 inches, with the basin side of the patio
24 typically being lower (Figure 203).

1
2 **FIGURE 203.** Differential settlement at construction
3 joints between concrete pavers.

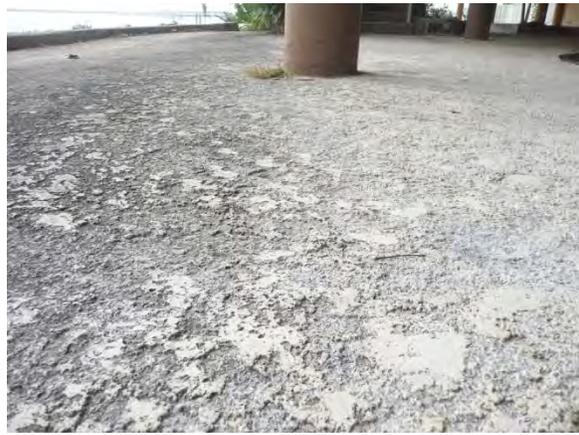
- 29 ▪ Extensive erosion and deterioration of the
30 rock salt finish of the first floor paving was
31 noted (Figure 206). Paving at the south end
32 of the site showed the most severe erosion and
33 deterioration.

10
11 **FIGURE 206.** Erosion of textured concrete finish.

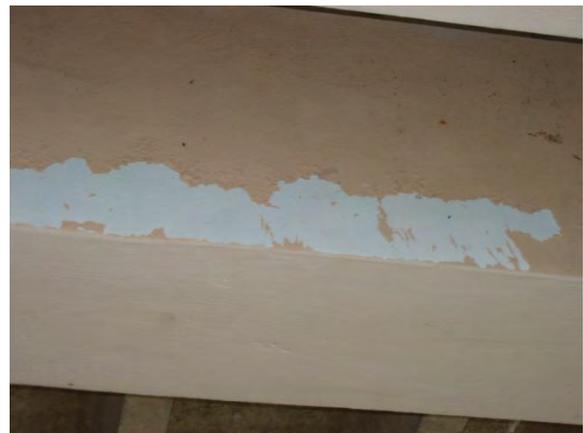
- 17 ■ Peeling paint was observed on all painted
18 surfaces (Figure 211 through Figure 213).
19 Extensive peeling was identified at the base of
20 the first and second floor columns and on
21 stucco walls and spandrel panels. Blistering
22 and peeling paint were observed at several
23 locations on the first and second floor
24 columns and piers (Figure 214).
- 25 ■ Organic growth in the form of mold,
26 vegetation, and algae were observed at roof
27 gutters and on vertical surfaces such as the
28 raised stucco panels (Figure 215). Organic
29 growth was most pronounced on the west
30 elevation, where landscape vegetation is most
31 dense.

34
35 **FIGURE 212.** Peeling paint on stucco spandrel panel.

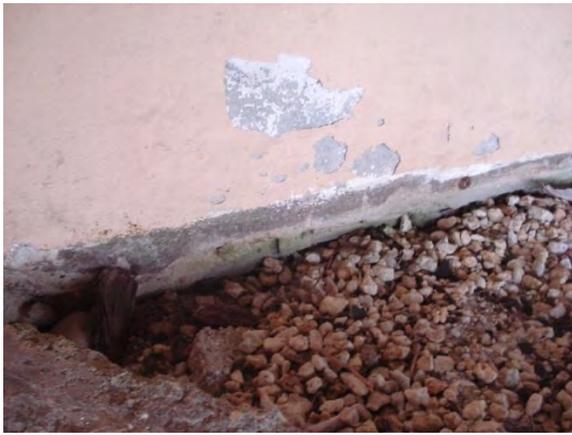
1
2 **FIGURE 213.** Peeling paint on stucco walls.

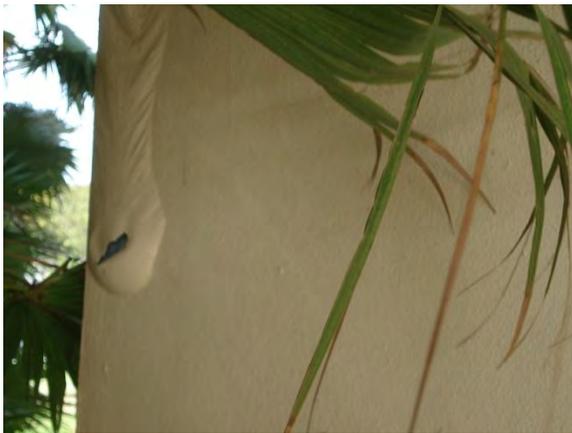
3
4 **FIGURE 214.** Blistering paint on concrete piers.

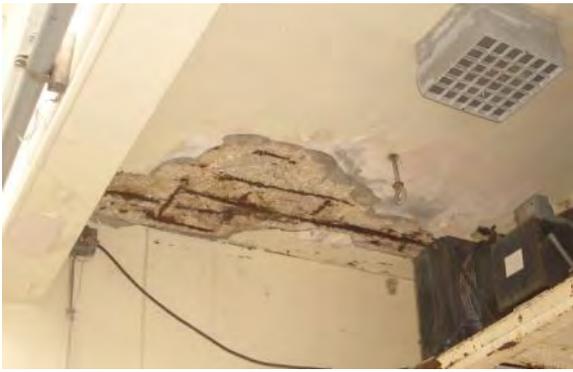
- 11 ▪ Corrosion staining attributed to the metal
12 expansion bead used to frame the stucco
13 ceiling was observed on the ceiling of the
14 second floor breezeway (Figure 225).
- 15 ▪ Concrete spalling and exposed corroded
16 reinforcing was observed in the roof overhang
17 above the loading dock on the west elevation
18 of the concessionaire component (Figure 226).
- 19 ▪ Horizontal cracking of the raised stucco
20 panels was observed at multiple locations on
21 the office and museum component (Figure 227
22 and Figure 228). Typically, the cracks were 30
23 inches above the bottom of the panels and
24 were related to the location of the concrete
25 floor slab. The reflective cracking in the stucco
26 is associated with differential movement of the
27 concrete slab and concrete spandrel panels.

1
2 **FIGURE 226.** Concrete spalling and exposed corroded
3 steel reinforcing over the loading dock at the south
4 end of the concessionaire component.

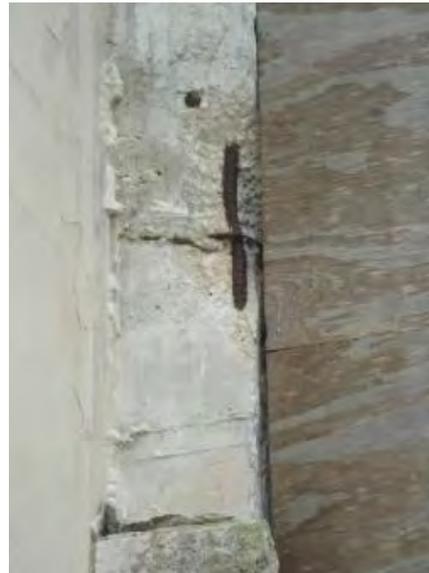
- 11
- 12 ■ Exposed and corroded reinforcing steel was
13 observed at the stair tower of the
14 concessionaire component where a Keystone
15 veneer panel had been removed (Figure 234).
 - 16 ■ Staining and organic growth were observed at
17 areas of moisture run-off across stucco
18 spandrel panels and along stair structures
19 (Figure 235 and Figure 236).
 - 20 ■ Spalling of stucco spandrel panels due to
21 corroded metals anchors was observed on the
22 east elevation of the concessionaire
23 component (Figure 237).
 - 24 ■ Cracking and debonding of previously
25 patched and repaired concrete beams was
26 observed. The previously installed patches
27 appear to be shallow, trowel applied materials
28 that are not mechanically attached to the
29 concrete substrates and have debonded from
the original concrete substrate (Figure 238).

30
31 **FIGURE 234.** Exposed and corroded reinforcing bar in
32 concrete structure of Keystone-clad stair tower.

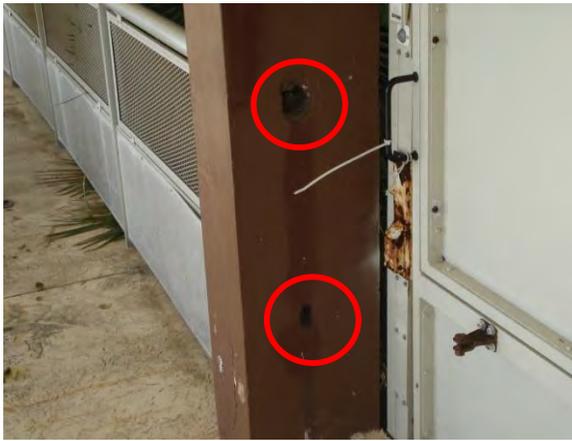
- 14 ▪ Electrical conduit and pipes are surface-
15 mounted and exposed to view on the
16 underside of structural framing members. In
17 some instances, the pipes and conduit
18 penetrate structural concrete columns
19 (Figure 239).
- 20 ▪ Exposed grout pockets are located in some
21 second floor columns where railings were
22 once installed and mounted (Figure 240). The
23 railing was removed between two columns on
24 the west elevation to allow for access to an
25 elevator lift.126
- 26 ▪ Spalling of parge coating was observed on the
27 concrete columns (Figure 241).

1
2 **FIGURE 240.** Exposed railing grout pockets at location
3 of removed railing near elevator entrance in
4 concrete column.

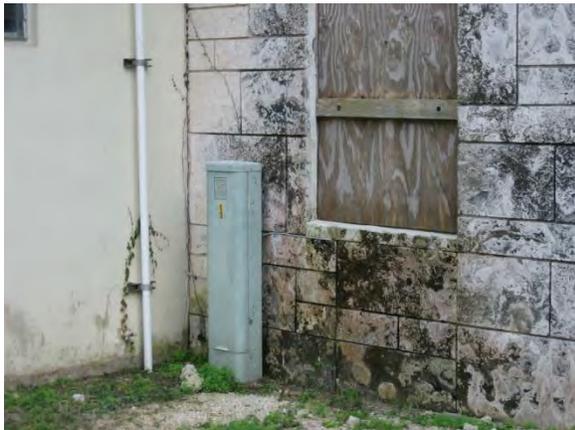
- 10 ■ Step cracking and open mortar joints were
11 noted at the west elevation of the north wing
12 of the office and museum component
13 (Figure 242).
- 14 ■ Deterioration and delamination of vertically
15 oriented Keystone veneer panels was observed
16 at the concessionaire component stair tower
17 and at elevated planting units at the south
18 plaza (Figure 243 and Figure 244).
19 Deterioration appeared to have occurred at
20 locations where the bedding plane of the
21 veneer panel was exposed or was impact
22 related. Delamination was associated with
23 failure of the mortar setting bed.
- 24 ■ Organic growth in the form of mold,
25 vegetation, and algae is present on the
26 Keystone veneer (Figure 245).

6
7 **FIGURE 245.** Organic growth on Keystone veneer.

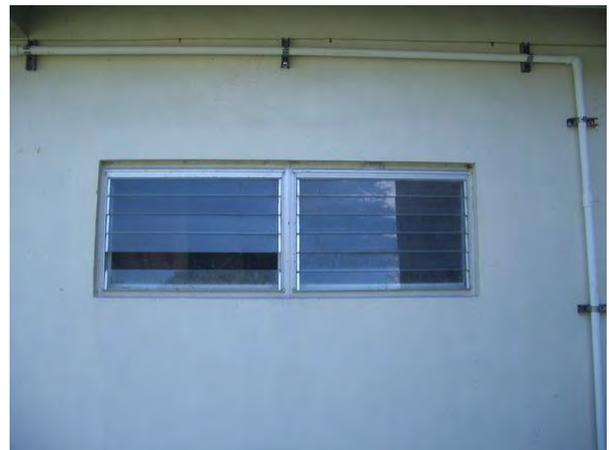
- 10 ▪ Two pair of what appear to be original jalousie
11 windows are located at the first floor west
12 elevation of the concessionaire component of
13 the building. The frames are in relatively good
14 condition however at least one glass slat is
15 missing (Figure 255 and Figure 256).

27
28 **FIGURE 255.** Possible original jalousie window at the
29 west elevation.

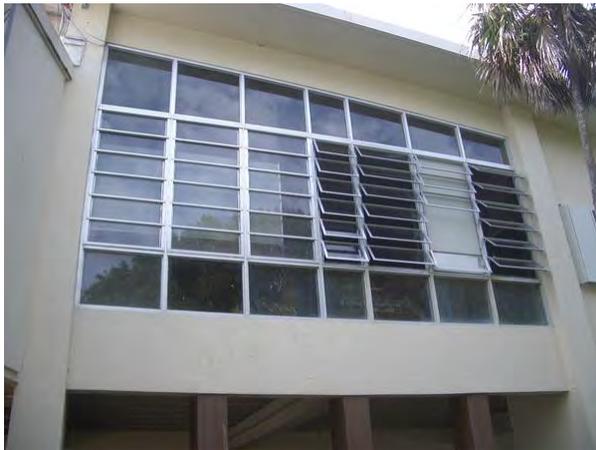
1 ■ The large window wall at the east elevation of
 2 the second floor lobby area is a non-original
 3 replacement unit, as documented in historic
 4 photographs and the original architectural
 5 drawings. The frame details and mullion
 6 configurations vary from other windows at the
 7 building. Several sash units are missing from
 8 this assembly; openings left by the missing sash
 9 are infilled with paneling. In addition, NPS
 10 staff report that many of the awning sash are
 11 inoperable and as such cannot be completely
 12 closed. Cracks exist in several of the glass
 13 panes (Figure 261 through Figure 263).

14
 15 **FIGURE 261.** Exterior view of the large window wall
 16 at the east elevation.

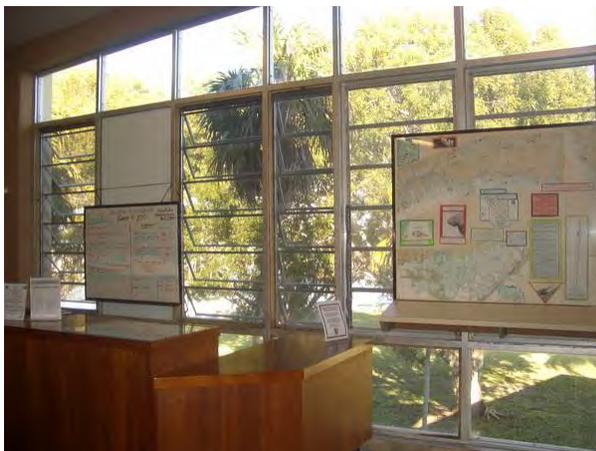
17
 18 **FIGURE 262.** Interior view of the lobby window wall.

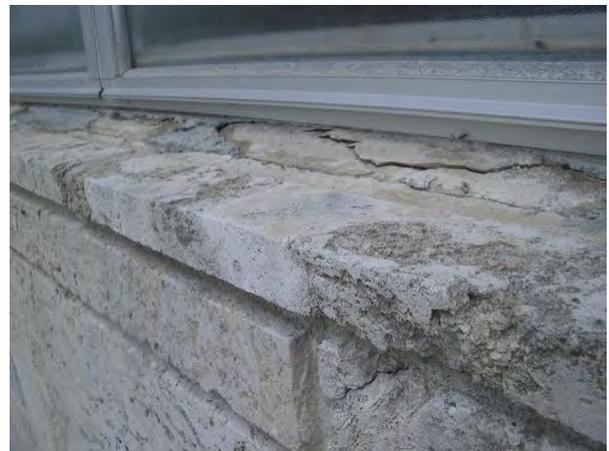
22 ■ Windows typically do not have sealant at their
 23 perimeters, relying on the bond between the
 24 window frame and mortar or stucco for
 25 weather protection at this interface; cracks
 26 exist in the mortar and stucco at a number of
 27 these interface conditions. Where sealant does
 28 exist at the window perimeter, it is weathered
 29 and also exhibits cracking (Figure 264 through
 30 Figure 266).

31
 32 **FIGURE 264.** Window sill detail.

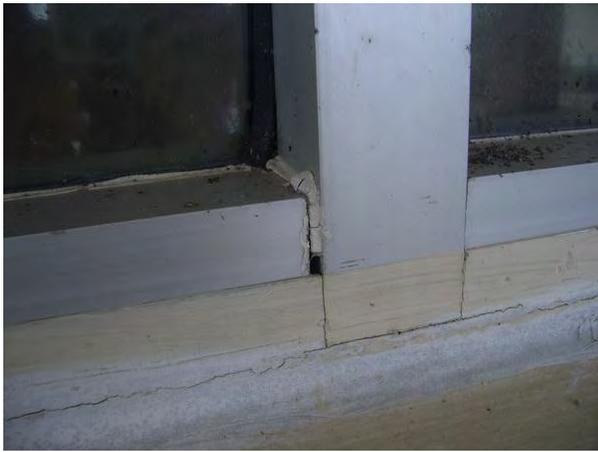
1
2 **FIGURE 265.** Window sill detail.

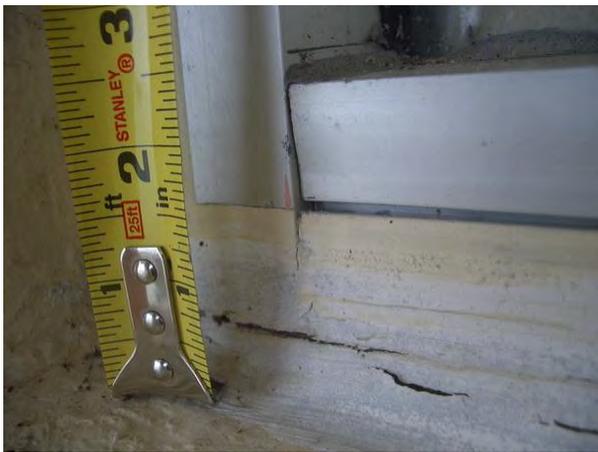
3
4 **FIGURE 266.** Weathered and split window perimeter
5 sealant.

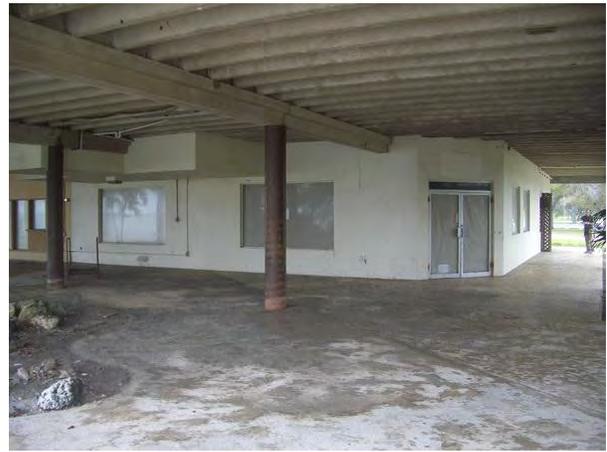
14
15 **FIGURE 267.** Aluminum-framed storefront windows at
16 the concessionaire component.

- 6
- 7 ■ Several windows at the concessionaire
 - 8 component of the building are exterior glazed
 - 9 aluminum-framed storefront assemblies with
 - 10 monolithic glass infill; several glazing stops are
 - 11 disengaged from the frame. In addition, the
 - 12 frames have been cap sealed to the glass;
 - 13 typically an indication of past water leakage
- (Figure 267 and Figure 268).

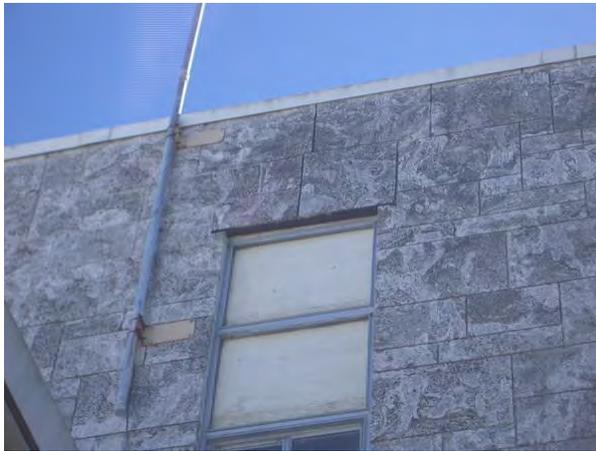
- 1 ■ At the vertical strip window at the north elevation of the stair tower of the concessionaire component of the building, much of the assembly is missing and plywood has been installed to protect the openings. The steel lintel at the head of the window assembly is corroded, which appears to be contributing to cracking and displacement of the stone above (Figure 269 and Figure 270).
- 2
- 3
- 4
- 5
- 6
- 7
- 8
- 9
- 10 ■ Trapezoidal fixed aluminum-framed windows at the north elevation appear intact from the exterior but have been hidden from the interior by installation of a low suspended ceiling (Figure 271).
- 11
- 12
- 13
- 14

15
16 **FIGURE 269.** Vertical strip window at stair tower with
17 steel lintel.

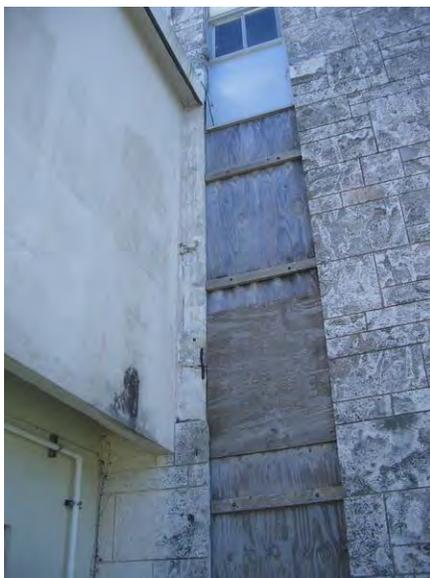
18
19 **FIGURE 270.** Vertical strip window at stair tower.

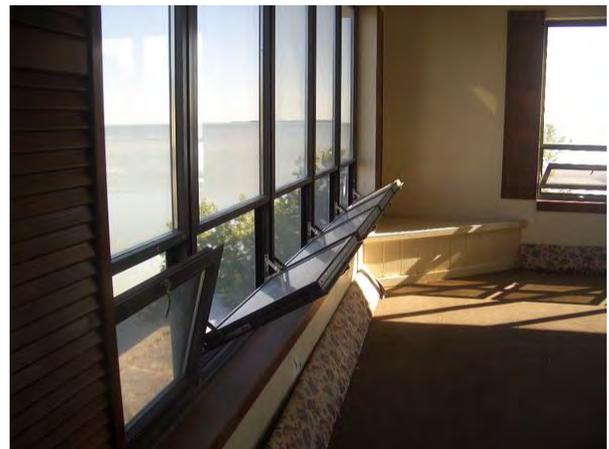
- 24 ■ New aluminum-framed thermally improved windows have been installed at the east and south elevations of the second floor of the concessionaire component of the building. These windows are configured with fixed units over bottom hinged inward projecting operable sash; both fixed and operable units have insulating glass infill. Despite the thermal improvements, these windows are unsympathetic to the original design due to their increased sightlines, dark bronze color, operation, and proportions. Despite the relatively young age of these replacement windows, minor corrosion has started to form on the operating hardware (Figure 272 and Figure 273).
- 25
- 26
- 27
- 28
- 29
- 30
- 31
- 32
- 33
- 34
- 35
- 36
- 37
- 38
- 39

40
41 **FIGURE 272.** New windows at the concessionaire
42 component.

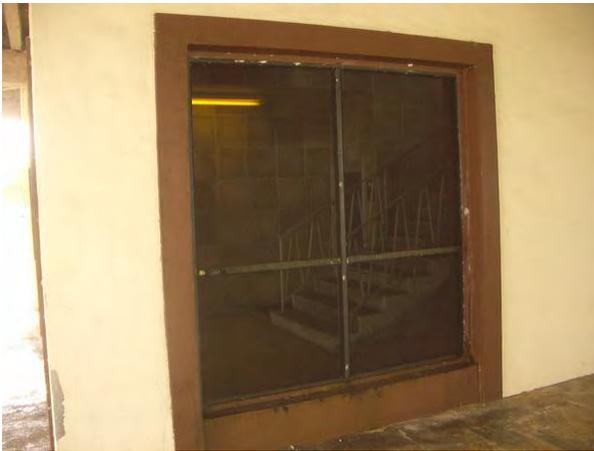
- 27 ▪ Aluminum- and wood-framed screens exist at
28 the first and second floor lobbies of the office
29 and museum portion of the building. The
30 aluminum-framed system at the second floor
31 lobby appears to be a relatively new
32 replacement system and is considered to be in
33 good condition. Narrow aluminum-framed
34 screens in wood frames enclose portions of
35 the first floor lobby; the aluminum frames are
36 severely corroded. Wood-framed screens also
37 enclose portions of the second floor lobby; the
38 wood is in varying degree of deterioration
39 (Figure 277 through Figure 281).

4
5 **FIGURE 278.** Screen enclosure at the first floor lobby.

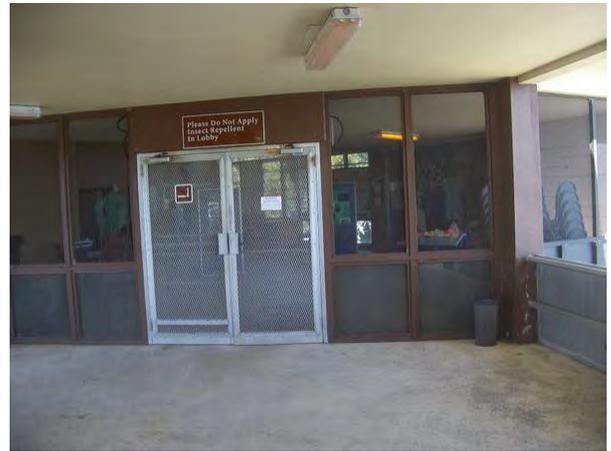
12
13 **FIGURE 281.** Screen enclosure and doors at the second
14 level.

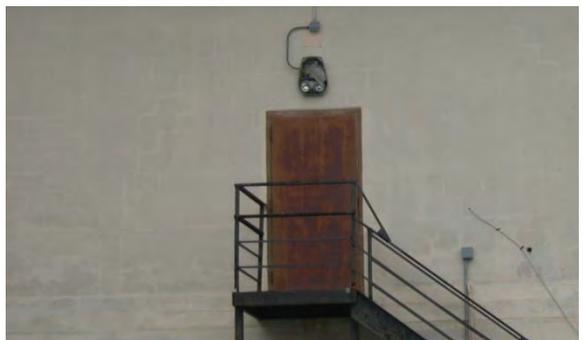
- 15 ▪ Corrosion and peeling paint were observed on
16 exterior hollow core metal doors (Figure 282).
17 The most significant deterioration was
18 observed at doors on the west elevation of the
19 concessionaire portion of the building, and
20 other doors that are most exposed to weather
21 conditions.

22
23 **FIGURE 282.** Corrosion of exterior metal doors.

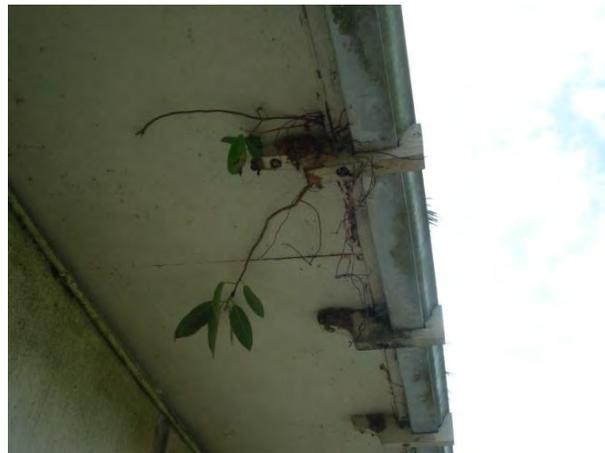
- 2 ■ Storm related damage and deterioration of the
3 plywood eave have led to openings in the
4 overhanging roof structure (Figure 283).
- 5 ■ Paint on the plywood eave is peeling
6 (Figure 284).
- 7 ■ Vegetation is growing in some roof gutters
8 (Figure 285).
- 9 ■ Deterioration of the wood fascia was noted at
10 the southeast corner of the building
11 (Figure 286). Portions of the historic wood
12 fascia are obscured by the application of a
13 contemporary metal fascia.
- 14 ■ At some areas, the membrane is not fully
15 adhered to the roof deck. A few isolated open
16 seams were observed, although most roof
17 seams appear well bonded (Figure 287).

26
27 **FIGURE 285.** Vegetation growing at the roof gutter.
