Physical Description and Condition Assessment

3 Interior Condition Assessment

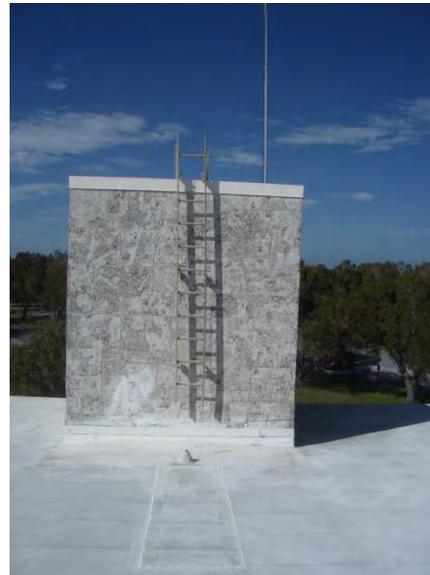
- 1 ■ Walking pads previously located on the
2 concessionaire area roof have been removed
3 (Figure 296). It is not clear if this removal was
4 intentional or due to past storm damage.
- 5 ■ At the stair tower roof, the counterflashing
6 along the west edge of the roof is detached
7 (Figure 297).
- 8 ■ The ladder at the east wall of the stair tower is
9 not adequately secured to the wall; it is
10 attached only at the top, with loose stand-off
11 brackets provided along the wall surface
12 (Figure 298 and Figure 299).
- 13 ■ Blistering of the roof coating was observed
14 above the museum (Figure 300). The blistering
15 may be caused by chemical attack due to bird
16 droppings from the nest atop the adjacent
17 communication tower (Figure 301).

24
25 **FIGURE 298.** The ladder at the east wall of the stair
26 tower.

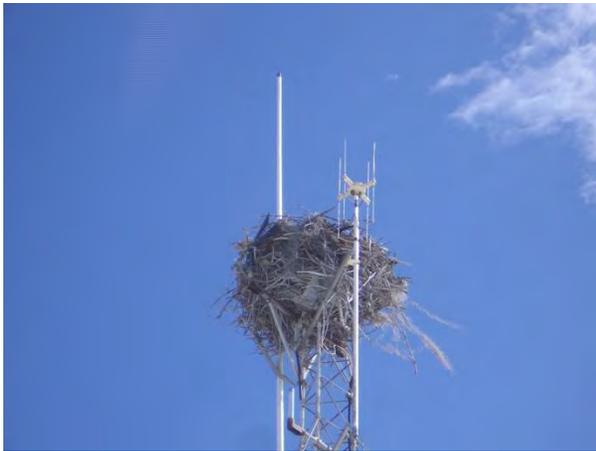
4
5 **FIGURE 301.** Osprey nest at the top of the
6 telecommunication tower.

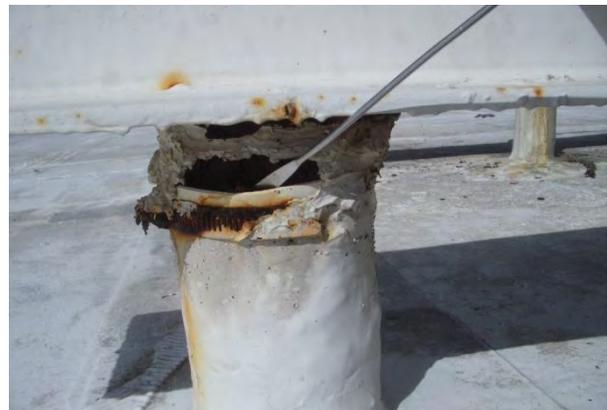
- 7
- 8 ▪ The anchorage for the communication
9 antenna guy wire at the south center fascia of
10 the office area is severely corroded
11 (Figure 302).
 - 12 ▪ At the museum roof, steel mechanical
13 equipment supports have significant corrosion
14 (Figure 303). Also, the roof membrane is not
15 adequately secured to the supports
16 penetrating the roof (Figure 304).
 - 17 ▪ Approximately half of the soffit cladding is
18 missing from south edge of office area roof
19 overhang, exposing the internal wood and
20 steel framing and the tectum roof deck to
 weather (Figure 305).

27
28 **FIGURE 304.** Roof membrane sleeve at pipe support
29 for mechanical equipment.

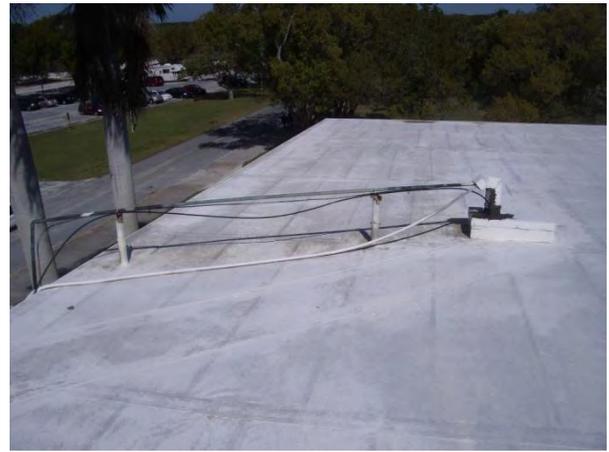
- 3 ■ Counterflashing is missing where the
4 museum/lobby roof meets the wall of the
5 office area; the edge of plywood underlayment
6 is exposed to weather (Figure 306).
- 7 ■ The office wing roof has a gooseneck sleeve
8 opening and support pipes for conduit
9 (Figure 307). The gooseneck is not well
10 integrated with roof membrane; also, a newer
11 communication cable has punctured the
12 gooseneck sleeve (Figure 308 and Figure 309).
13 This opening is located directly above an
14 office area where water damage is visible at the
15 interior ceiling.

19
20 **FIGURE 307.** View of the gooseneck conduit sleeve on
21 the office wing roof.

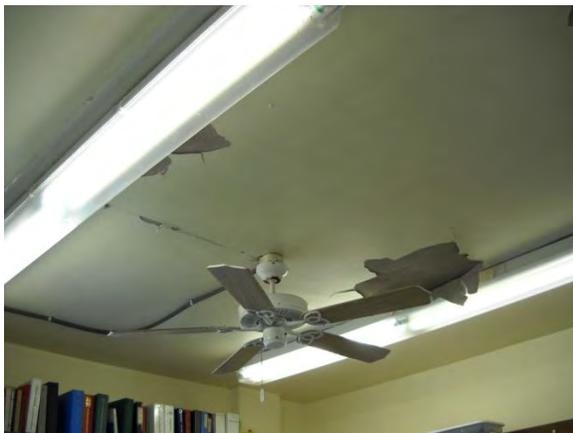
21 finishes seen throughout the office space. The
22 ceiling in the room shows signs of moisture or
23 impact damage (Figure 330).

FIGURE 330. The squad room ceiling.

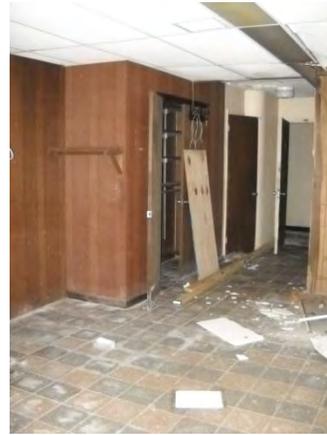
27 West of the stockroom and fitting room is the
28 former concessionaire office. Most recently the
29 space appears to have been affiliated with the gift
30 shop. This area includes a larger open space, three
31 closets, and a restroom. The open area has plaster
32 walls with wood paneling in some areas, a vinyl tile
33 floor with a vinyl base, and a suspended acoustical
34 tile ceiling (Figure 348).

FIGURE 348. Former concessionaire office, adjacent to the gift shop.

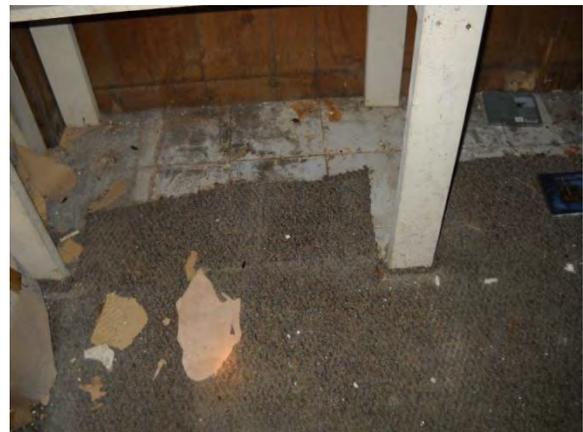
6 The north closet has a carpet floor covering vinyl
7 tile, wood paneled walls, and a suspended acoustic
8 tile ceiling (Figure 349). There are also built-in
9 wood shelves (Figure 350).

FIGURE 349. Carpet flooring in the north closet, off the former office space.

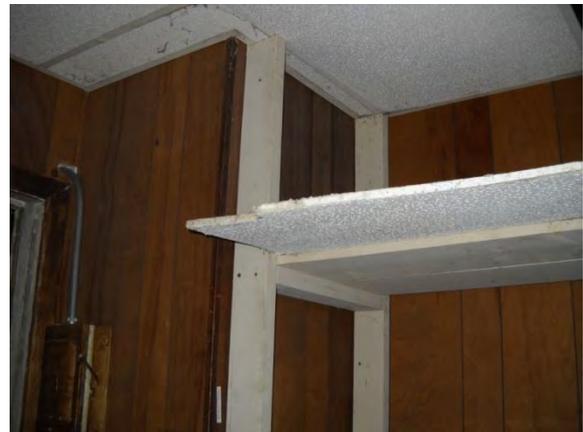
FIGURE 350. Built-in wood shelving in the north closet.

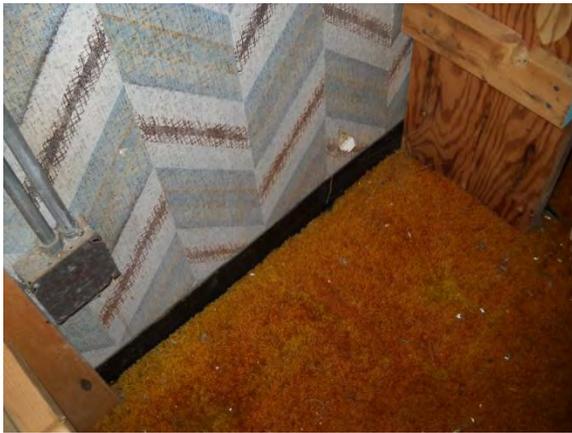
10 The center closet has wall paper covering a plaster
11 wall, a textured plaster ceiling, and shag carpeting
12 installed over vinyl tile (Figure 351).

FIGURE 351. Shag carpeting and wall covering in the center closet.

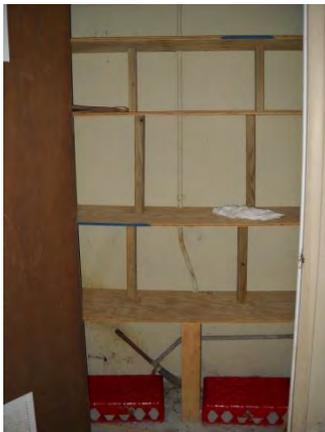
13 The south closet is the smallest of the three. The
14 closet has plaster walls and a concrete floor
15 (Figure 352).

FIGURE 352. View of the south closet.

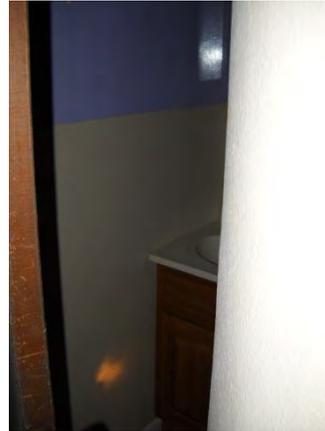
1 The bathroom in the former office area has a vinyl
2 tile floor with a wood base, and plaster walls with a
3 plastic wainscot (Figure 353). The fixtures in the
4 bathroom are newer than the original construction
5 of the building.

27
28 **FIGURE 353.** Restroom with plaster walls and plastic
29 wainscot. This room is accessible from the former
30 concessionaire office.

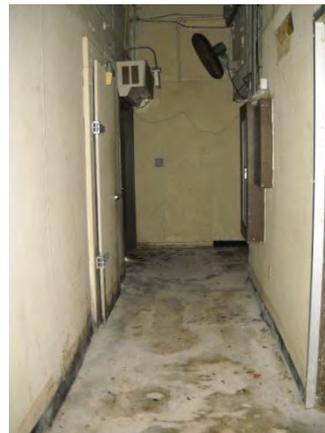
FIGURE 354. View of corridor south of the former
concessionaire office space. The corridor connects
the gift shop, lounge, service elevator, and loading
dock.

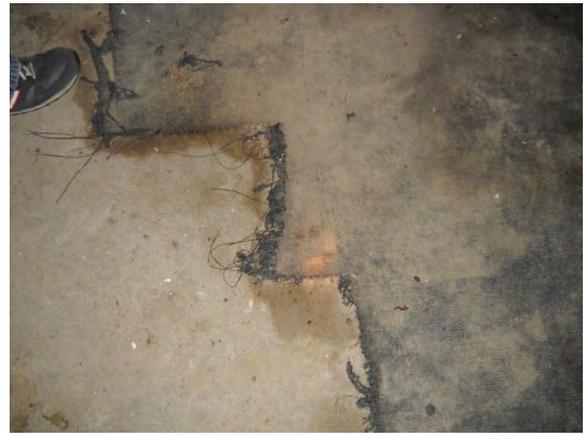
20 plaza under the south wing of the concessionaire
21 component. The lounge has a concrete floor that is
22 partially covered by carpet with a wood base
23 (Figure 358). The walls in the room are painted
24 wood paneling while the ceiling is exposed with
25 remnants of a suspended acoustical tile ceiling
26 (Figure 359 and Figure 360).

FIGURE 358. Concrete subfloor and carpeting in the lounge.

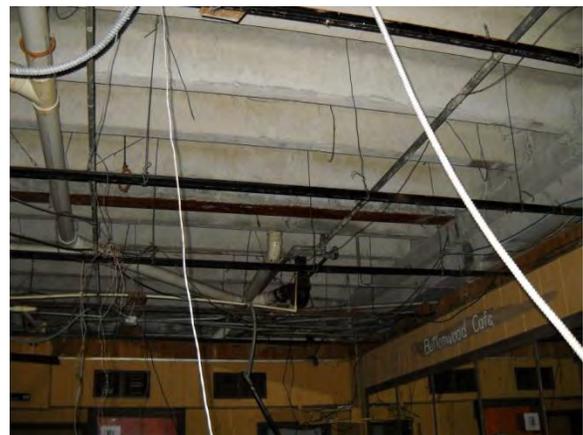
FIGURE 360. Ceiling of the lounge. Note exposed structural framing, pipes, and suspended ceiling framing.

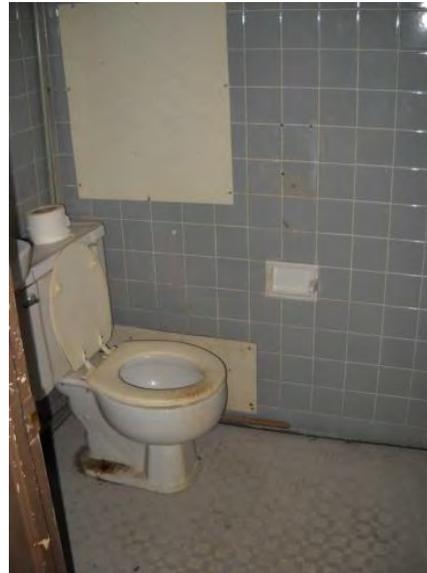
27
28 **FIGURE 363.** Tiled flooring and walls are typical
29 interior finishes of the restrooms.

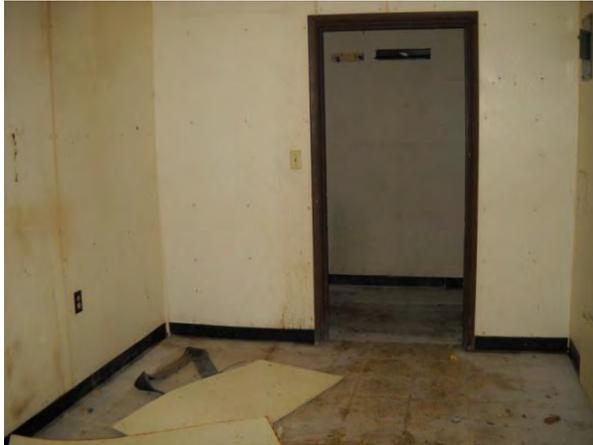
21 A small kitchen accessible from the lounge and the
22 corridor south of the former concessionaire office
23 space is located north of the restrooms. The
24 kitchen has vinyl flooring with a vinyl base, plastic
25 paneling on the walls, and a plaster ceiling
26 (Figure 366).

4
5 **FIGURE 366.** The kitchen has vinyl tile flooring and
6 plastic wall paneling.

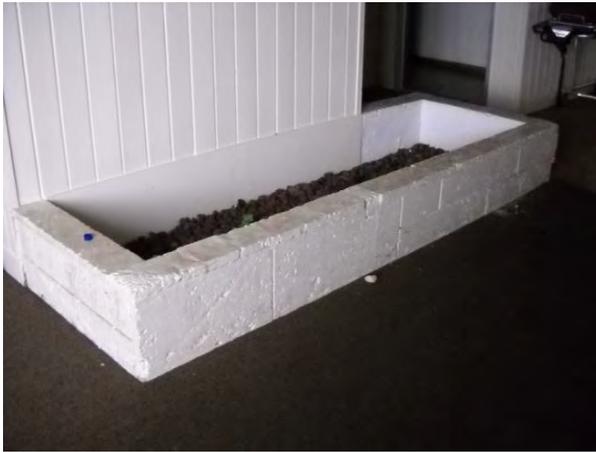
16 A small Keystone planter is present outside of the
17 restrooms. The Keystone has been coated with
18 paint (Figure 374).

1
2 **FIGURE 374.** Interior planting bed with paint coating
3 over original Keystone.

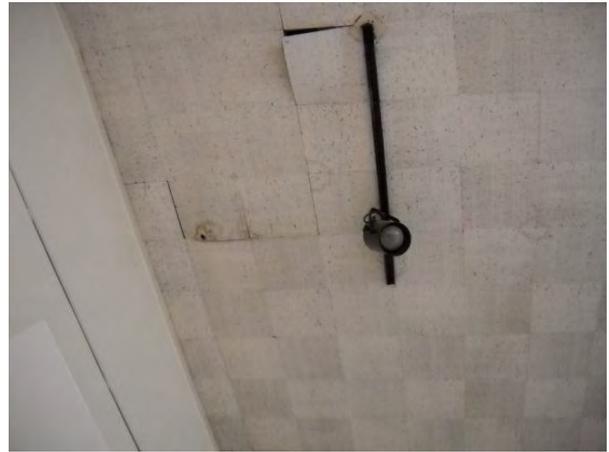
24 are plaster, while the north and west walls are
25 painted wood paneling. The ceilings are
26 suspended concealed-spline acoustical tile that is
27 likely original (Figure 377).¹³¹

9
10 **FIGURE 377.** Concealed-spline acoustical ceiling and
11 track lighting fixtures in dining room.

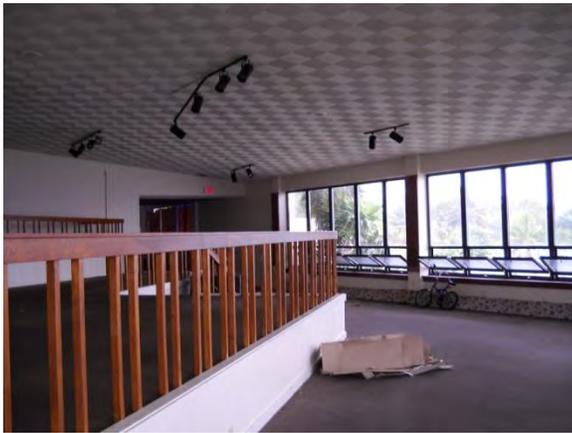
15 There are five sets of aluminum-framed windows
16 on the east and south walls of the room. Each set
17 consists of four window units. None of the
18 windows in the dining room are original
19 (Figure 379).

FIGURE 379. Windows on east wall of dining room.

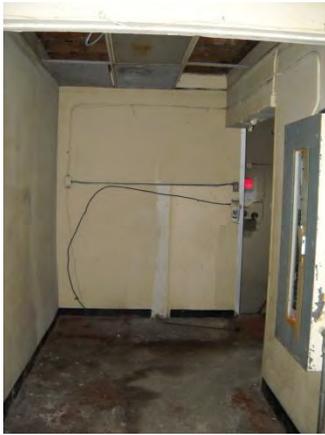
16 A small hallway connects the kitchen with the
17 staircase and service elevator (Figure 387). The
18 hallway has a concrete floor with a vinyl base,
19 plastic paneled walls, and remnants of a suspended
20 ceiling (Figure 388).

FIGURE 388. Hallway between kitchen and service elevator and stair.

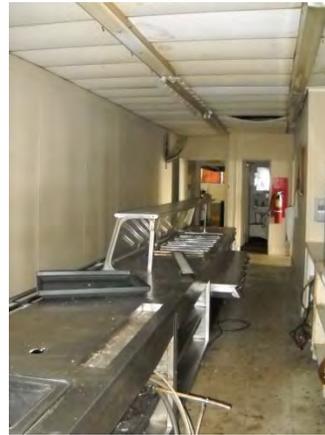
- 11 The serving line contains painted plastic paneled
- 12 walls, tile floors, and a suspended ceiling
- 13 (Figure 391). Wood paneling is present on the
- 14 south wall of the room behind the remaining
- 15 kitchen equipment (Figure 392).

FIGURE 391. Vinyl tile, plastic panel, and suspended-frame acoustic tile ceiling in serving line.

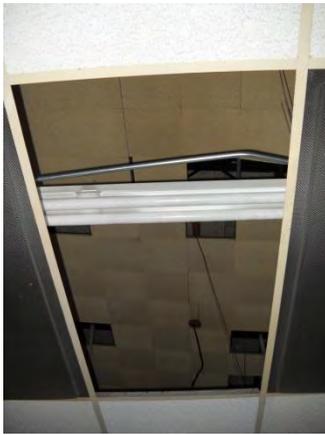
- 1 Accessed from the bar/lobby space, the employee
- 2 cafeteria has wood paneled walls, carpet flooring,
- 3 and a suspended acoustical ceiling covering the
- 4 original suspended concealed-spline acoustical tile
- 5 ceiling above (Figure 389).

FIGURE 389. Employee cafeteria ceiling showing original suspended concealed-spline acoustical tile ceiling above newer suspended ceiling.

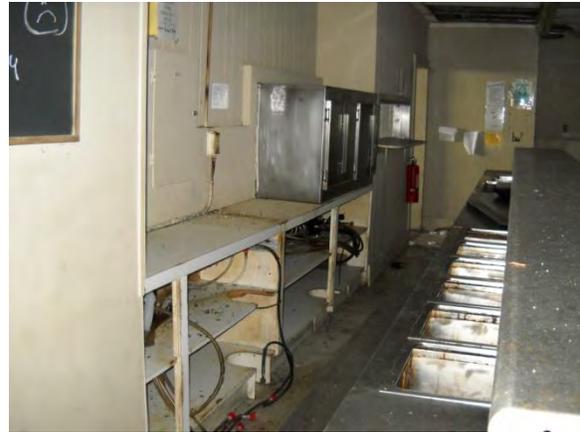
FIGURE 392. Wood paneling on south wall of serving line.

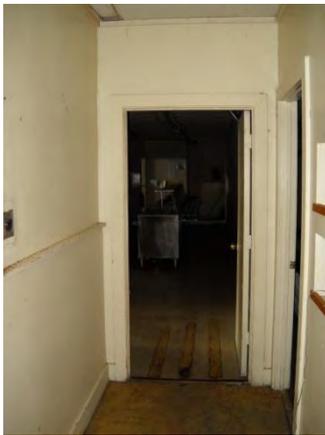
- 6 South of the employee cafeteria is a hallway that
- 7 connects the bar/lobby to a room containing the
- 8 serving line where employees were served. The
- 9 hallway has plaster walls, tile floors with a wood
- 10 base, and a suspended ceiling (Figure 390).

FIGURE 390. Hallway leading to serving line room.

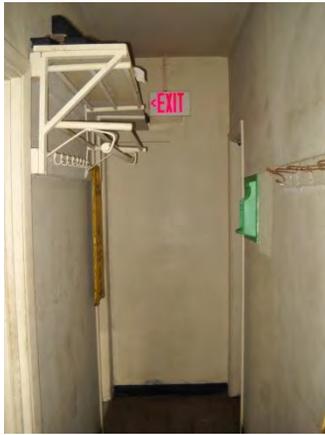
- 1 A corridor located south of the employee dining
- 2 area connects the serving line to the back hallway.
- 3 This corridor also provides access to two
- 4 restrooms and a small closet (Figure 393). The
- 5 corridor has ceramic tile floors with a vinyl base,
- 6 plaster walls and ceiling, and built-in wood
- 7 shelving (Figure 394).

FIGURE 393. Restroom corridor.

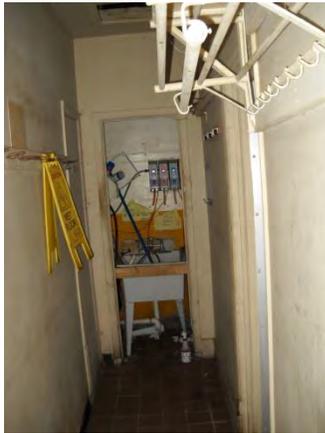
FIGURE 394. Ceramic tile flooring, plaster walls, and built-in shelving in restroom corridor.

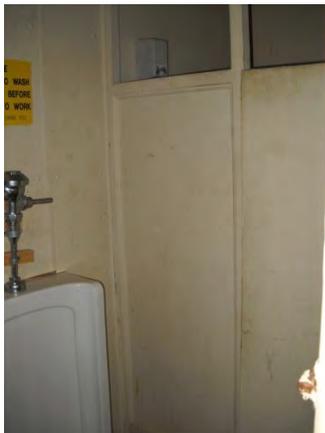
- 8 The women's restroom has similar finishes to the
- 9 corridor while the men's restroom has plastic
- 10 paneled walls and ceilings (Figure 395). Wood
- 11 partitions are present in both restrooms.

FIGURE 395. The men's restroom has plastic paneling and wood partitions.
