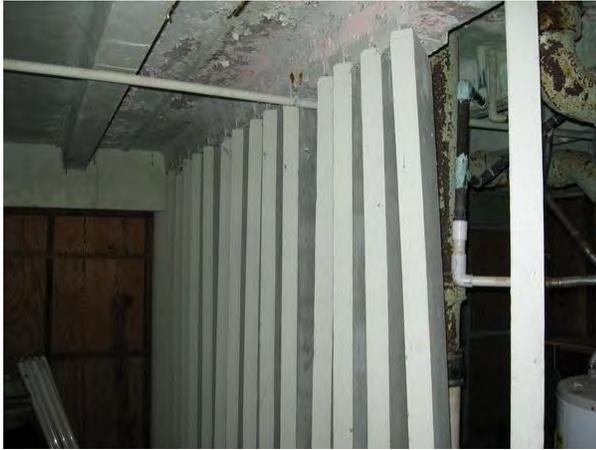
30 Behind the central stairs located on the north
31 elevation on the ground floor are enclosed storage
32 spaces. The original design of the building
33 included two identical partially enclosed ground
34 floor storage rooms, each sixteen feet by ten feet,
35 defined by wood-framed screen walls at the east
36 and west end, and concrete louvers at the north
37 and south sides. Remnants of these original
38 enclosure walls remain, although both rooms have
39 been expanded and reconfigured (Figure 509).

FIGURE 509. View of original concrete louvers, now enclosed within the expanded ground floor spaces.

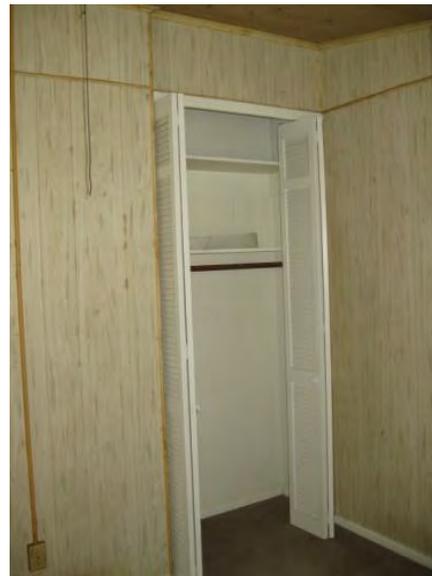
1 The walls of the second bedroom are completely
2 covered by wood paneling. The small closet in this
3 room has louvered bi-fold doors (Figure 563).

14
15 **FIGURE 563.** Second bedroom.

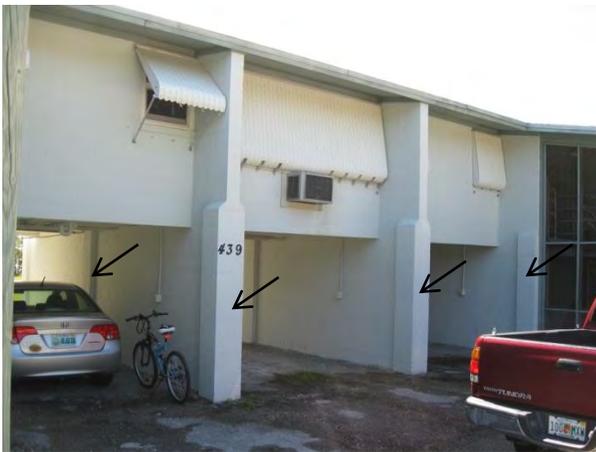
24 Although not indicated on the drawings, part of
25 the original construction included 16 inch square
26 piers integrated into the ends and midpoints of the
27 concrete masonry bearing walls at the ground
28 floor (Figure 564).

29
30 **FIGURE 564.** View of building 439 showing the
31 16 inch square piers at the ends and midpoint of
32 each ground floor bearing wall (arrows).
