Paintings Survey

Glacier National Park, Montana

September 27 - October 5, 2005

M. Randall Ash & Associates
Denver, Colorado

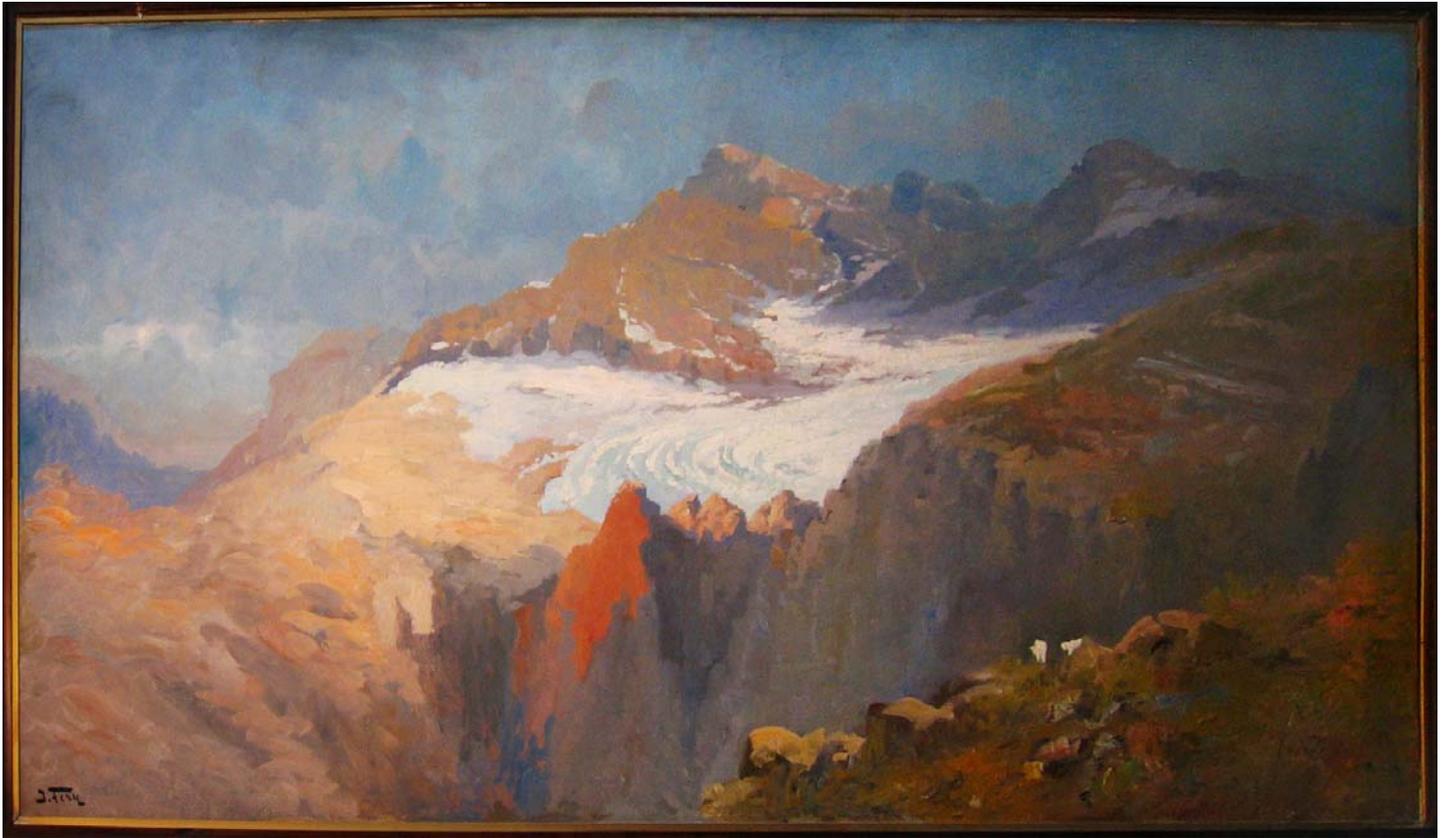
"Romey Glacier"
Artist: John Fery

- masonite strips used as a frame rabbet - top rt half missing but lodged on lower rt half

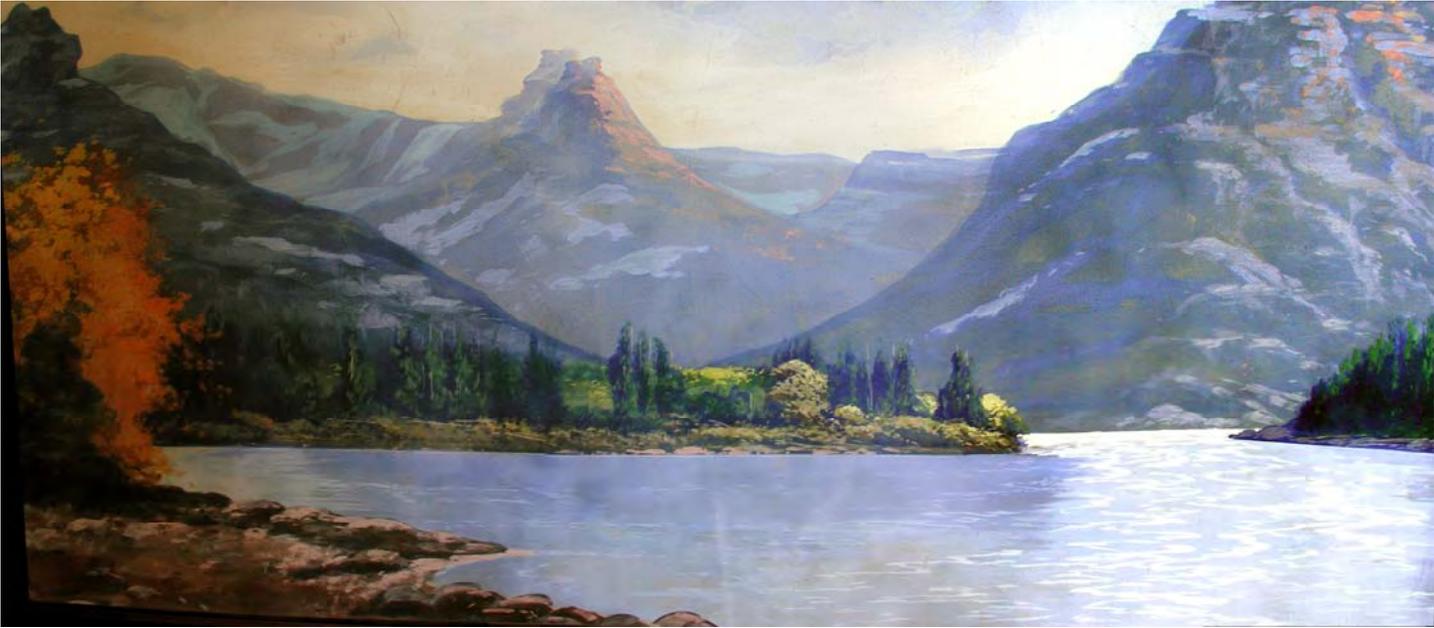
Sinopah
Artist: Unknown

- This ptg. is hung by a front cleat that is usually open. Not the best placement for any art object
 - There was an earlier restoration attaching the heavy canvas to a masonite support.

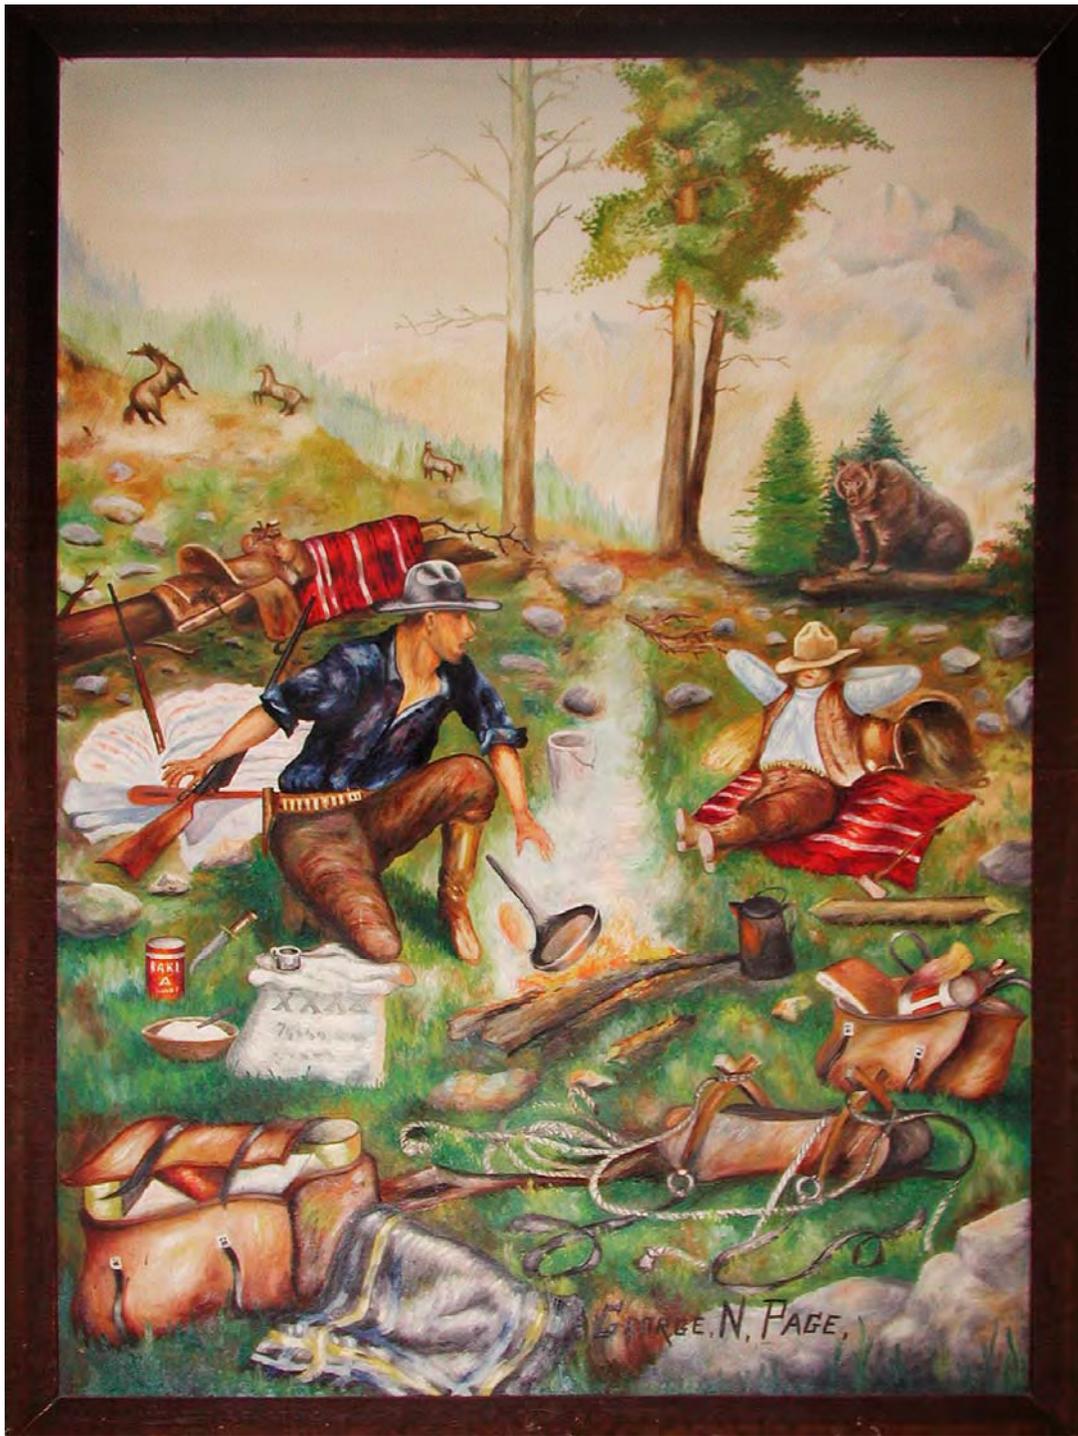
Bear In Camp
Artist: George N. Page

* holes on verticals indicate another hanging -
* only one hanger - not adequate - need 2, always

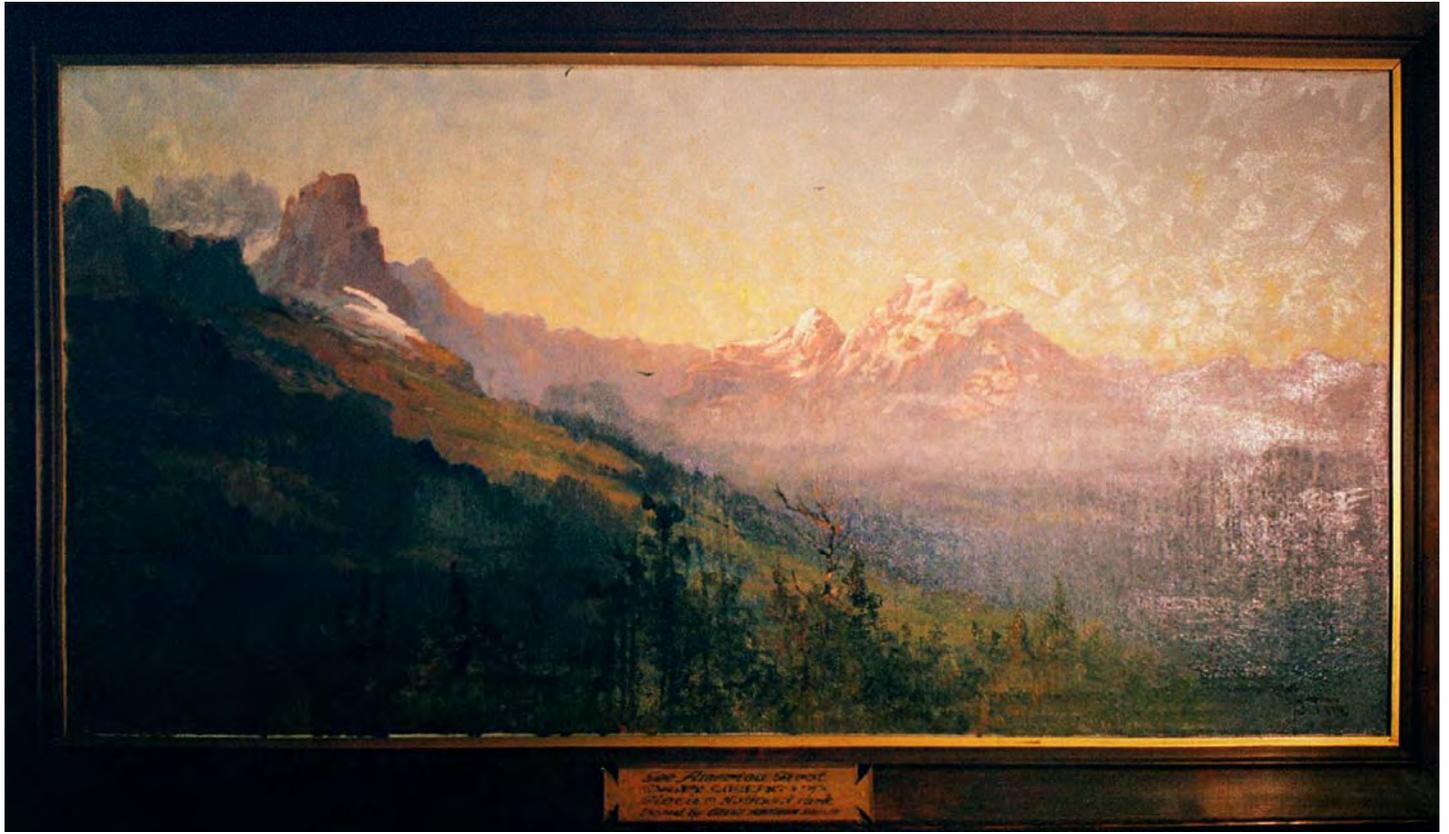
"Swiftcurrent Pass"
Artist: John Fery

*w. paint loss 1/2 from left x 3" up.

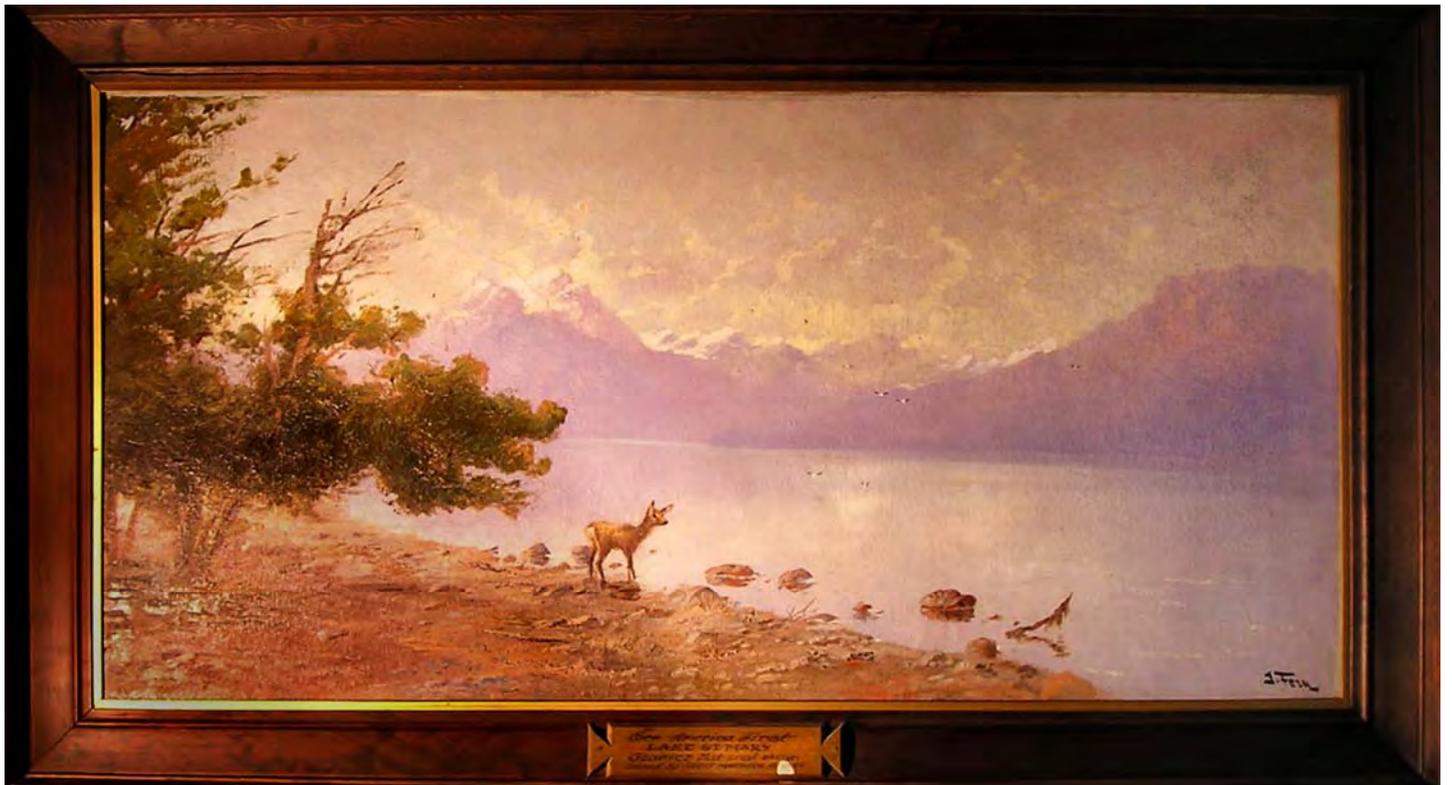
"Lake St. Mary"
Artist: John Fery

- the canvas is laid over a solid support possibly masonite -
 - the most amount of damage is located in a 16" vertical band going across the entire lower horizontal - this is an area most accessible to the public
 - appears the pt. was first attached to wall/board & then the frame put over & screwed into wall -

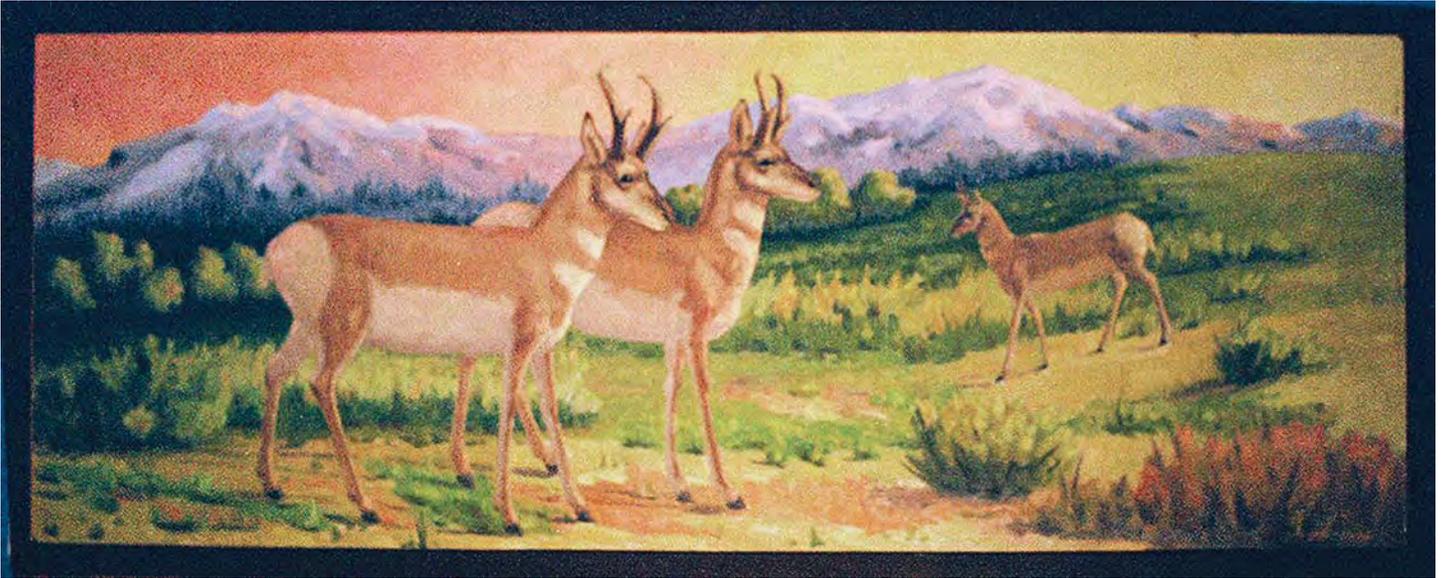
Antelope
Artist: Richmond

NOTES: - pt. screwed into wall frame over it nailed into wall.

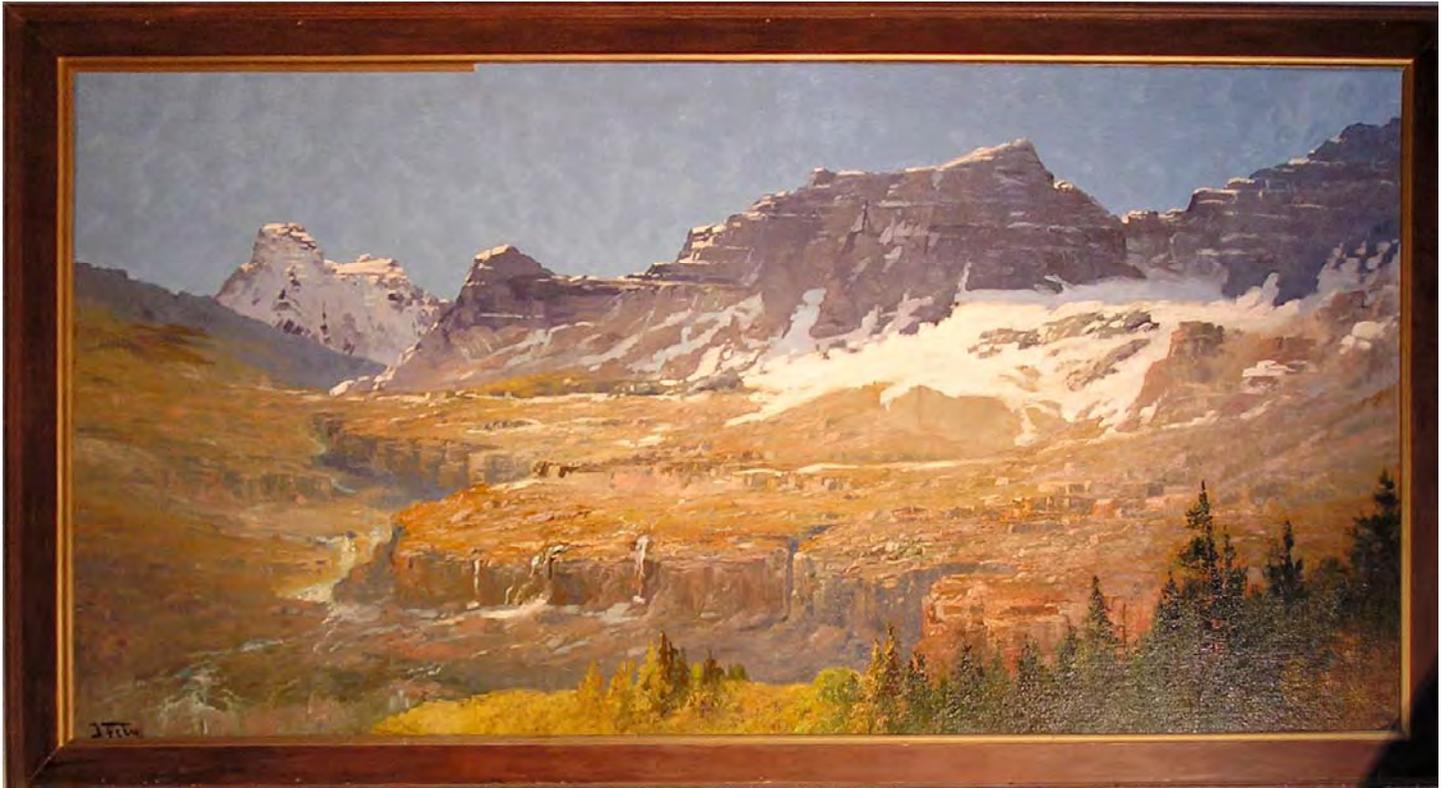
Mountain Landscape
Artist: John Fery

NOTES:
 - Relatively good condition
 only needs cleaning and a
 protective surface cleaning.

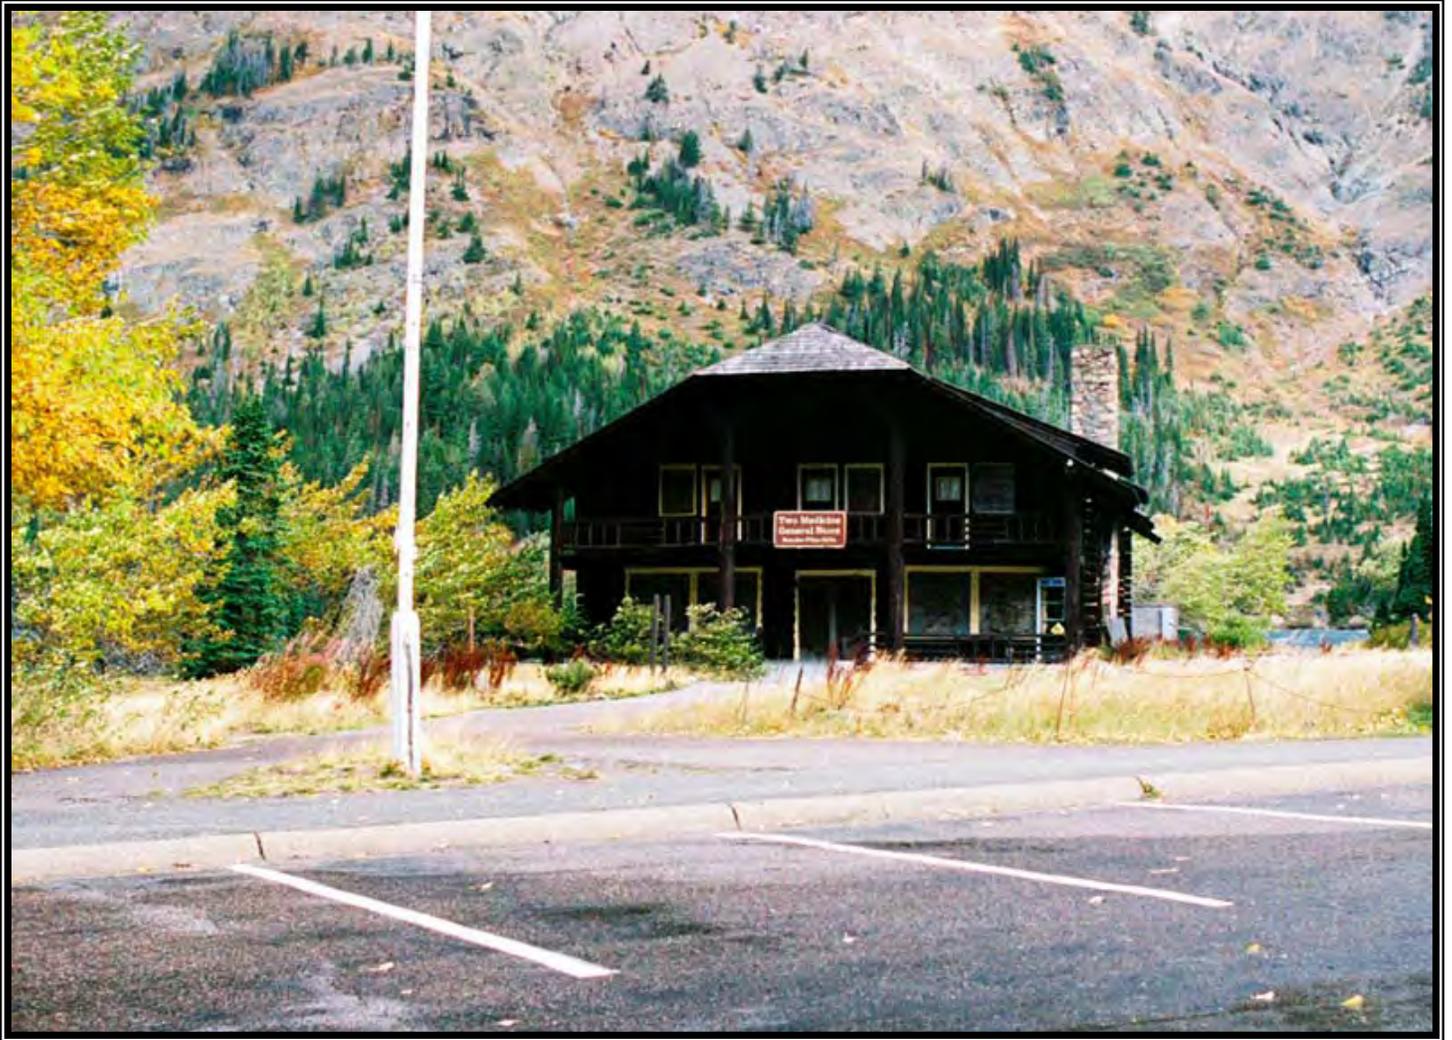
- All utilities are turned off during the winter season
- This building appears to have better insulation, thus the environmental conditions are more moderate.
- The art is hung high on the walls in the center of the building, and are not exposed to window light (U.V.) or access by the public.
- There is accumulated dirt and grime on the surface of the paintings, but this is to be expected in a publicly used building and being placed high on a wall with any heat/dust rising.
