## **Golden Gate Dairy (Lopes Brothers Dairy, Ranch M)**

### **Cultural Resource Reports and Site Treatments: Cultural Landscape Report Historic Structure Reports Archeological Assessment and Treatment Report**

June 10, 2013  
United States National Park Service,  
Golden Gate National Recreation Area  
Division of Cultural Resources

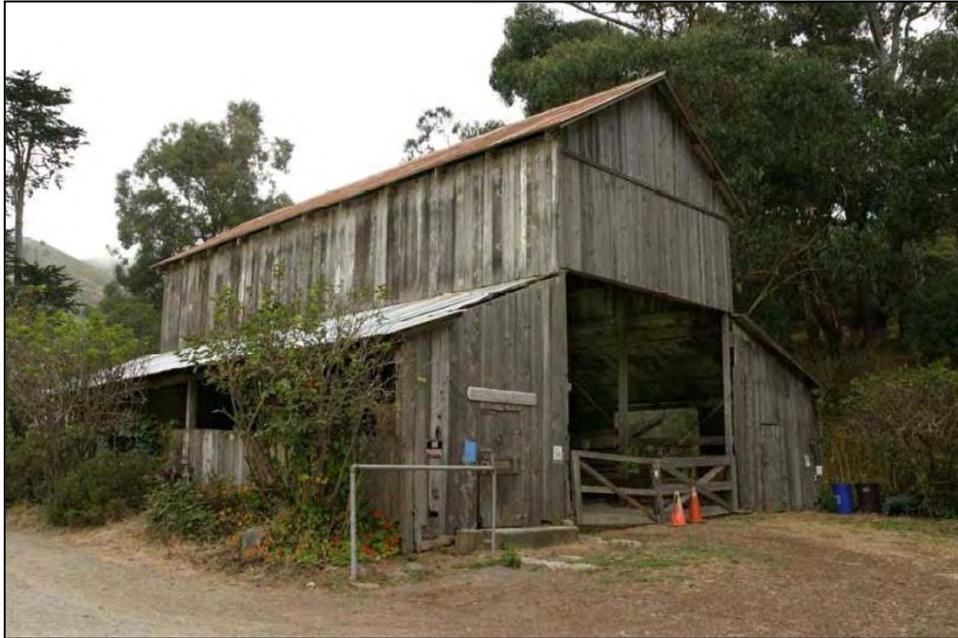
and concrete piers. A later addition to the south end collapsed in 1978 and has not been replaced. At present, the building is utilized for hay storage and horse boarding.

The original milking barn was destroyed by fire in the 1920s. This replacement was constructed during the period of significance, and is a contributing resource.

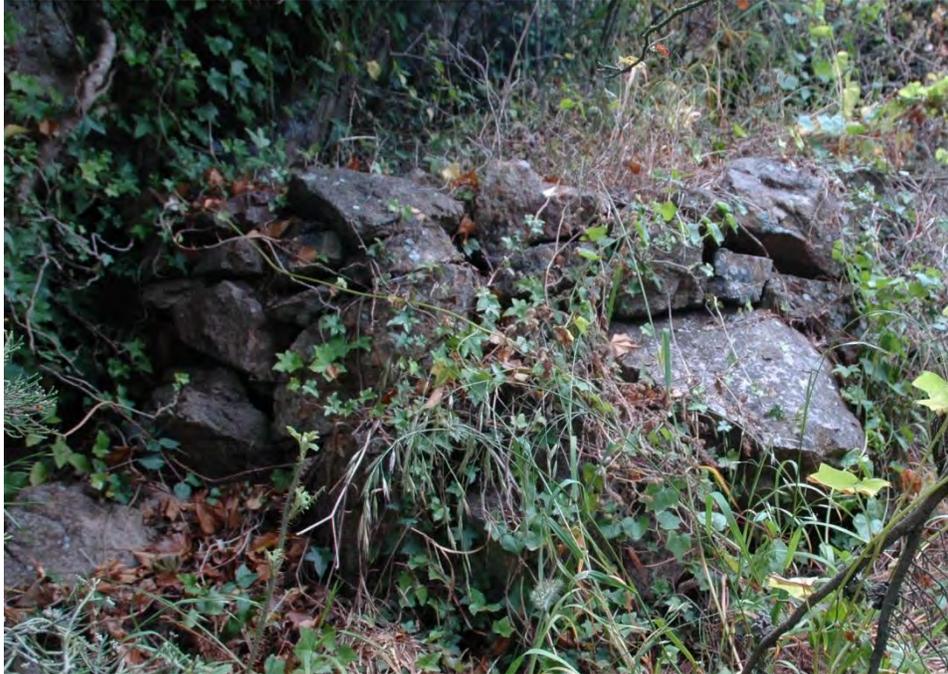
constructed, though the walls are somewhat distinguishable in a 1942 aerial. Although vegetation has largely obscured the walls, they still exist in good condition.

Detail of one the garden terrace stone walls, located east of the Main House.

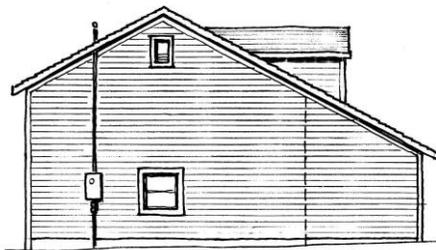
MBVFD Barn Remodel Concept Side (East) Elevation

*Not Recommended:* Changing the building form and shape by extending the north wall and modifying the roofline, adding a dormer; changing important elements of the building style (rake boards and corner returns).

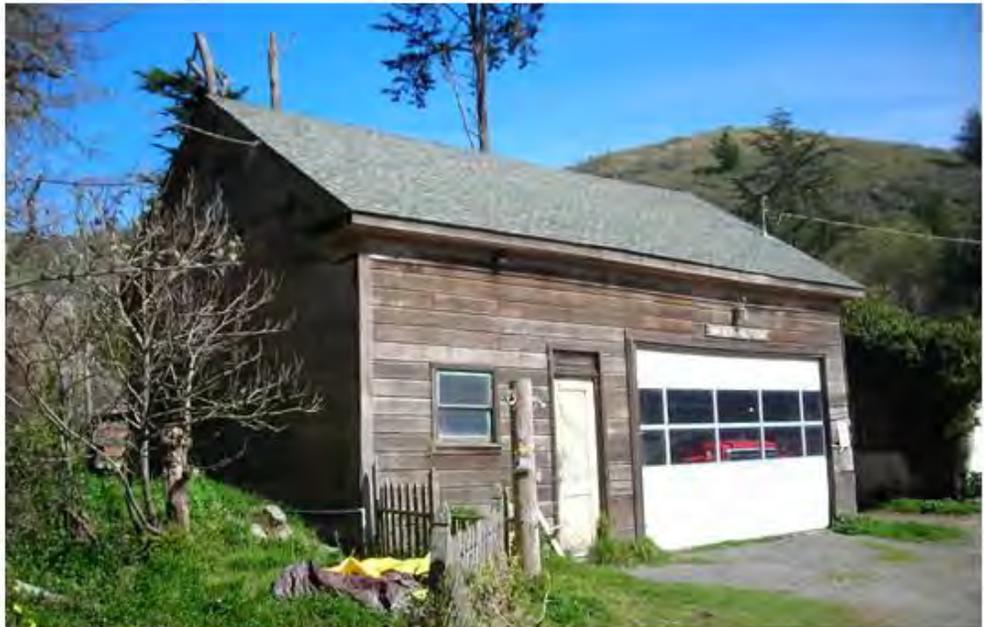
**Golden Gate Dairy Creamery Building South Façade 2008**

Note the window that appears to have been closed off but has shelves on the interior. Note also the lack of (or extreme foreshortening) of the door penetration in this location.

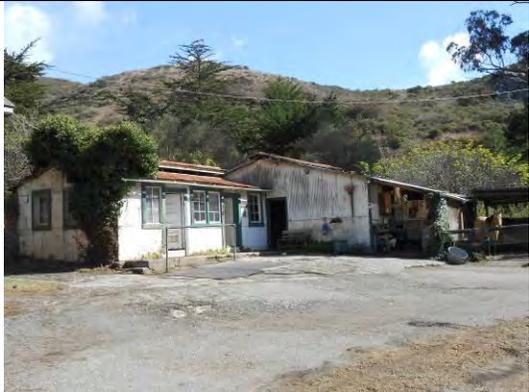
<p>Looking southeast at dairy house and stable (NPS Photo, 2012)</p>	<p>North east corner at outhouse (NPS Photo, 2012)</p>

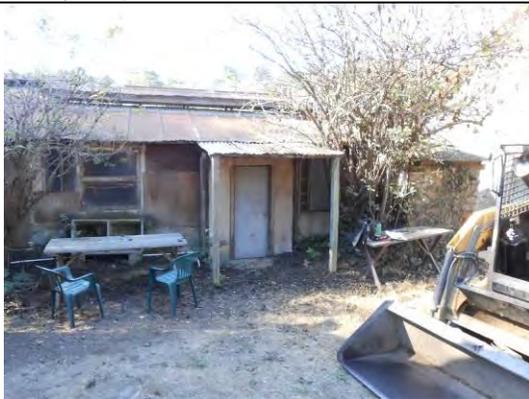
<p>East wall (north end) milk cooler door and outhouse (NPS Photo, 2012)</p>	<p>South end stable wall (NPS Photo, 2012)</p>

addition that protects the extant front wall and door of a walk-in milk storage room addition. The extant wall is constructed of cementitious plaster painted gray over wood studs with 4" cork insulation. The extant door opens inward (3" below existing grade) and is a manufactured refrigerator door dating from the late 1930s. The wall between the outhouse and the refrigerator door is typical, unpainted and there is a knob from the early electrical wiring extant. A three foot section of vertical siding adjacent to the door on the north is missing and the exposed wood studs and sills are badly rotted and damaged by insects. The wall adjacent to the refrigerator door to the south is composed of salvaged plywood patches abutting a unique wood sash window with raised concrete floor slab below. The window is composed of a fixed 36" square window divided horizontally into two lites by 2" thick wood framing and is adjacent to a narrow 38"x 17" wood sash casement window divided into 6 lites by narrow wood muntins set into the remaining 2x4 framed opening. This window (both frame and sash) has insect damage and is in fair condition. The bottom pane of the divided sash is missing and is covered with plywood. The wall at this window has cementitious plaster up to the top of the window frame on both sides, which is unusual. The transition between the low-walled dairy house wing and the attached stable is not expressed on the building exterior on this façade; neither in the wall nor the roof. The wall at this location has a full height plywood patch perhaps indicating the presence of an in-filled doorway. The exterior wall of the stable portion of the building is composed of concrete with form board patterns and corrugated steel, is unpainted and is in fair condition. At the far end of the wall (centered in the stable room) is a 6'-6"x 4'-0" wooden 2-panel sliding window. Sliding wood panels are composed of three 1x12 boards and one 1x6 board oriented vertically, butt-joined with 1x4 horizontal batten boards on the exterior – 2x4 framing is exposed at bottom and covered with 1x4 trim at top. Window panels, framing and trim is unpainted redwood and is in fair condition. Faintly carved lettering was noticed on the wood window panels. Vegetation along this wall of the building is overgrown, set too close to the building and should be removed.

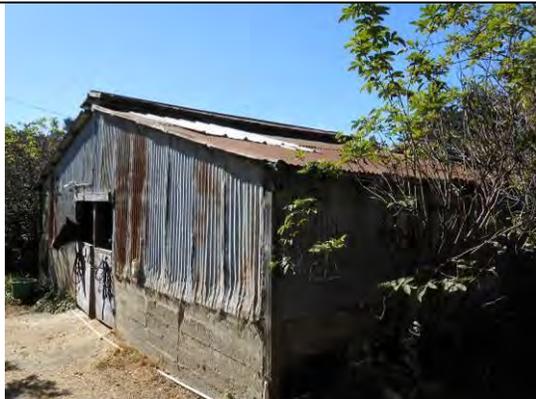
The south wall is the 31'-4" long gabled wall of the stable room, is composed of concrete and corrugated steel, is unpainted and is in fair condition. As with the north wall, the roof has a full length ridge vent that is capped such that the vented opening and ridge cap is expressed on this façade, but in this case the stable room is almost twice as wide and the ridge vent is centered above a 7'-0" wide door opening. This main door opening has been modified with 2 paddock gates inset in the opening and the original sliding door is no longer extant (a sliding door is evidenced by extant rail brackets and the "ghosts" of the rails are visible on the corrugated steel wall panels for a door that opened to the east). Similarly, a sliding door is evidenced at the far west side of the wall where the feed alley is located. This 3'-0"x 6'-4" opening has been in-filled with a Plexiglas and wood. The concrete stem wall on the east side of the main door has a 10" wide form board pattern finish whereas the wall on the west side of the main door is finished in a smooth cementitious plaster.

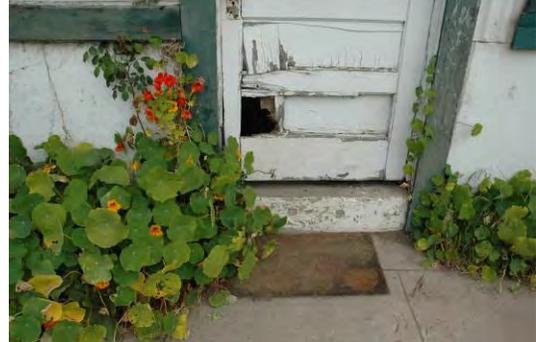
Also visible on the north, offset from this façade 26’-0” is the adjoining section of the stable portion of the building that has one 3’-0”x7’-0” swinging door. The door is composed of 1x8 boards oriented vertically with 1x4 horizontal battens and a diagonal brace in good condition. This door is not historic. Originally a hanging door sealed this entry to the stable and one piece of rail hardware is extant on the wall. The concrete stem wall in this gabled wall of the stable wing has varying height due to grade changes as the ground gradually slopes to the south. In the concrete pavement in front of this portion of wall are inscribed the words “Manuel” with presumably the date underneath, which is illegible (possibly “SET 1943” for Setembro or September). This wall has 3 modern lights installed along the eaves line. The roof has a full length ridge vent that is capped such that the vented opening and ridge cap is expressed on this wall above the descending roof of the dairy house wing and aligned with its exterior wall. The corrugated steel siding and concrete stem wall is painted white and is in good condition. At the far south end of the wall is a 1x4 vertical end board painted green in fair condition. The shed addition wash room extends from there, is not original to the period of significance, but is in fair condition overall.

<p>North room entry door (NPS Photo, 2012)</p>	<p>Looking southeast at stable and shed addition (NPS Photo, 2012)</p>

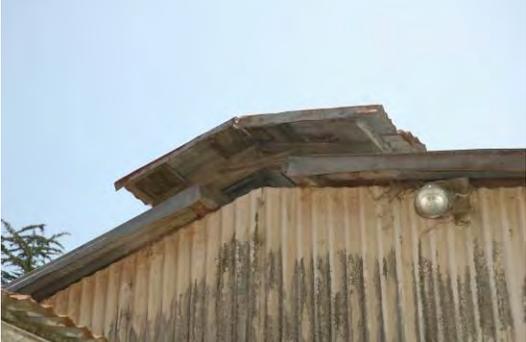
<p>Northeast corner inside outhouse; abandoned water piping possibly from boiler or heater on opposite side; north room (NPS Photo, 2012)</p>	<p>Capped ridge vent detail (NPS Photo, 2012)</p>

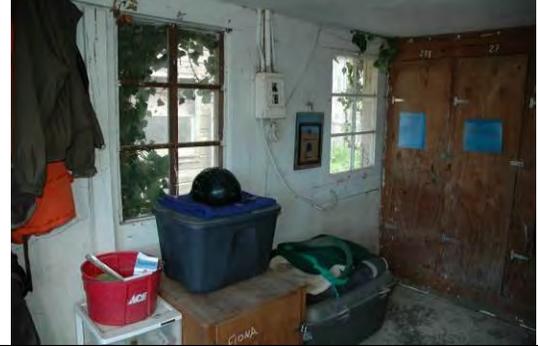
The north room is 15'-0"x9'-1" and is characterized by a sloping concrete floor with center drain, cementitious stucco walls and ceiling all painted white. The floor drain grate is missing, but otherwise the room features are worn but in good condition. Windows are trimmed in 1x6 wood, and are flush with the wall for sanitary purposes, as is the ceiling access hatch, which is no longer extant. On the ceiling there is one single ceramic light socket mounted on a surface mounted junction box. Built-in plywood lockers obscure the walls on the east and south. On the north wall are two similar 6 lite wood sash windows. To the right of the electrical panel is a small ceramic light socket mounted to a wood block embedded flush in the stucco wall. Below the panel the stucco finish is severely cracked. On the west wall are a single window and door. The window sash is a shoddy replacement and the door trim is not flush with the wall, which could indicate a later remodel. The south wall shows evidence that the wall was removed at an earlier period before the present wall was installed. Because of this it is not possible to discern whether or not there was a door or passage between this room and that to the south, however because of an extant trim board stranded in the wall it appears there may have been a wall opening. At present, the connection between the two rooms is served by an exterior concrete walkway.

<p>North room interior looking northeast (NPS Photo, 2012)</p>		<p>North room ceiling, attic hatch and ceiling light looking east (NPS Photo, 2012)</p>

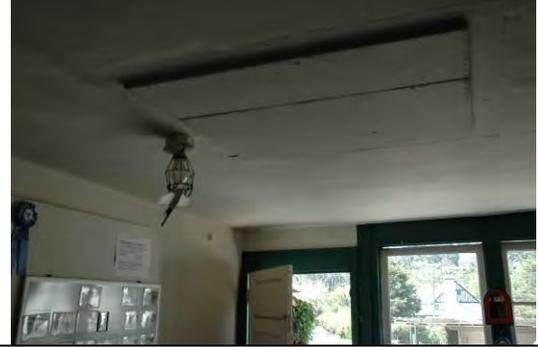
<p>Milk cooling room ceiling hatch and ceiling light looking west</p>		<p>Milk cooling room floor drain (NPS Photo, 2012)</p>

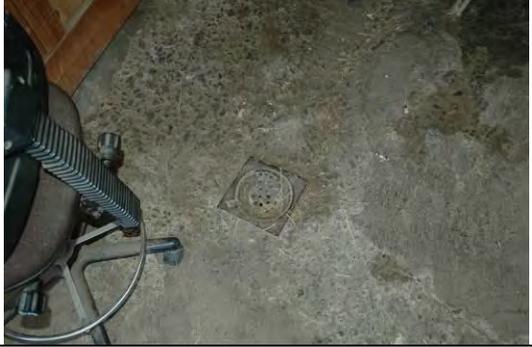
The central room in the low gabled milk house portion of the building is 15'-0"x9'-7" and is characterized by a sloping concrete floor with center drain, cementitious stucco walls and ceiling all painted white. The complete floor drain with grate is extant. Unique to this room is the manufactured refrigerator door centered in the east wall and painted an unusual combination of white and deep green with cream colored hardware. On the ceiling there is one single ceramic light socket with wire cage mounted on a surface mounted junction box. The ceiling hatch is covered with salvaged boards. Also on the ceiling in the south east corner of the room is a pipe base flange and a penetration, perhaps from a water pipe or conduit. The wall on the north is a non-historic plywood partition and the south wall is stucco.

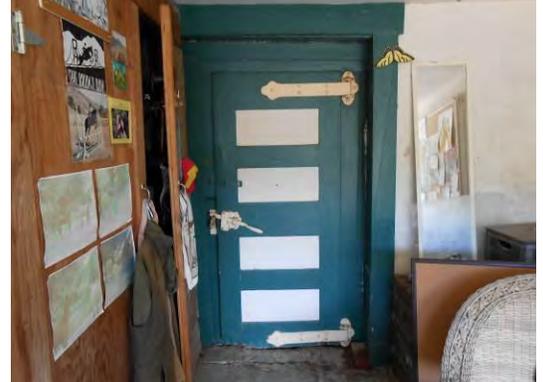
<p>Milk room cooler door (NPS Photo, 2012)</p>	<p>Attic framing in ceiling of north room looking south at milk cooler room hatch and boxed duct (NPS Photo, 2012)</p>

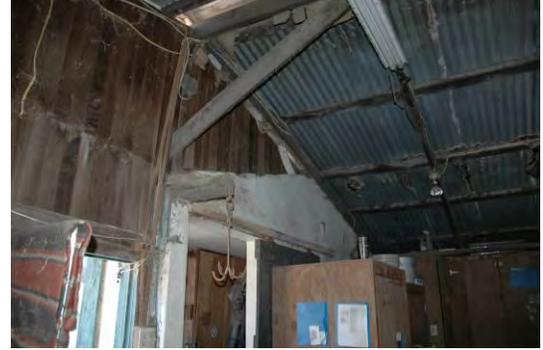
<p>Milking stable north end gable showing ridge bracing and gabled end of milk house (NPS Photo, 2012)</p>	<p>Milking stable south gable showing beadboard wall finish, wood bracing and piping (NPS Photo, 2012)</p>
