Tennessee Valley Stables (Cunha/Rapozo Ranch, Ranch A/B)

Cultural Resource Reports and Site Treatment: Cultural Landscape Report Historic Structure Reports Archeological Assessment and Treatment Report

June 10, 2013
United States National Park Service,
Golden Gate National Recreation Area
Division of Cultural Resources

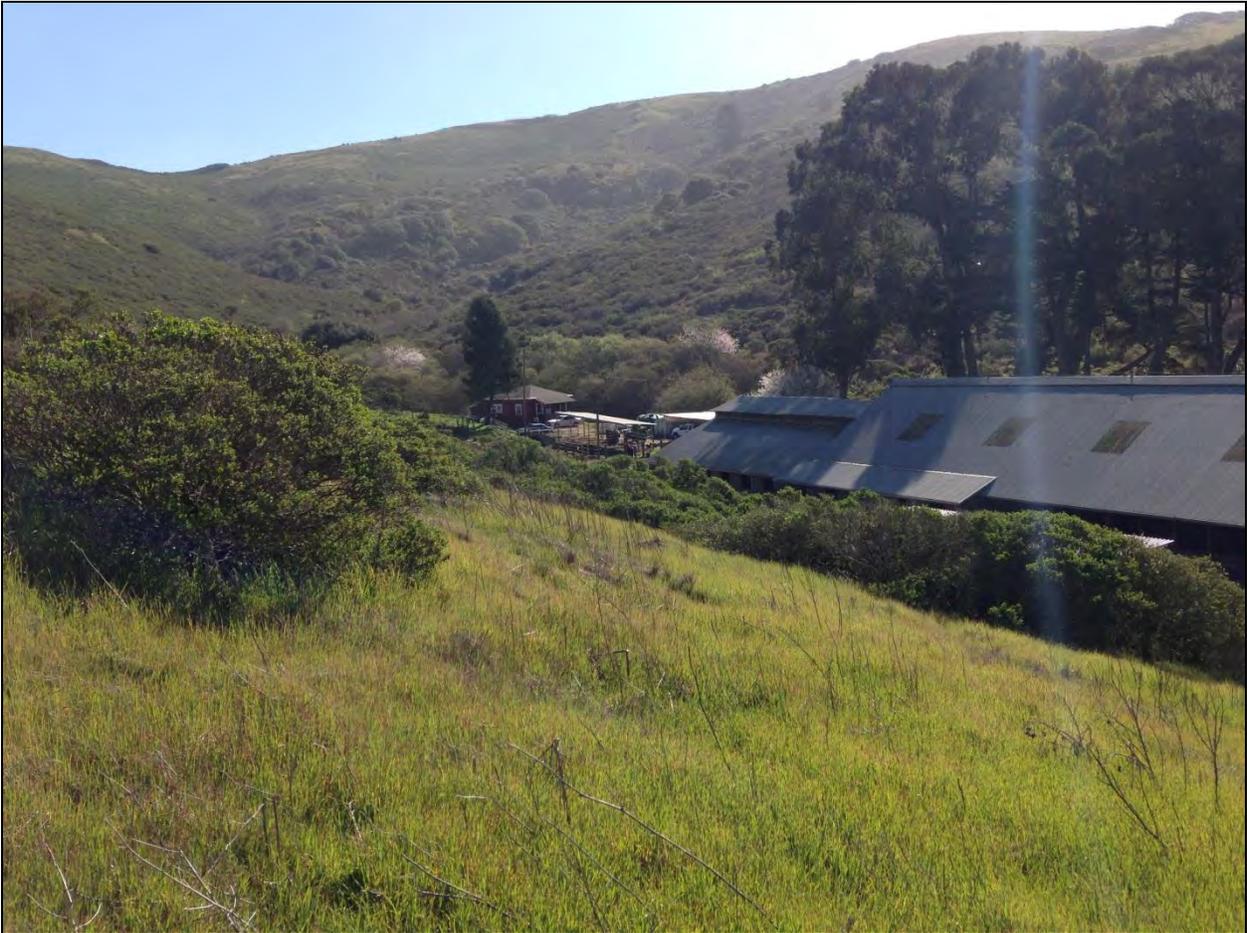
The cessation of grazing has allowed coastal scrub plant communities to outcompete grasslands.

- Manage open grasslands and coastal scrub plant communities that surround the developed area and contribute to the historic character of the site.
- Ensure that all horses, resident or guests, are fed only weed-free feed to reduce the risk of invasive plant introduction.
- Retain and manage the riparian corridor as a natural system.
- As feasible, observe the riparian corridor set back of 50' for all new structures and parking facilities.
- Major changes to existing grades should be avoided, especially those requiring retaining walls.

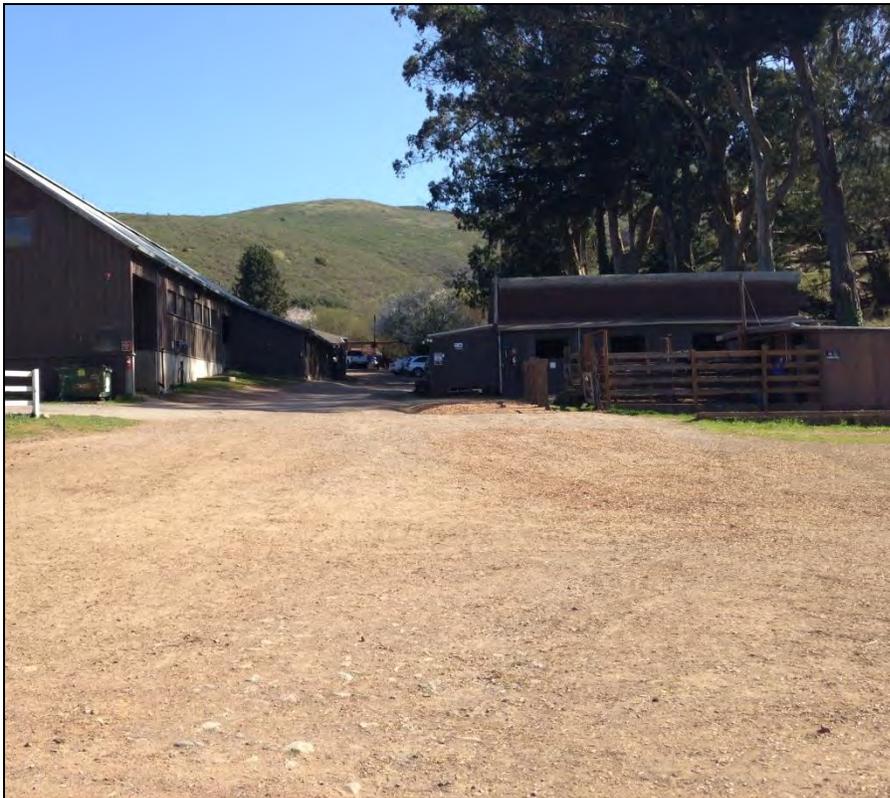
The rustic, understated circulation features are a character defining feature within Ranch A/B and should be preserved.

- As feasible, restrict use of concrete to the historic limits which include remnant foundations and ramps and the concrete alley north of the main barn complex.
 - Any modifications to the historic concrete must be performed in consultation with the park’s historical landscape architect.
- If a hardened surface is required, consider use of road base with a binding agent, such as Perma-Zyme®, TerraHold or a triple shot of chip seal, as has been proposed for Satterlee Road at Fort Baker.
- Do not attempt to define parking spaces with stripes, wooden curb stops, or any other manufactured features. The use of stones or logs may be appropriate.
- New circulation features should be located outside of the historic building core, where feasible.
- The use of historic building foundations for parking is discouraged.

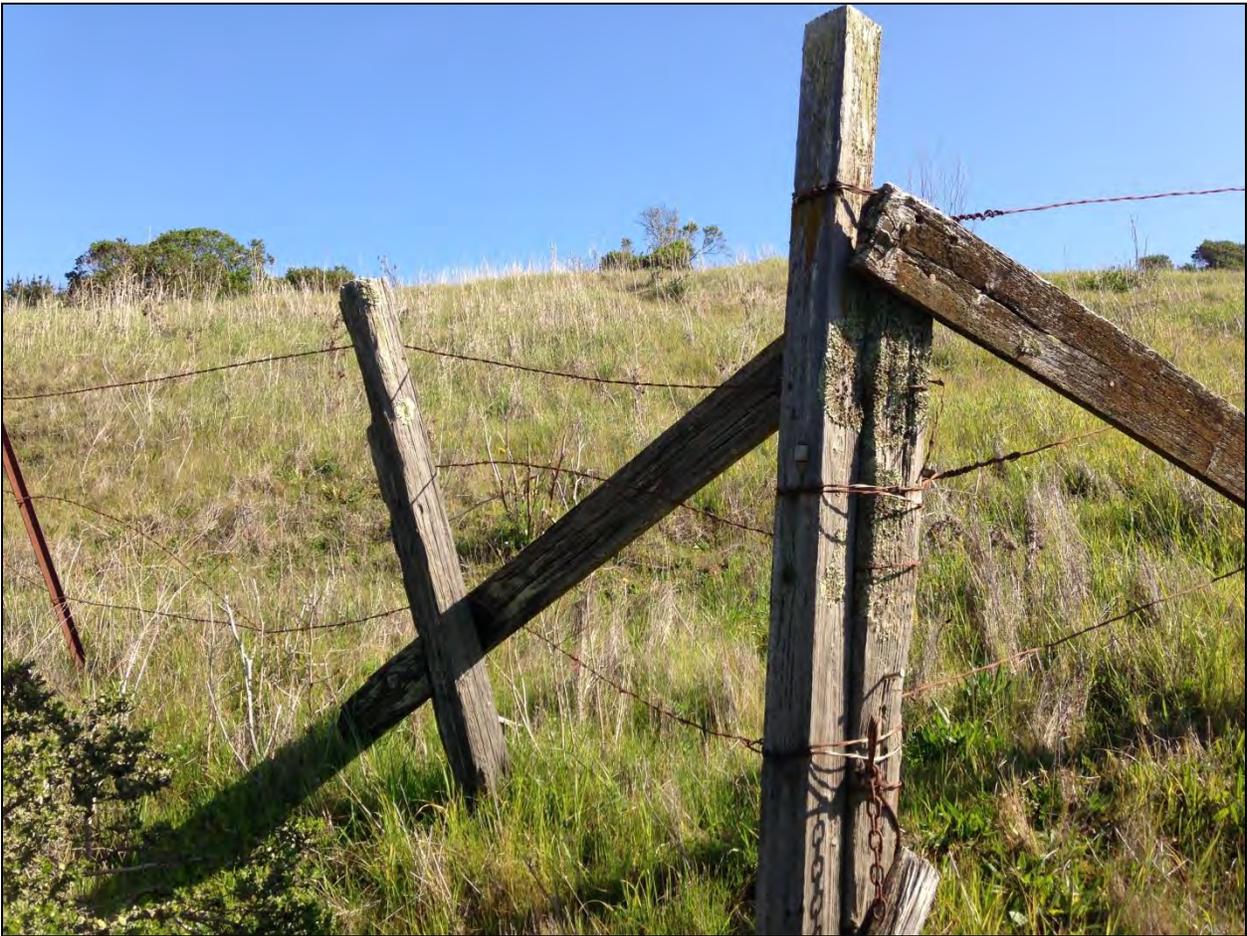
Fence posts should be maintained as a contributing resource.

- Maintain and preserve the fence posts as contributing resources.
- Maintain historic utilities, as feasible.
 - Introduction of contemporary utilities and facilities associated with operations should be visually compatible with historic structures within the core.
- Conduct historical archeological investigations to document remnant historic small scale features throughout the historic district such as dump sites, fence lines, utilities and infrastructure, the location of non-extant structures and foundation ruins.
- Limit the addition of new small scale site features for contemporary use. If new small scale features are required, the following guidelines apply:

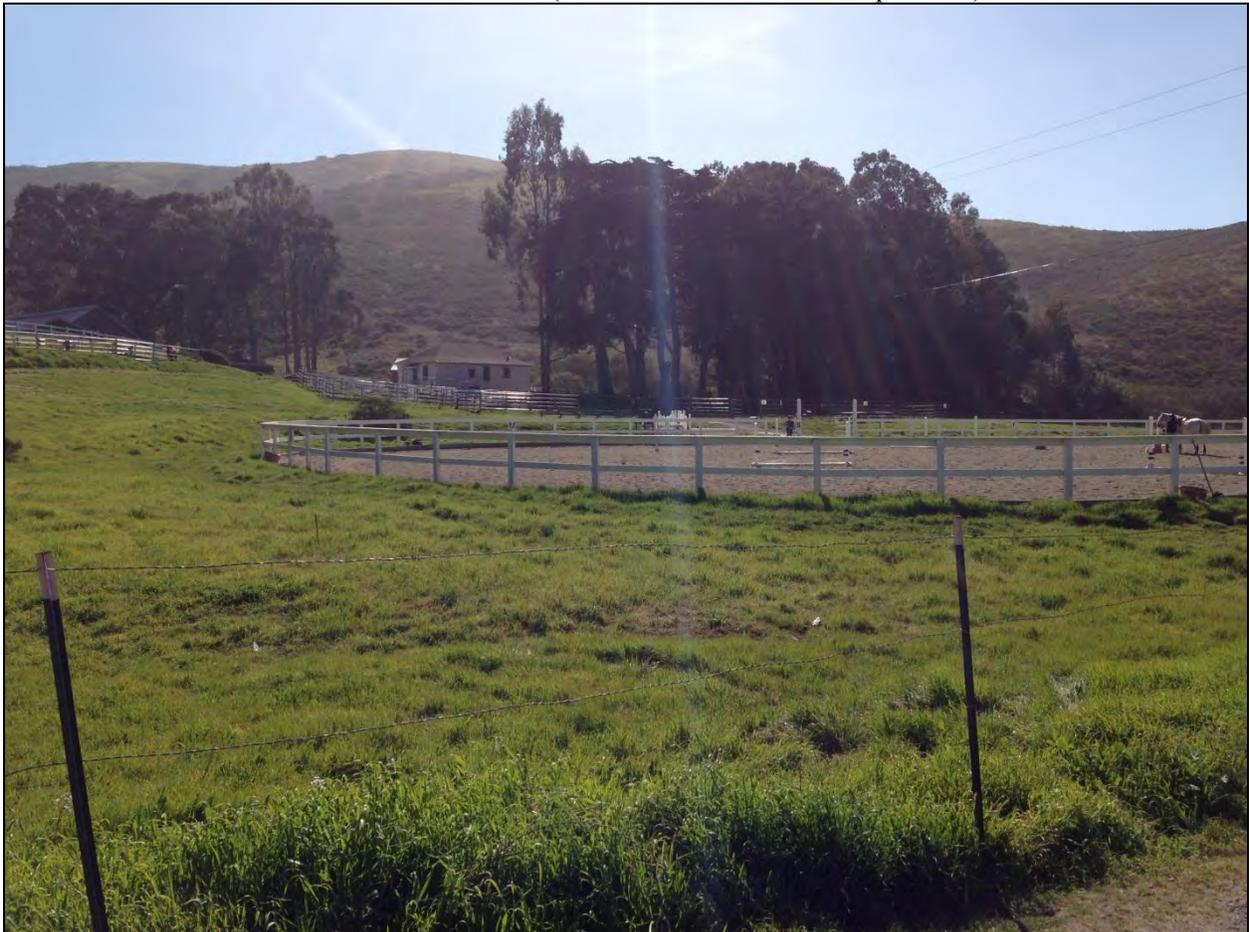
The two historic windbreaks and grasslands are remnants of the historic vegetation.

- Preserve and maintain the historic vegetation, which includes 2 windbreaks and the open grasslands.
- In consultation with an arborist, preserve and maintain the historic windbreaks by pruning the trees for long term health.

- Maintain the footprint and continuous canopy of the windbreaks as a primary character feature.
 - Windbreaks should be assessed by a certified arborist to ensure that there are no immediate threats to life/safety, buildings and structures, and the trees themselves.
- When it is no longer safe to maintain existing windbreaks, trees should be removed and replanted en masse in order to achieve an even aged stand.
 - Replacements should match in species and spacing, as possible.
 - Removal of any historic, or possibly historic trees, should be done in a manner that adequately documents the species and location through both photography and GIS information (coordinate with Park GIS specialist).

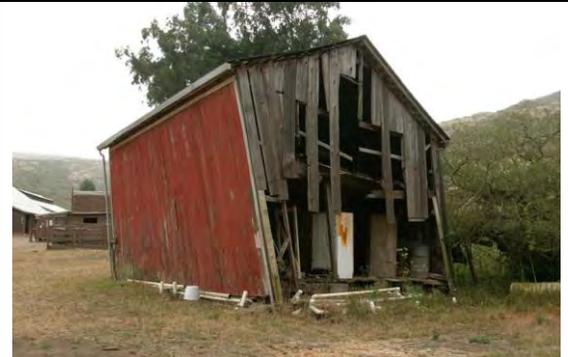
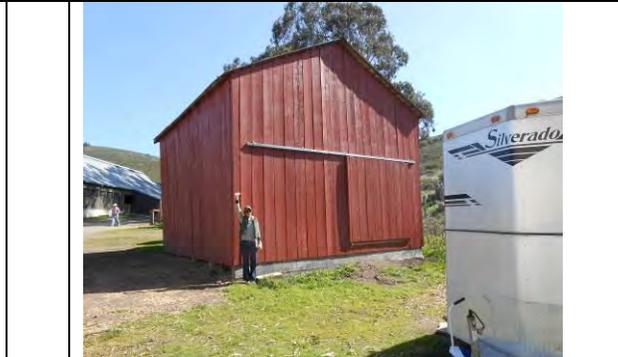
<p>House Barn (Garage/Red Barn) (NPS Photo, 2008)</p>	<p>House Barn (Garage/Red Barn) (NPS Photo, 2013)</p>

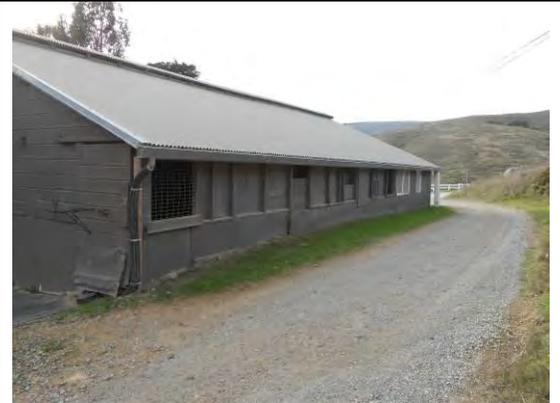
<p>Milk house north wall detail (NPS Photo, 2012)</p>	<p>Looking west at shed addition stables and milk house (NPS Photo, 2012)</p>

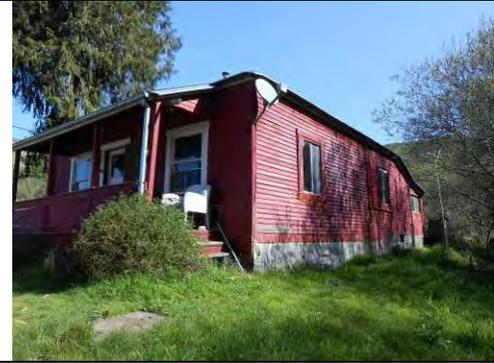
<p>Bunkhouse looking northeast (NPS Photo, 2012)</p>	<p>Bunkhouse west wall southwest corner (NPS Photo, 2013)</p>

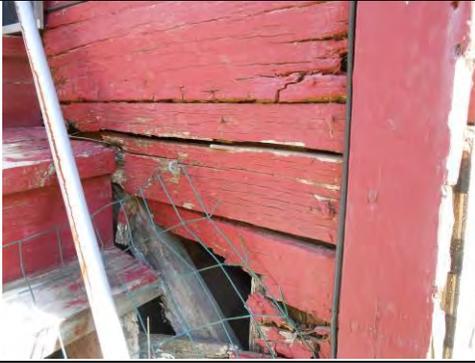
- Concrete pier footings with wood posts in fair condition; frame walls and 4" wide wood horizontal lap board siding painted red in fair to poor condition; wall has 1x4 end boards painted red in fair condition. The east end of this wall is part of a shed addition of unknown installation date having a mix of wood shake siding and 4" wide wood horizontal lap board siding painted red in fair to poor condition. On this wall the siding does not extend to the ground to create skirting of the crawl space so that various means of rodent proofing function as skirting.

- One 3'-10" x 4'-4" sliding aluminum sash window in poor condition. This window appears to be a 1960s era salvage window that was improperly installed. Polyurethane foam has been injected under the trim boards until overflowing and not addressed further.

4. Create a Rehabilitation concept for the Bunkhouse (Auxiliary Residence/TV-102) that will address the deterioration of the building exterior envelope and structural deficiencies of the foundation and rear shed addition, including repairs and conservation of the horizontal lap siding, repairs and replacements to the deteriorated rear shed addition, front porch, front stairs and rails, and repairs, replacements and rehabilitation of the windows and doors.

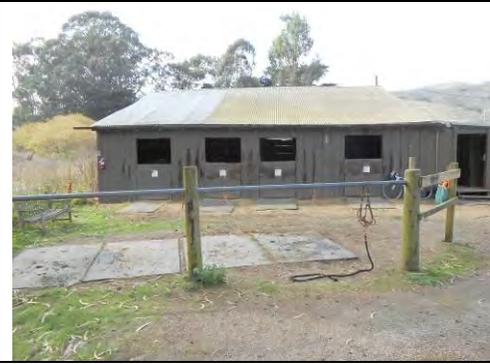
<p>Calf Barn (Auxiliary Stables) looking west (NPS Photo, 2012)</p>	<p>Calf Barn (Auxiliary Stables) south wall siding detail (NPS Photo, 2013)</p>

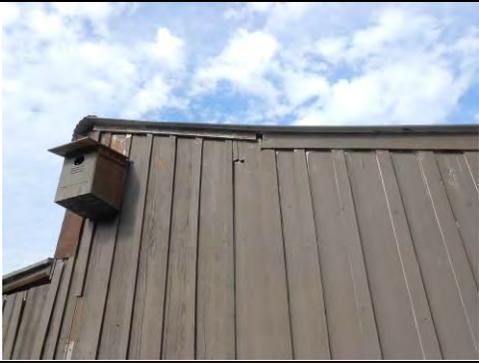
- Wood framed west wall has four horse stall doors spaced irregularly. A large portion of the framing does not appear to be original and includes pressure treated lumber. This makes it difficult to discern where and how the building was altered from dairy to equestrian use. The west wall is actually a partial height (roughly 10'-0" tall) 3'-8" deep shed addition to the enclosed original half-gable of the barn, has 1x12 vertical board siding with 1x4 battens and is in fair condition.

5. Create a Rehabilitation concept for the Calf Barn (Auxiliary Stables/TV107) that will address the needed maintenance of the building exterior envelope and any structural deficiencies of the building, including repairs and conservation of the vertical board and batten siding and roof. The replacement of the missing east side of the building (restoring a compatible gabled barn with access from ranch road and relocation of the shed addition) would be a sensitive approach.

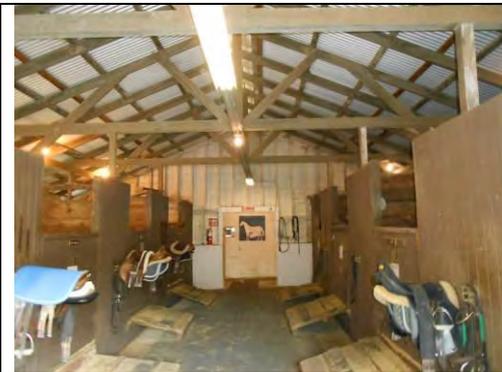
Milk House Sanitary Barn (Stables) looking southeast to hall. Note open frame gabled partition wall (NPS Photo, 2012)

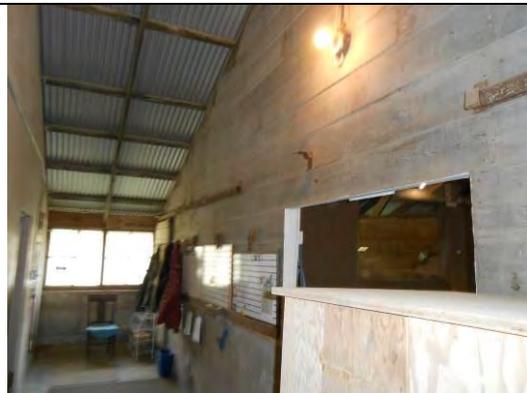
Milk House Sanitary Barn, looking north in hall between milking parlor (Stables) and milk storage areas (Office). Note sliding door and transition of finish materials (NPS Photo, 2013)

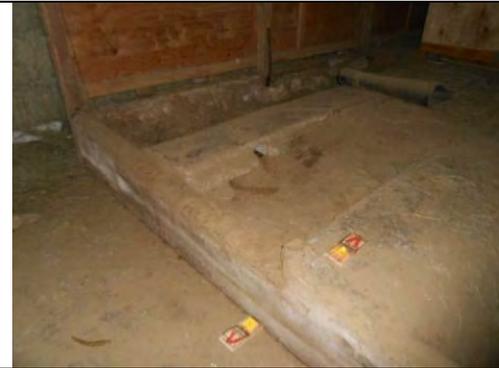
<p>Milking Barn (Hay Barn) concrete manger and raised feed alley (NPS Photo, 2013)</p>		<p>Milking barn (Hay Barn) interior structural detail (NPS Photo, 2013)</p>

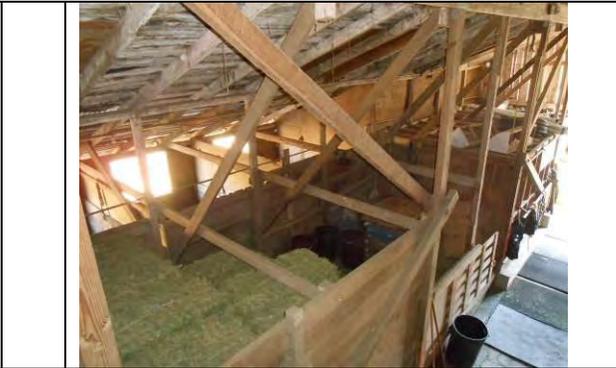
In the Main Barn Complex the structural system is light wood framing. In the oldest portion of the building, the Milking Barn (Hay Barn & Stables), the structural framing system consists of four parallel post and beam lines running east to west comprised of slender 4x4 posts on 6'-0" centers, with 2x4 top plates. Column lines are braced with 2x6 horizontal bracing at roughly 8'-0" above the floor, and 2x6 rafters at 3'-0" centers with 1x6 skip sheathing support a shed roof of wood shingles under corrugated galvanized steel sheets. In the central high bay space, a modern arrangement of 4x6 beams supporting a glulam beam with 2x6 diagonal braces has been added in parallel to the 20'-0" tall posts of the central

bay, covering the louvered ventilation features that support the gabled roof. The diagonal braces appear to be older than the recent work yet not as old as the original construction and brace the column lines together in two directions. Bracing at the lower column line, between the column and the outer walls is mostly missing, and the few extant braces are discontinuous. This creates a unique and somewhat unorthodox structural system of unknown evolution.

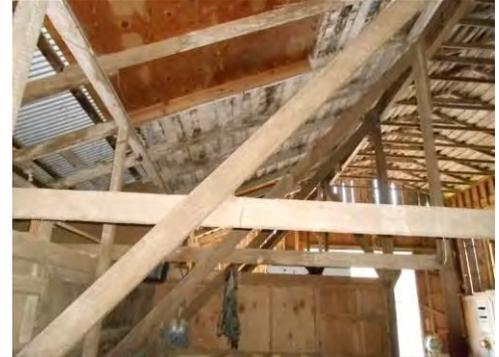
<p>Milking Barn (Hay Barn) north side structural and roof details (NPS Photo, 2013)</p>		<p>Milking Barn (Hay Barn) east entry wall detail (NPS Photo, 2013)</p>

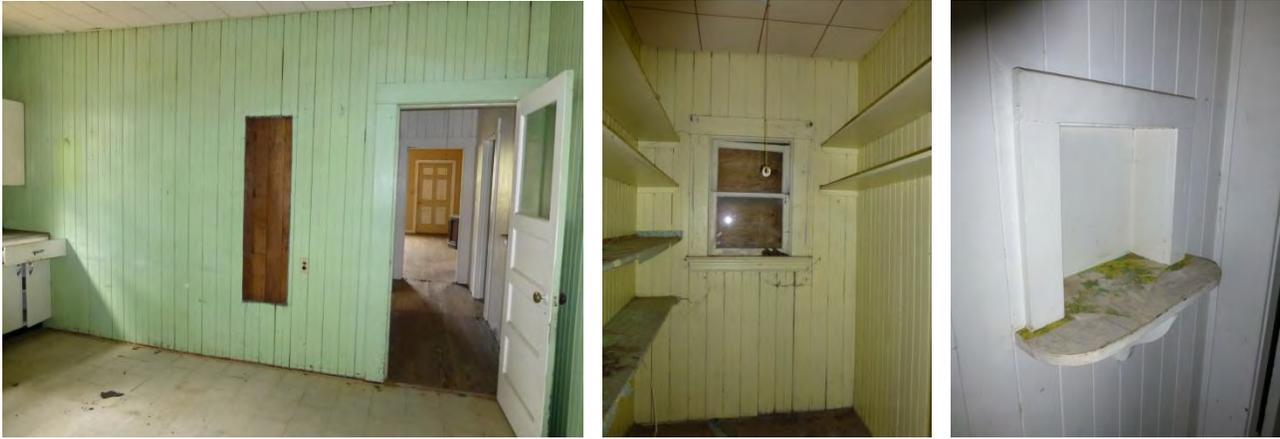
Condition: Many of the interior rooms are finished with a painted wood wall paneling. There are vertical and horizontal installations and V-groove and beadboard versions of this finish at the wall and ceiling. These finishes are highly sensitive to alteration and should be restored and repaired to the greatest extent possible to maintain the historic integrity of the former farm house interior. A section of panel is missing in the kitchen (possible location of a previous shelf or closet), but the majority of the wood paneling is in fair condition with some areas in good condition requiring some prep and paint. Other architectural features including wood shelves in the pantry and the small shelf in the hallway should be maintained and restored. Less sensitive to alteration of course, are the acoustic ceiling tiles found in most rooms and wallboard finished spaces at the front north part of the building.

Beadboard wood panel (Room 210), pantry shelving (room 209), hallway shelf (Room 211) (NPS Photos 2013)

Recommendation: Restore or repair wood beadboard and V-groove wall finishes. Remove all acoustic ceiling tiles to reveal the remaining wood panel ceiling finishes and restore. Wallboard wall finishes may remain and should not be given new wood panel finishes to match the rest of the house. Surfaces may be painted a new color to suit the new use of the building.
